Evaluation and Conservation of Fissures

Report

Watts Towers State Historic Park

Los Angeles, California

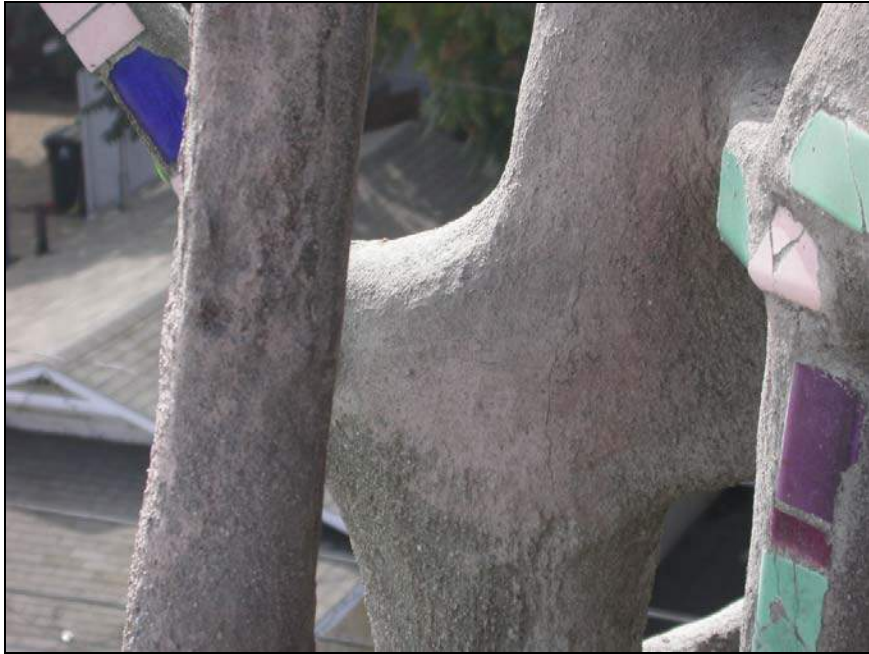
Condition type 1: One of the common conditions noted in the survey of the towers are hairline cracks. (See Appendix A, Figure 4). The use of the term 'hairline' in describing cracks in concrete or mortar is generally agreed upon to refer to cracks so small in width that they are barely perceptible and are nonstructural.² Another criterion used in the Watts Towers survey was that cracks having a width less than 0.5 millimeters, or 0.02 inches, were classified as hairline cracks. Approximately 70 hairline cracks were noted in the three tallest towers. The majority of the hairline cracks identified in the survey are in areas of previous repairs. This includes a few areas where there are multiple hairline cracks in a pattern of craze cracking. (See Appendix A, Figure 5). Hairline cracks can be caused by a number of factors, including shrinkage of the mortar during its initial set, differential expansion of materials due to corrosion of reinforcement, movement, or wind, seismic, or thermal stresses. Cracking of cementitious materials usually occurs because proper application procedures were not followed, resulting in high evaporation during initial cure or too wet a mix, although it can also be caused by carbonation of the surface layer which results in shrinkage of the cementitious material. Even at hairline cracks, moisture,

Figure 4: Hairline crack on Center Tower at intersection between exterior column and brace in an area of previous repair.

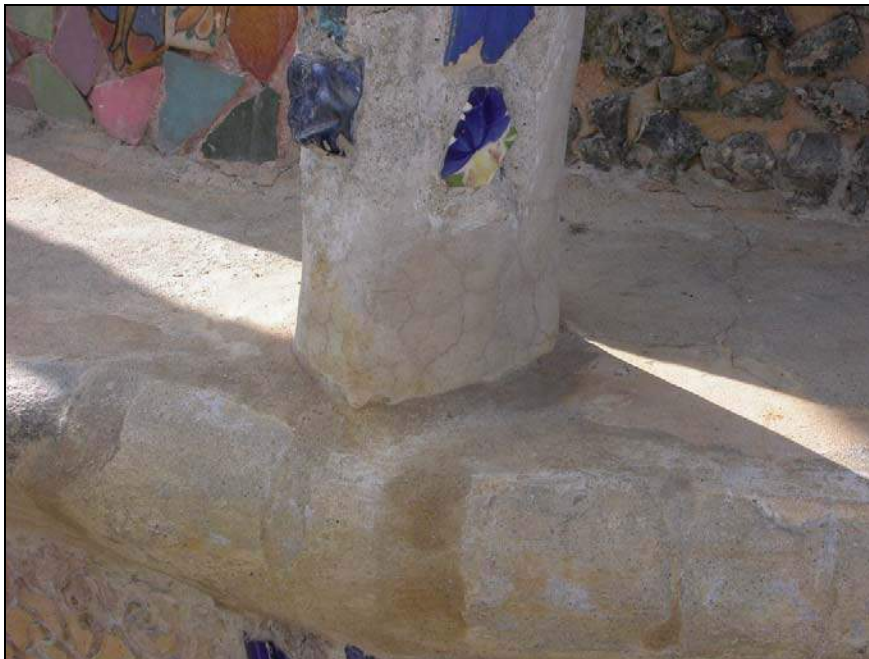
Figure 5: Crazing at previous repair on West Tower at bottom of exterior column.

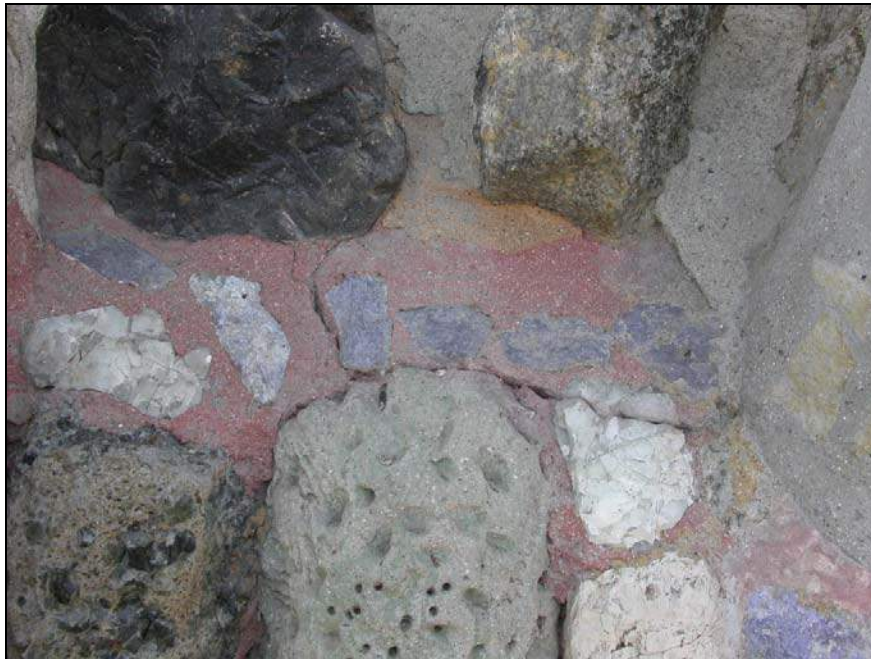
Condition type 2: There are over 100 cracks at the three tallest towers that are larger than hairline width and where the mortar at the edges and around the crack is sound. (See Appendix A, Figures 6 to 10). These cracks vary in length from 1 to 2 inches to over 48 inches. The longer, wider cracks tend to occur on the exterior columns. The most likely cause of these cracks is differential expansion of materials due to corrosion of the internal reinforcement that has caused the displacement of the mortar shell. Once the crack is larger than hairline width, water can more easily enter the crack and the metal corrosion-mortar cracking cycle propagates. Although there is no obvious pattern to most of the cracking observed at the towers, the exterior columns on the Center Tower exhibit a series of vertical cracking that is most likely due to corrosion of the armature.

Figure 6: Crack on Center Tower at base.

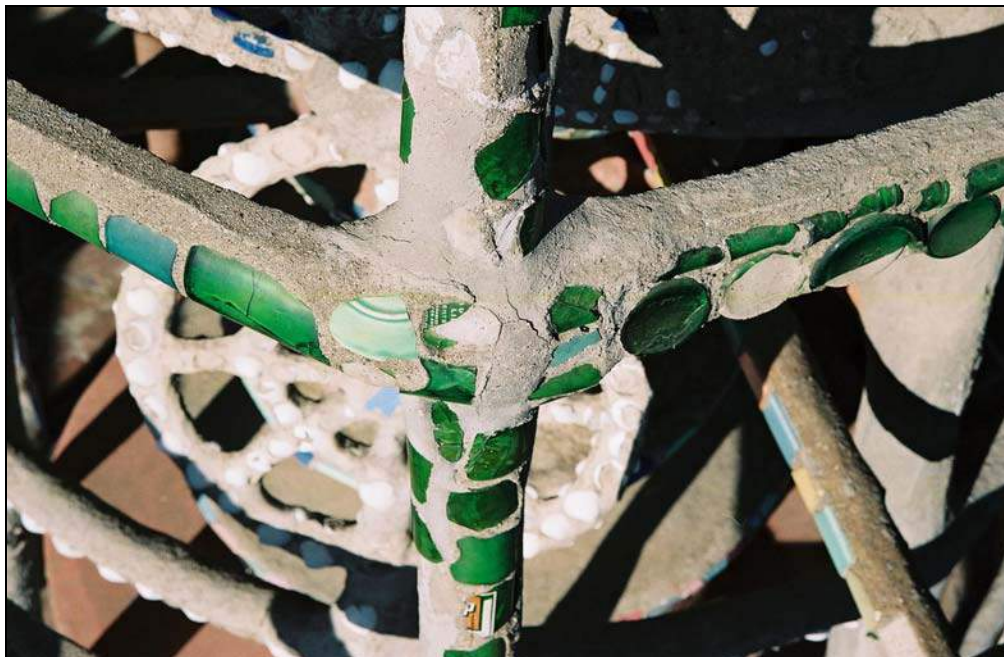
Figure 7: Crack on East Tower at intersection between of exterior column and exterior band.

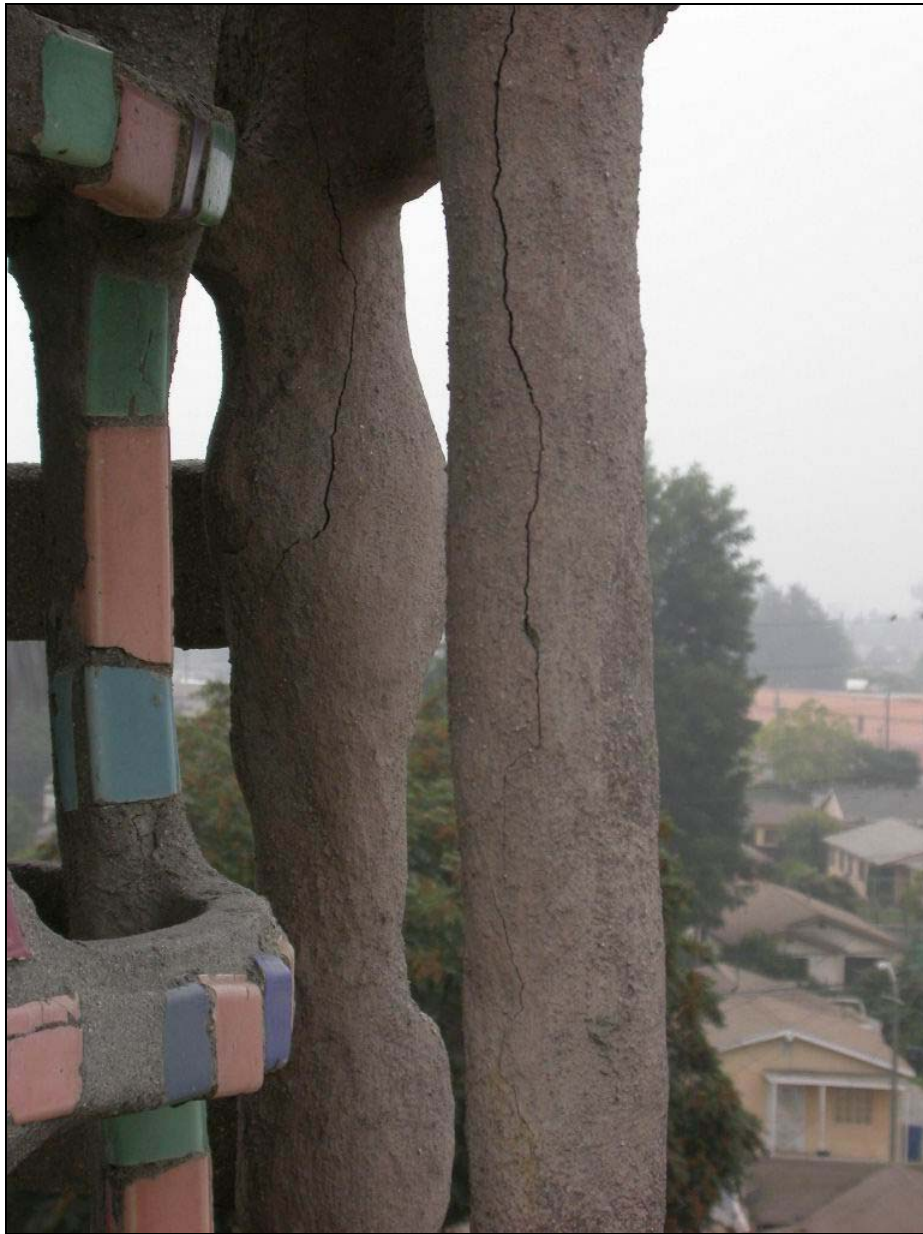
Figure 8: Crack on Center Tower at exterior column in an area of previous repair.

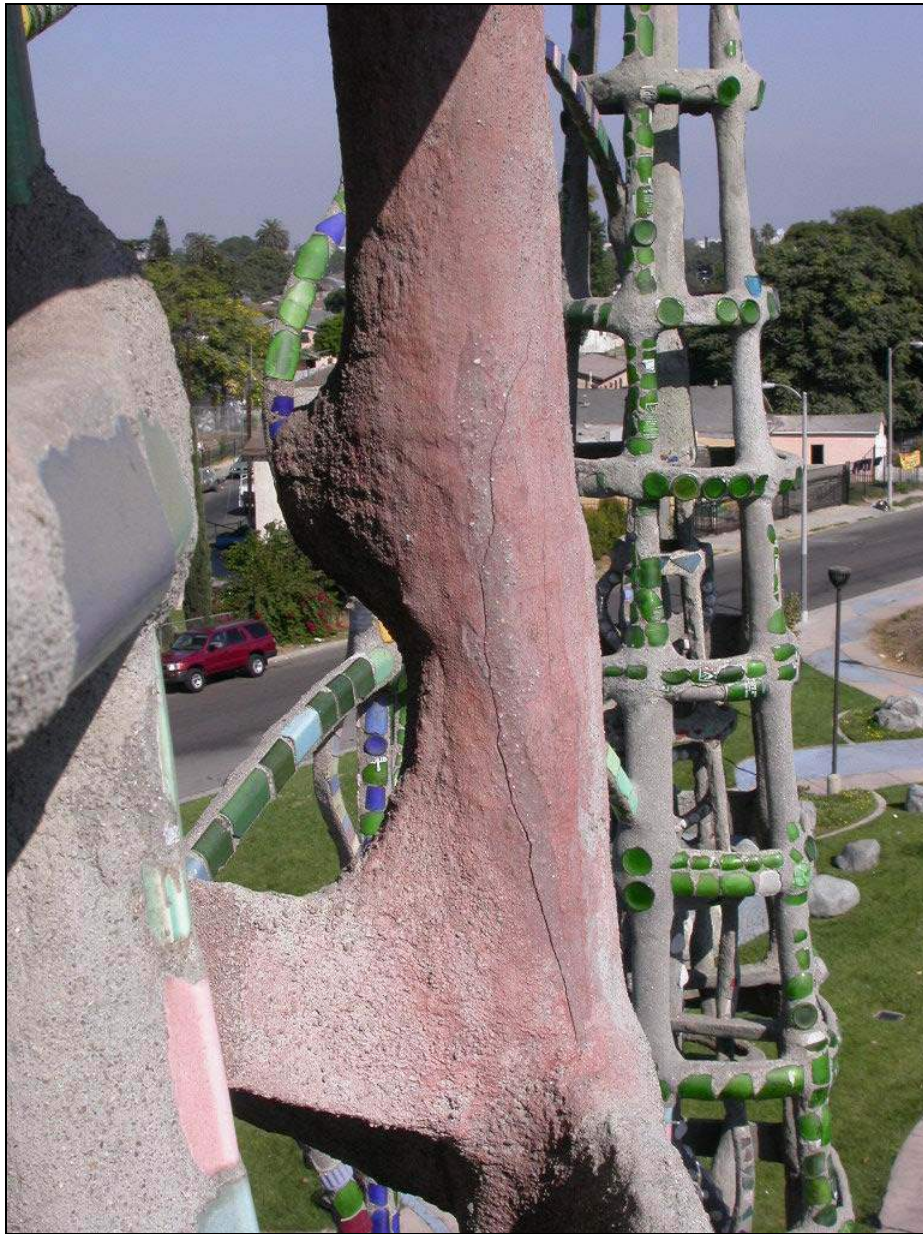
Figure 9: Cracks on Center Tower at exterior columns.

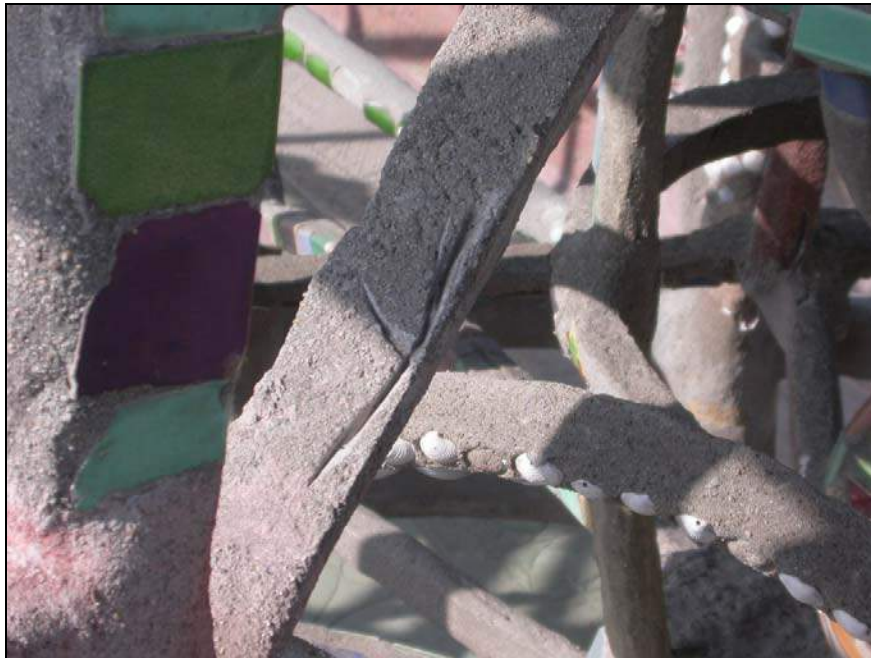
Figure 10: Crack on West Tower at loop that has been partially cut out.

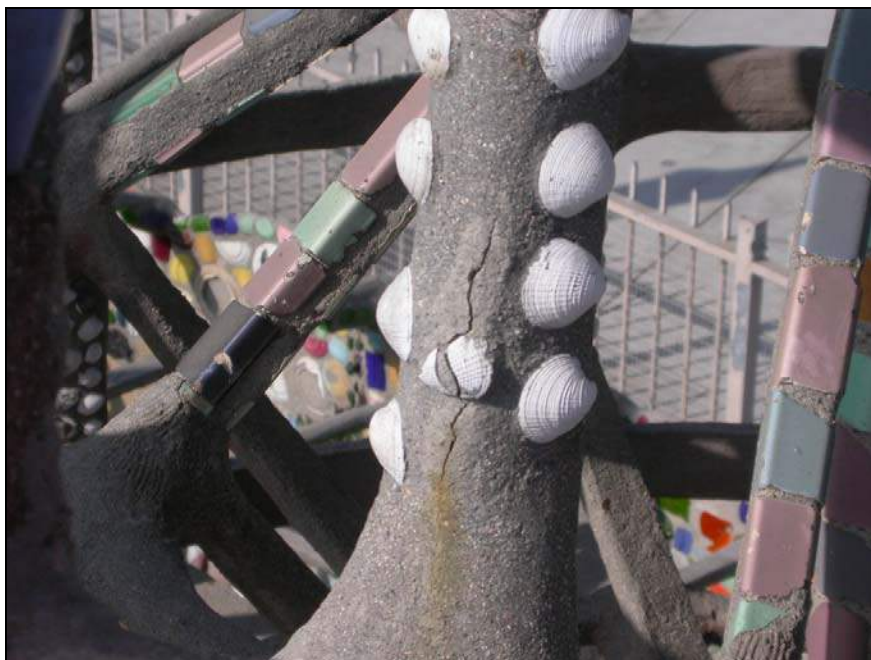
Condition type 3: Some of the cracks through the mortar shell also run through embedments. (See Appendix A, Figures 11 and 12). There are 16 examples of this condition on the three towers. This does not include the cracks that travel through areas where there is an impression of a former embedment or where there was once an embedment that is no longer present. The cracks through the embedments affect all of the different embedment materials. The presence of glass, ceramic, shell, and metal embedments introduce another cause of cracking because the embedments may concentrate thermal stresses or result in differential coefficients of thermal expansion and contraction.

Condition type 5: In some cases, there is iron staining associated with the cracking, typically at the bottom of the crack. (See Appendix A, Figure 11). This indicates that there is active corrosion at the steel armature or wire mesh, and the corrosion products are being carried to the mortar surface by water and moisture. There are also areas of exposed wire mesh, where the shallow cover of the mortar shell has eroded or was insufficient in its original application to completely cover the mesh. (See Appendix A, Figure 13). In most cases, corrosion of the metal is visible, but there is no cracking, spalling, or other deterioration at the surrounding mortar. Most of these areas of exposed metal are quite small, typically less than 6 inches by 6 inches.

Figure 11: Crack through shell embedding on West Tower at exterior column showing iron staining at bottom of crack.

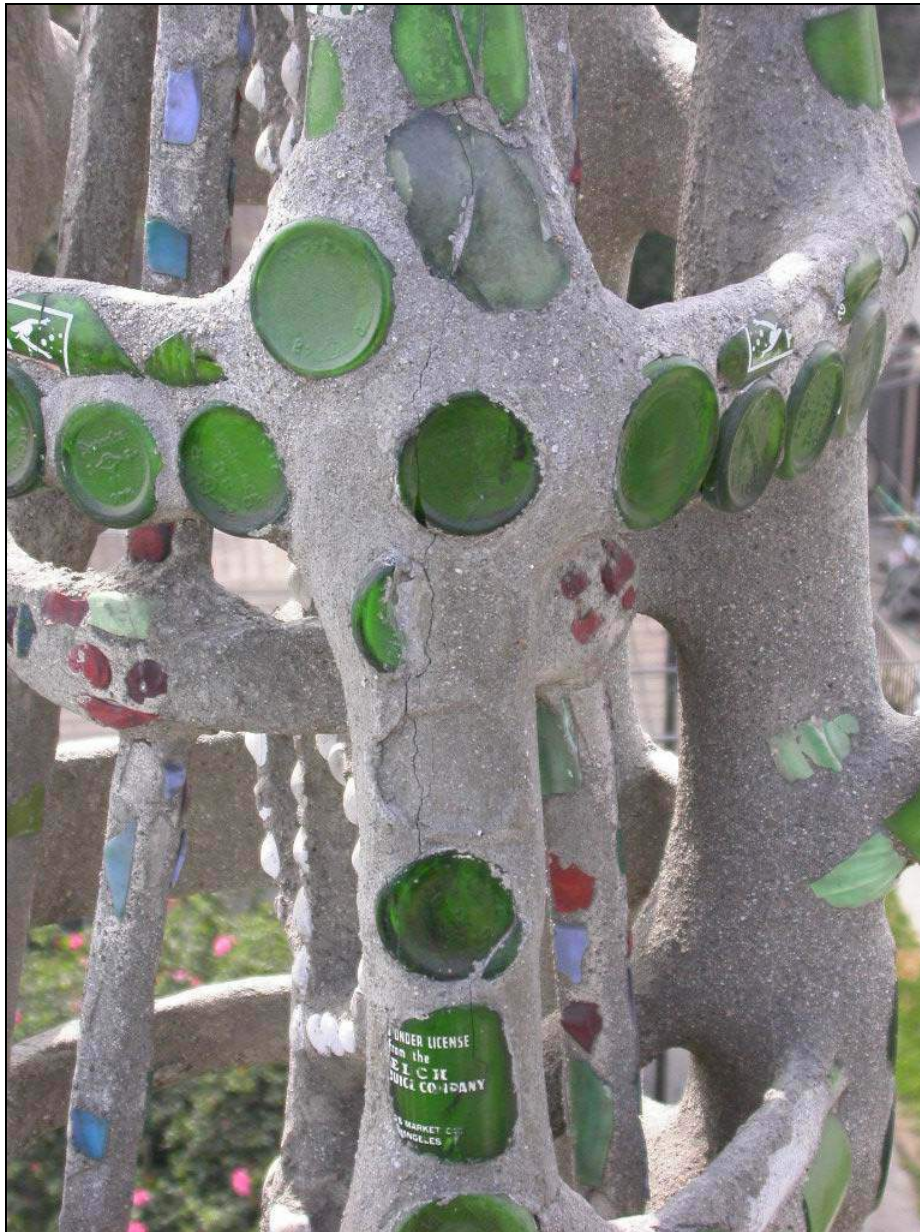
Figure 12: Cracks on East Tower at exterior column through glass embedment.

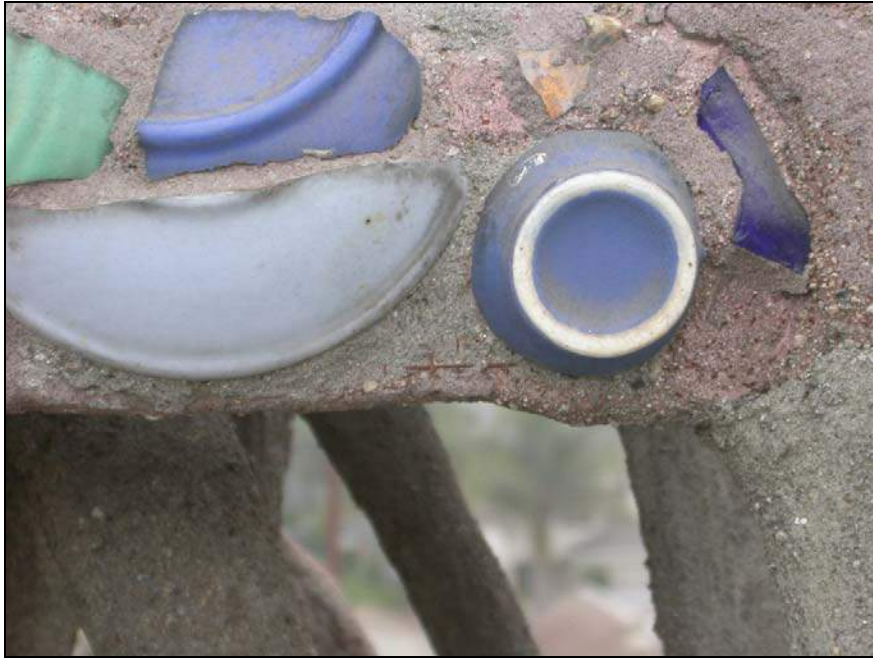
Figure 13: Exposed wire mesh at bottom left of embedded cup on Center Tower.

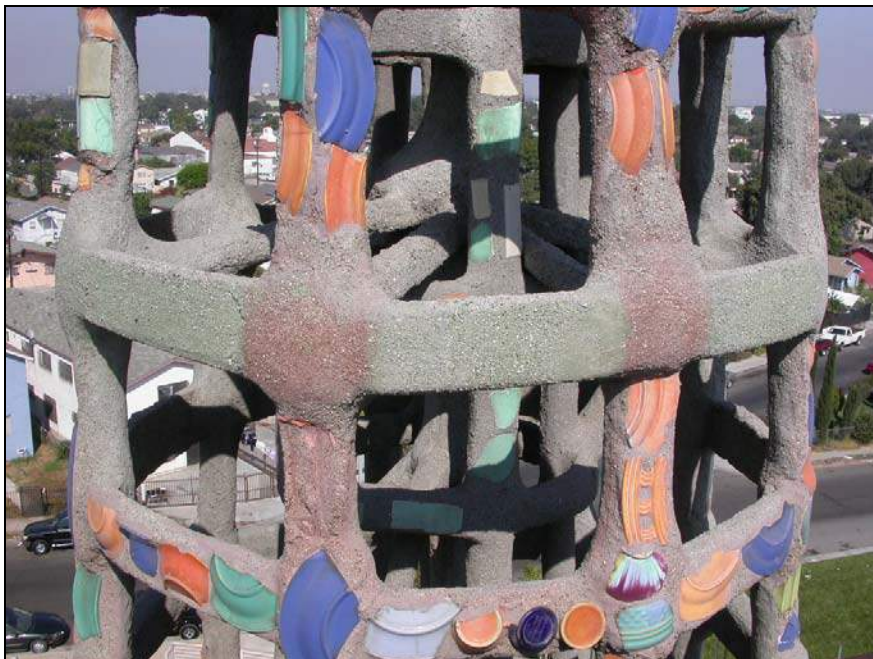
Figure 14: View of south elevation of Center Tower showing different mortar colors used.

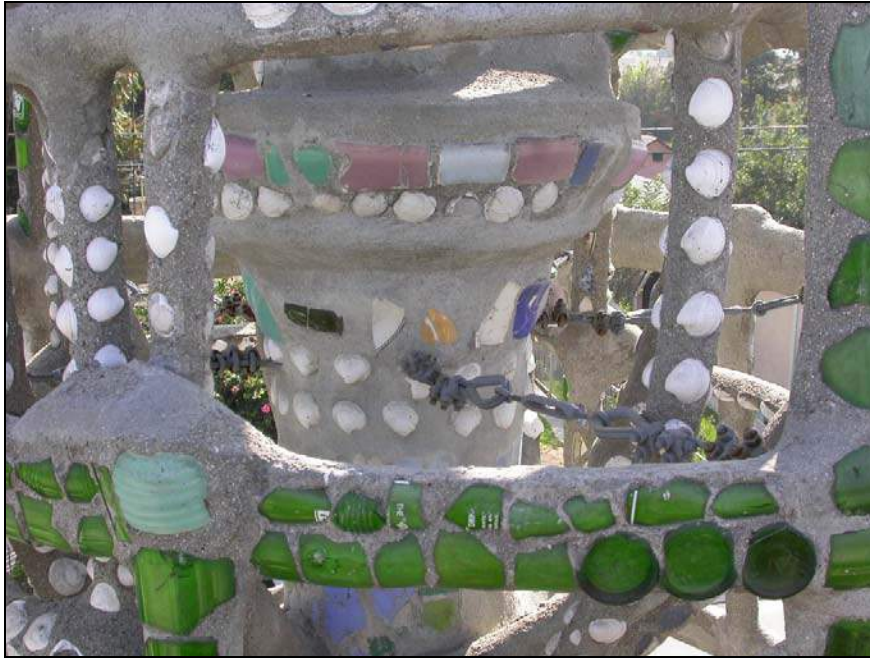
Figure 15: Cable bracing at Center Tower.

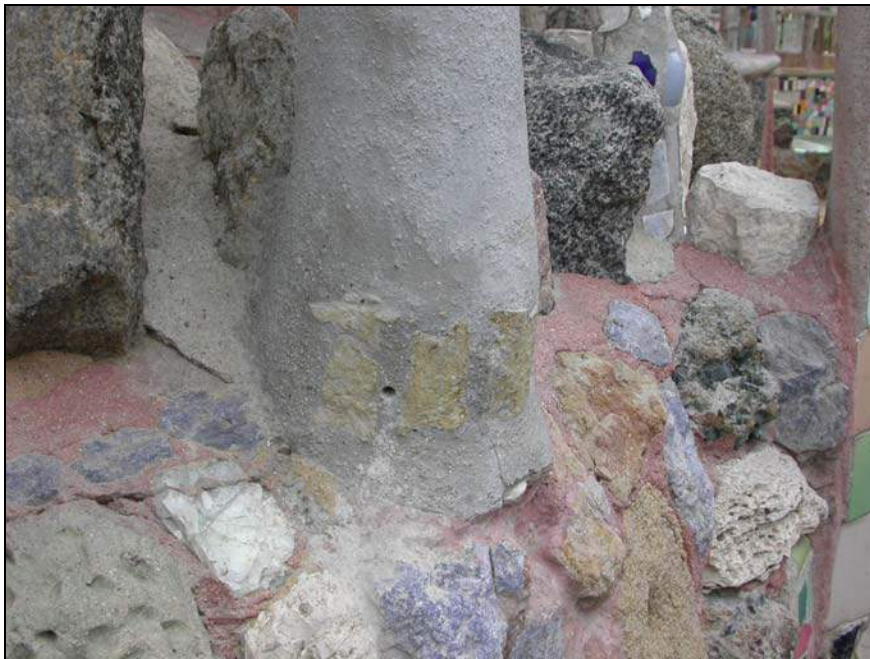
Figure 16: Weep hole at bottom of exterior column at Center Tower.

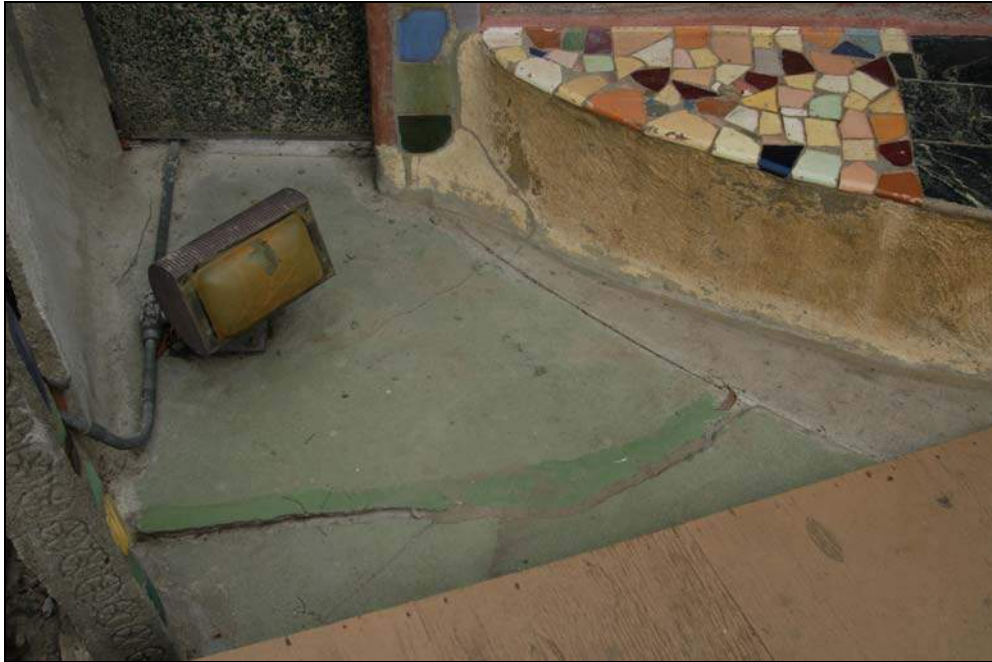
Figure 19: Floor at northwest corner of site showing crack with displacement and previous repair.

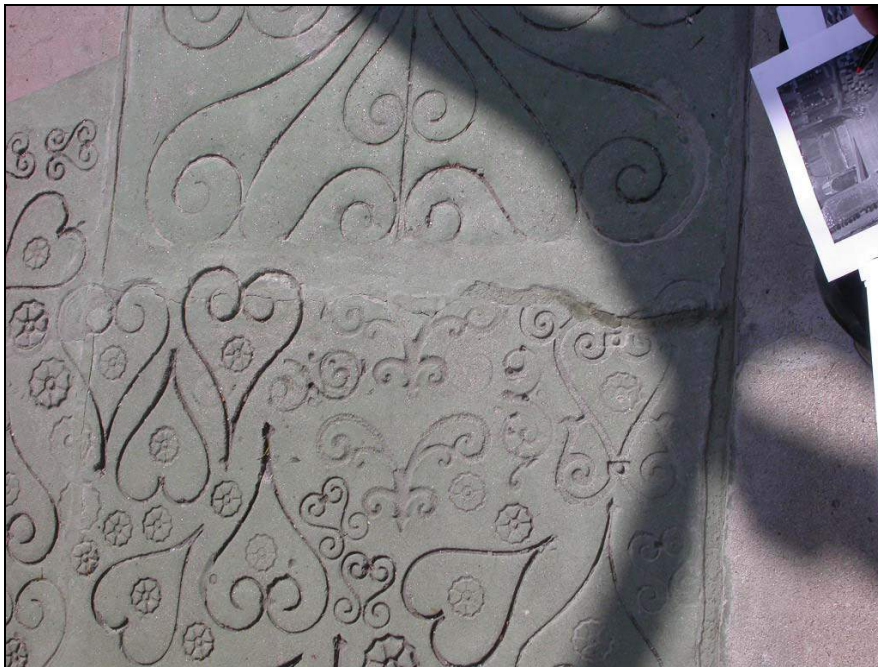
Figure 20: Crack through green colored concrete that has been previously repaired.

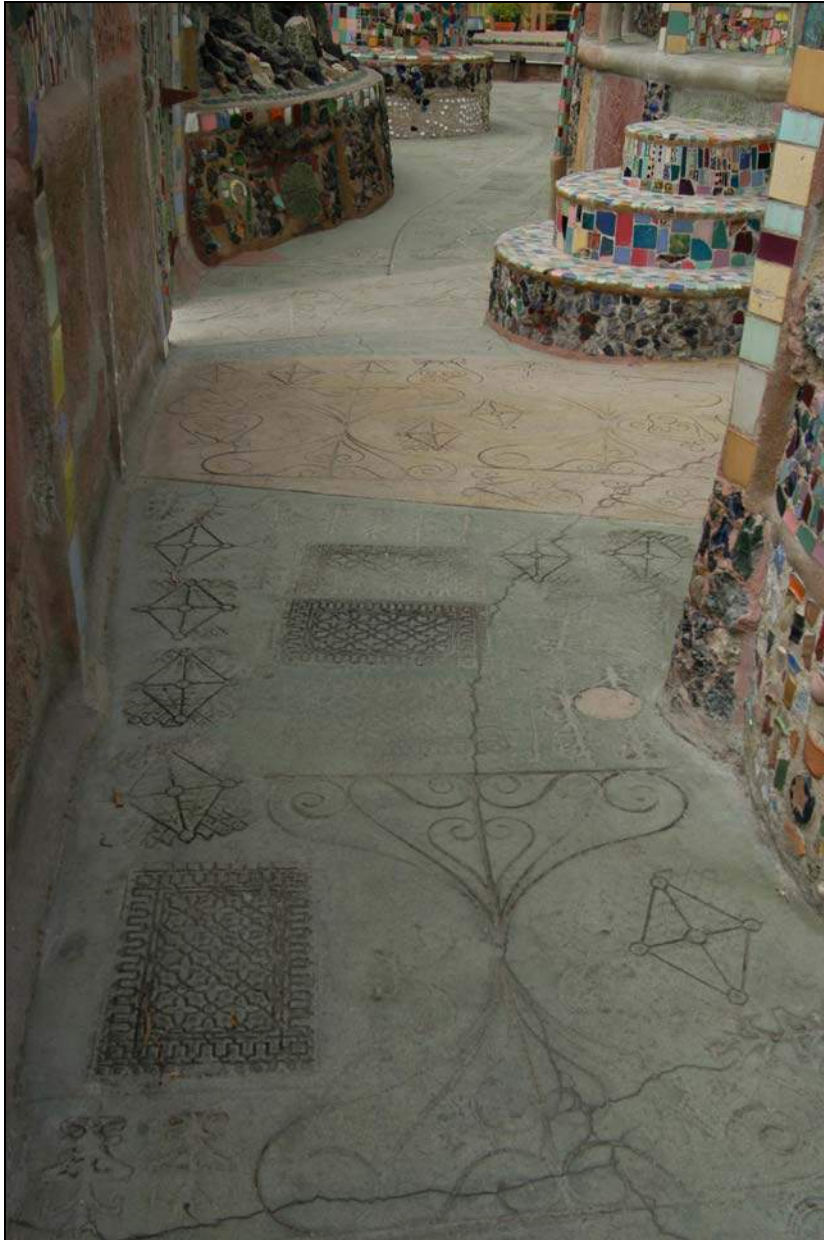
One of the patterns observed in the cracking of the ornamental floor is a series of cracks connected by score lines in the floor that encircles the Center Tower. There is no displacement at this crack, indicating that it is not related to an active structural condition and the more likely cause may be related to the foundation material underneath the center tower. In general, drainage of water off of the ornamental floor is good. Water that falls on the floor tends to drain toward openings at the bottom of the north and south walls. These openings, roughly 4 inches by 4 inches, are assumed to be original to Simon Rodia's construction and intended for this purpose. One location that does not drain well was observed on the north side of the Center Tower. At this location, two sections of concrete slope downward toward each other, forming a valley where water collects. This condition may be original to the construction of the floor, as there are no signs of cracking or later displacement that would indicate a later condition. There is also poor drainage of the ornamental floor at the northwest corner of the site, where water can penetrate below the floor slab at areas of open soil. At this location poor drainage and movement of the soil underlying the ornamental floor has resulted in severe displacement of the floor.

Figure 21: Floor at south side of Center Tower with crack circling the perimeter of the tower approximately 2 feet from the base.

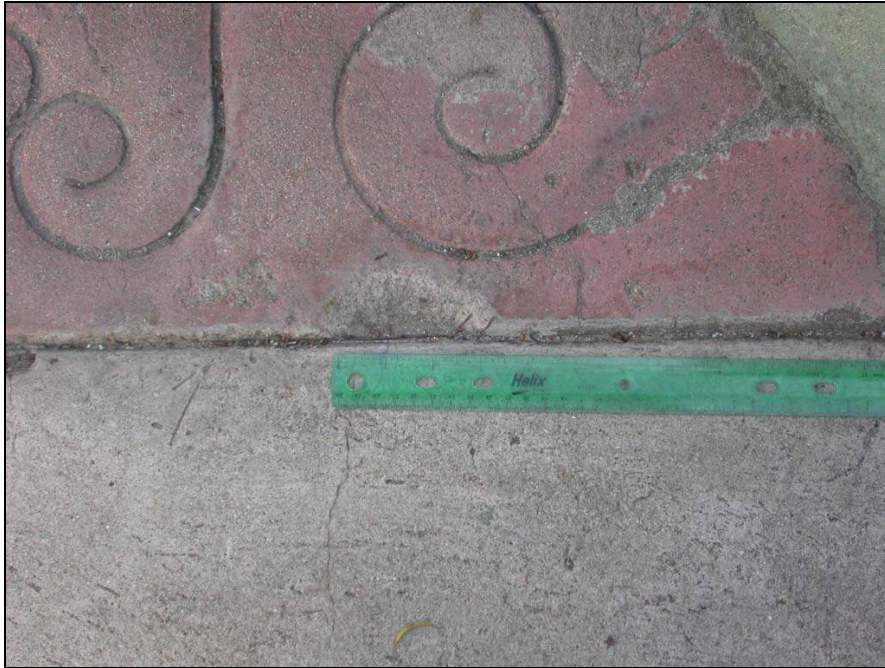
Condition type 8: Cracks that are larger than hairline are each documented on a photograph. These large cracks may also have some edge damage along the length of crack, or exhibit some minor displacement. The cracks that exhibit minor displacement were noted because they could potentially be a tripping hazard. There is one location where more distinct displacement occurs, this area is in the northwest corner of the site adjacent to the gazebo. (See Appendix A, Figures 19 to 21). There are a number of spalls on the concrete flooring; however, most are small and exist in locations that are vulnerable to spalling, like the areas where the metal gates attach to the concrete flooring. (See Appendix A, Figure 22)

Figure 22: Spall at edge of score line in concrete floor.

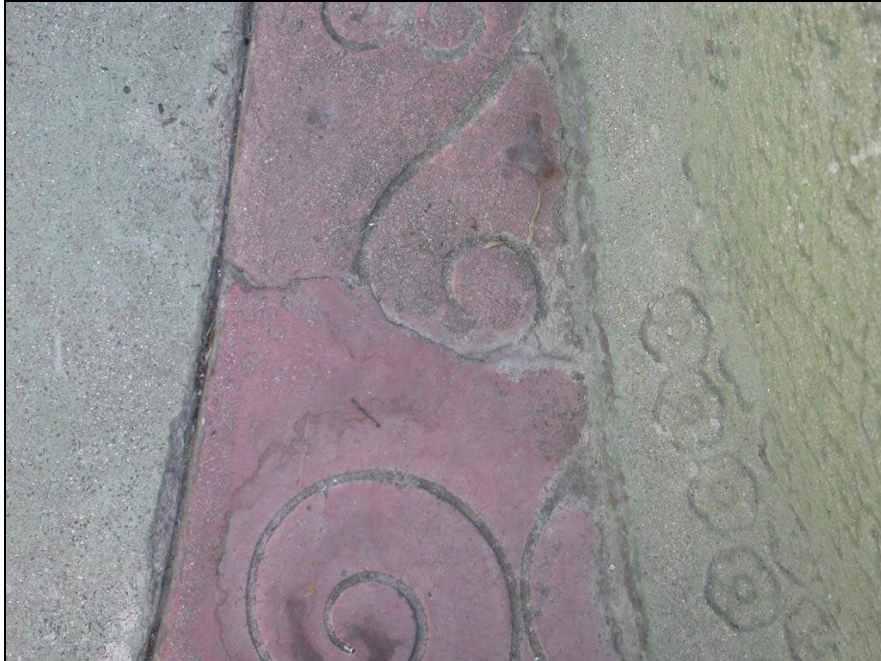
Figure 23: Patch (bottom of photograph) at red-colored concrete floor.

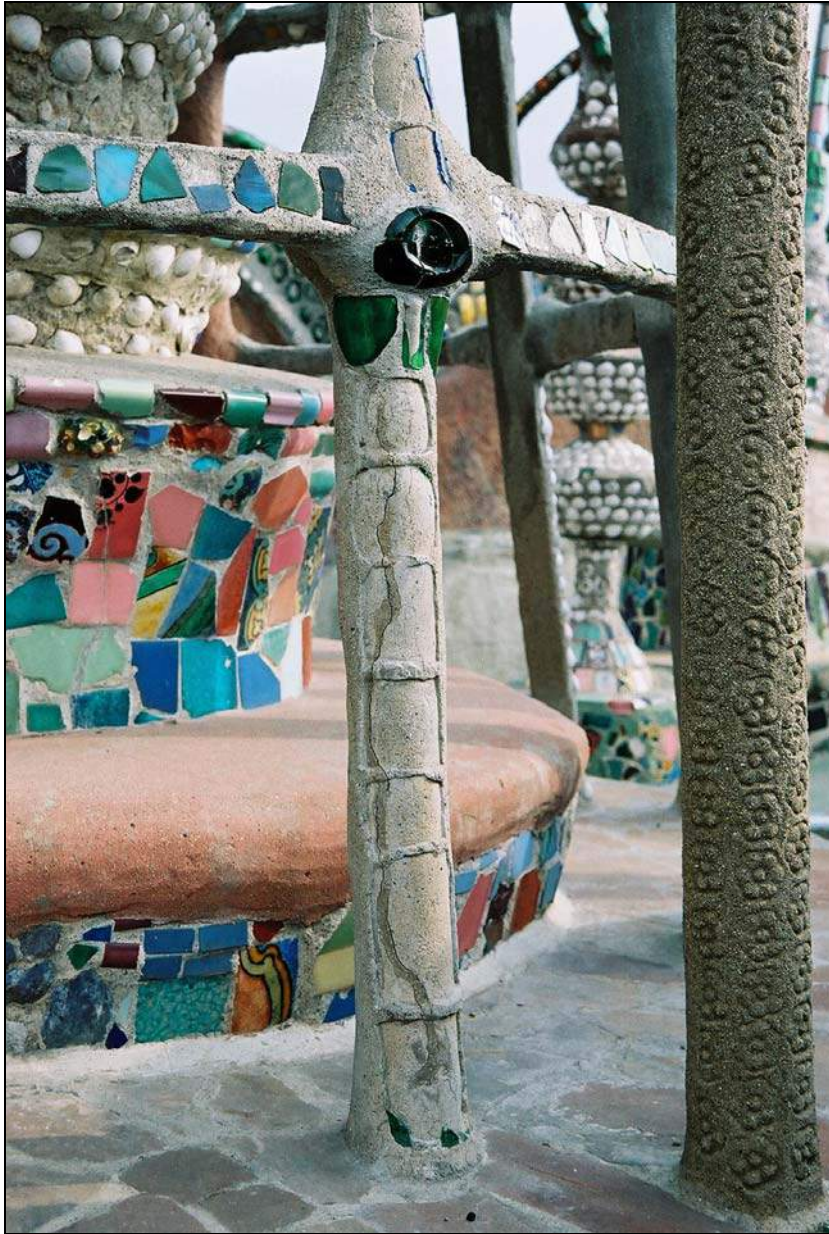
Figure 1: Mock-up no. 1 at intermediate column on south side of the East Tower before cutting out. The darker color mortar at the vertical crack is from a previous repair.

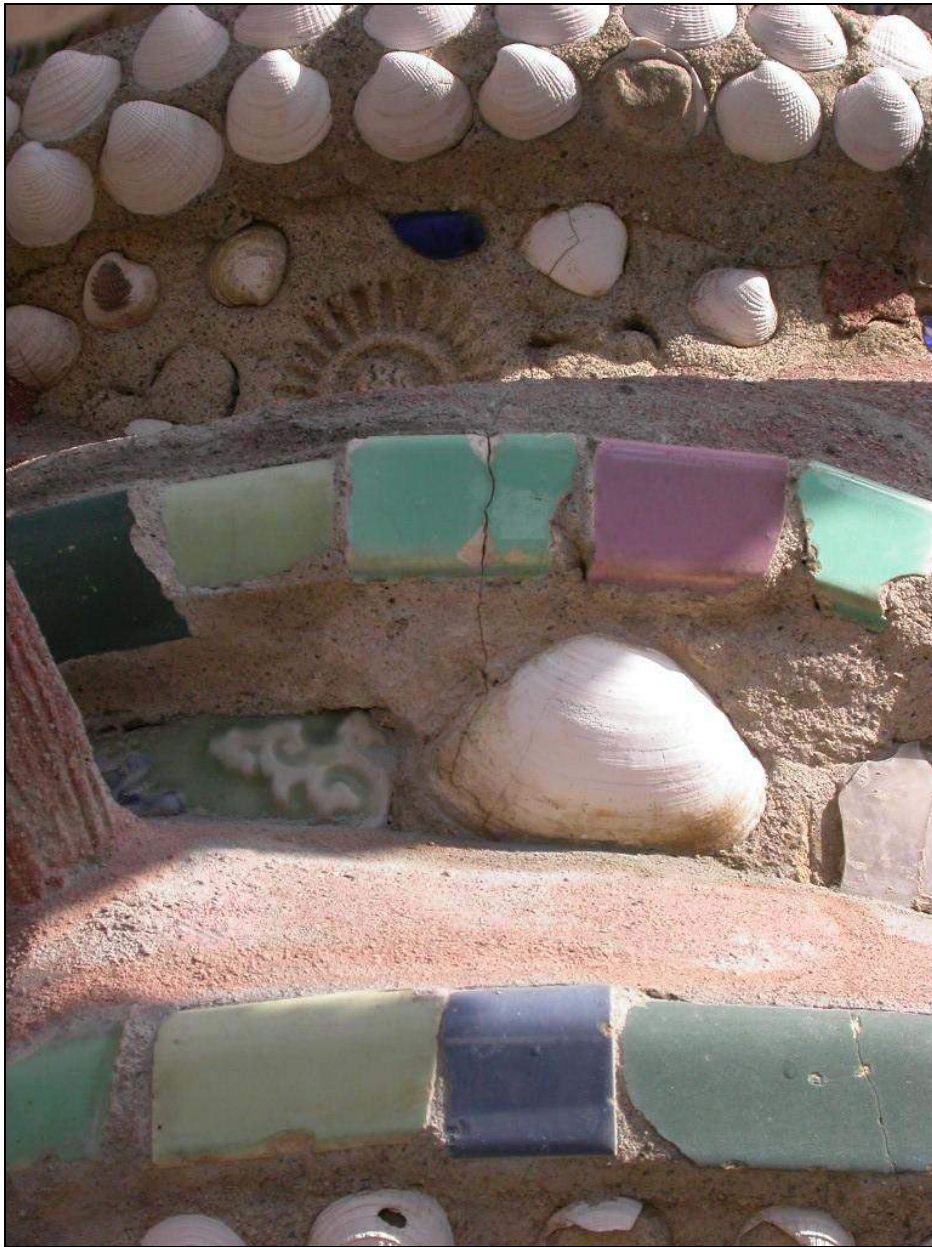
Figure 14: Mock-up no. 5 at center core of East Tower showing crack through mortar and embedded tile before treatment.

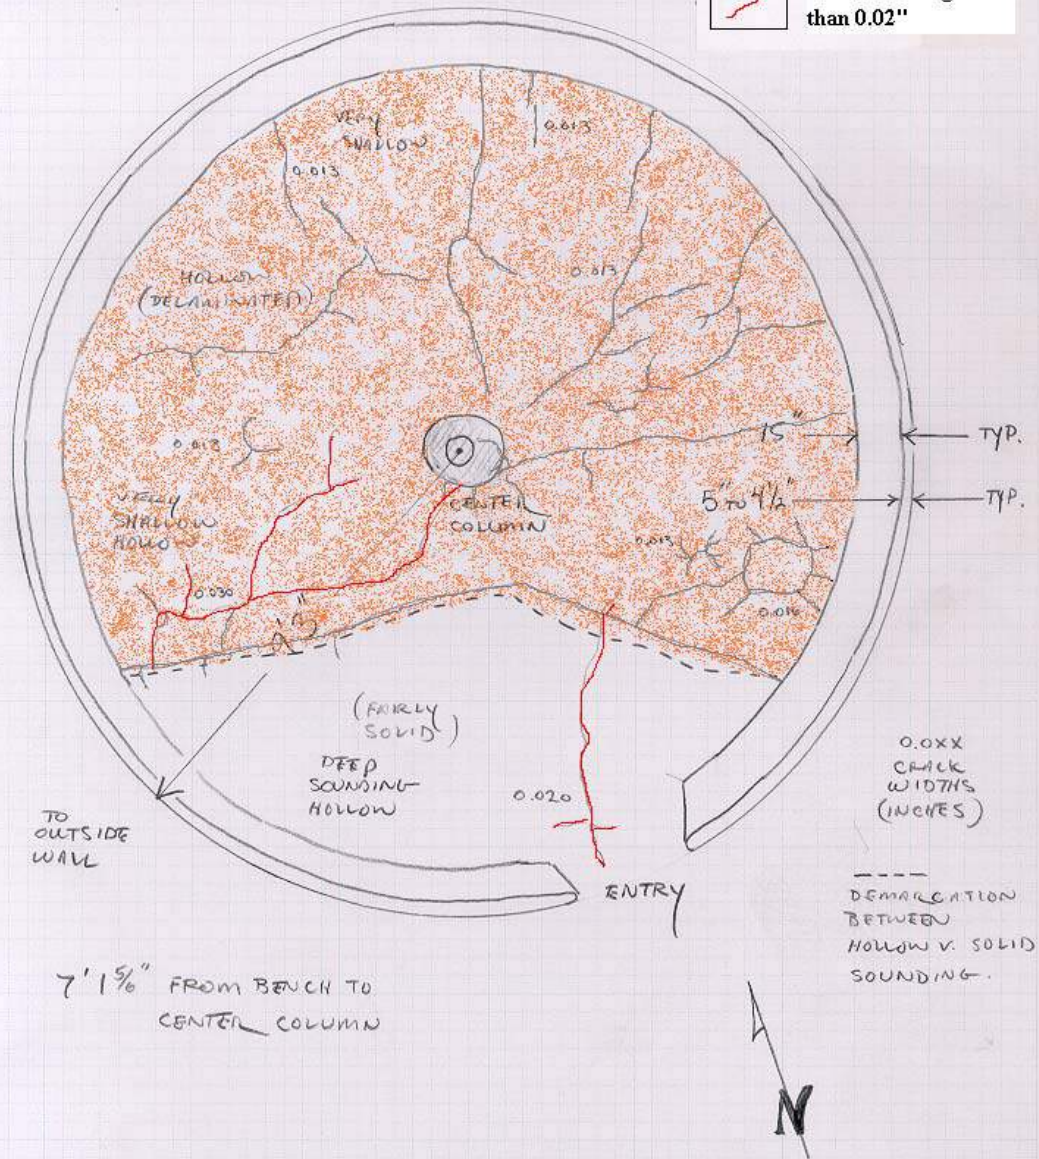
Figure 8. Sheet 1 from field notes. Gazebo crack pattern and area of hollow sounding.

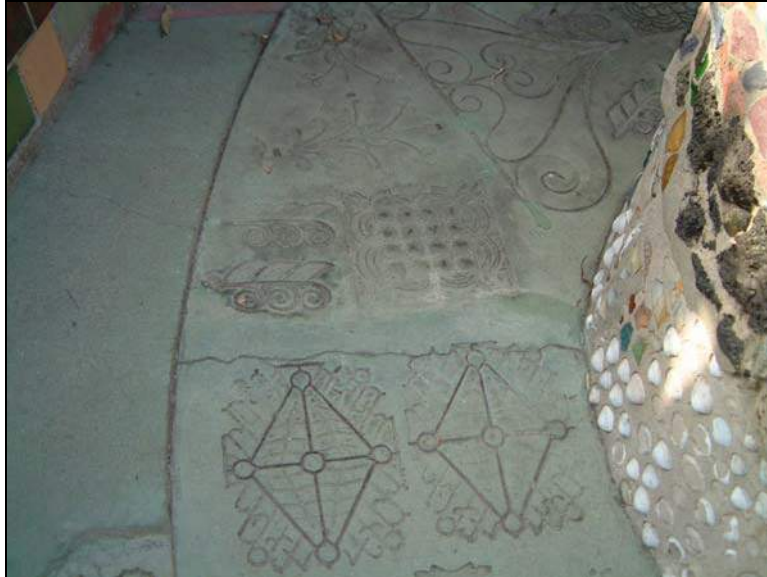
Photo 3. Crack development within sections. The cracks typically occurred perpendicular to the longest axis of the placement.

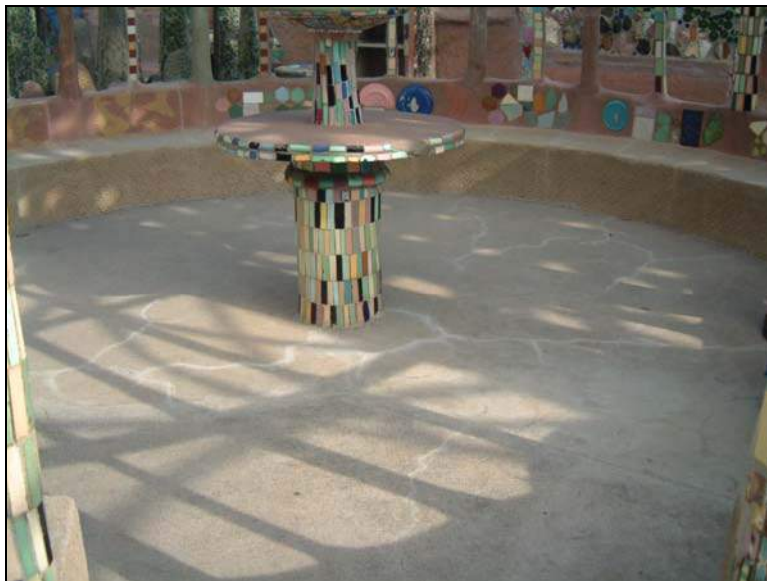
Photo 4. Crack pattern in Gazebo. The area in the foreground of photo had the least amount of cracks and had solid sounding indications. The area in the background (behind pedestal) had a large number of cracks and had hollow sounding indications.

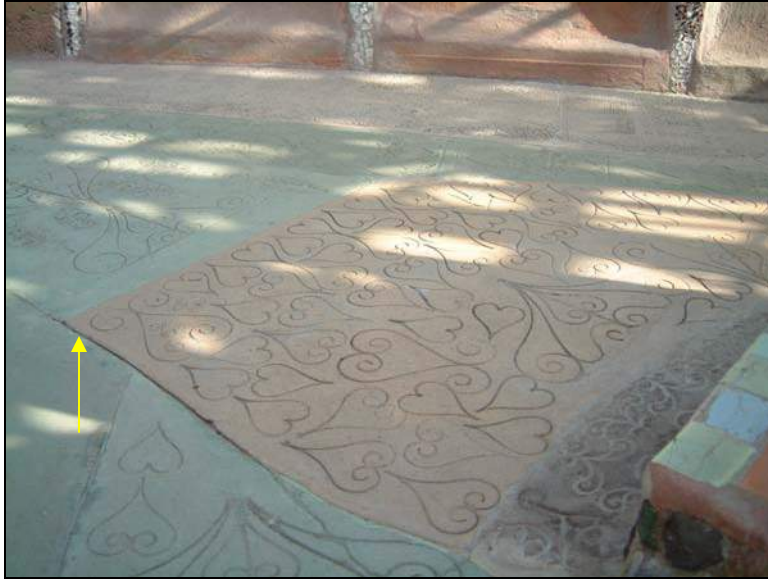
Photo 5. Slight uplift between colored sections just northwest of Center Tower (arrow).

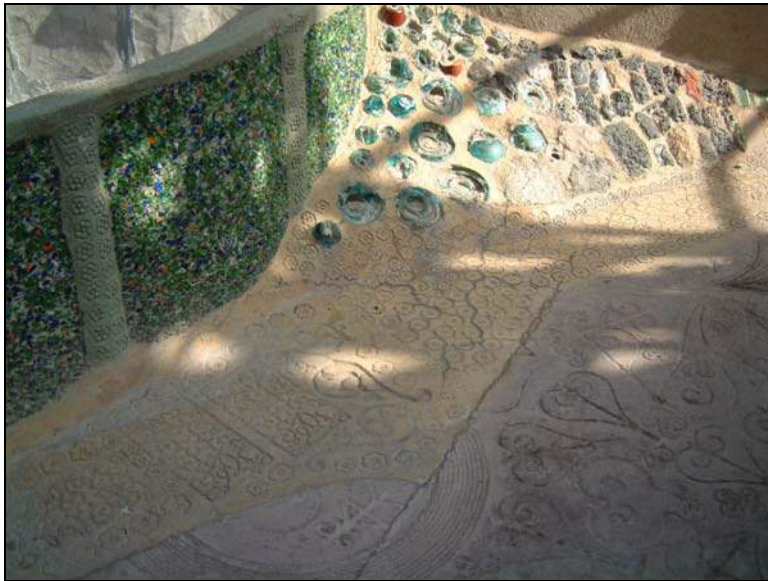
Photo 6. Cracking between color sections in southern portion of slab.

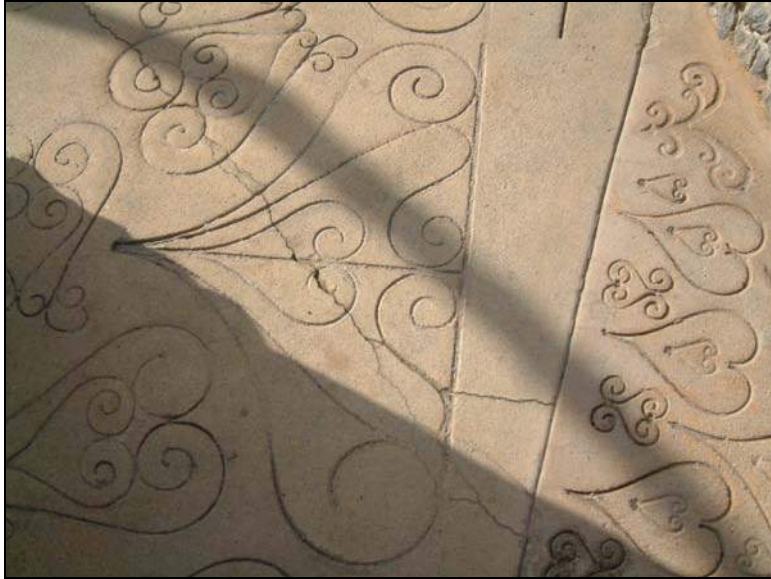
Photo 7. Cracking within section

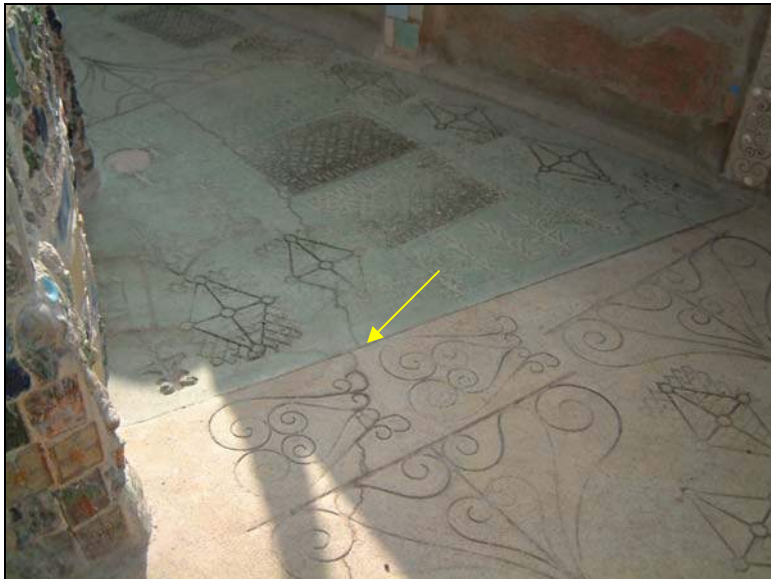
Photo 8. Crack bisecting section and crossing joint (arrow).

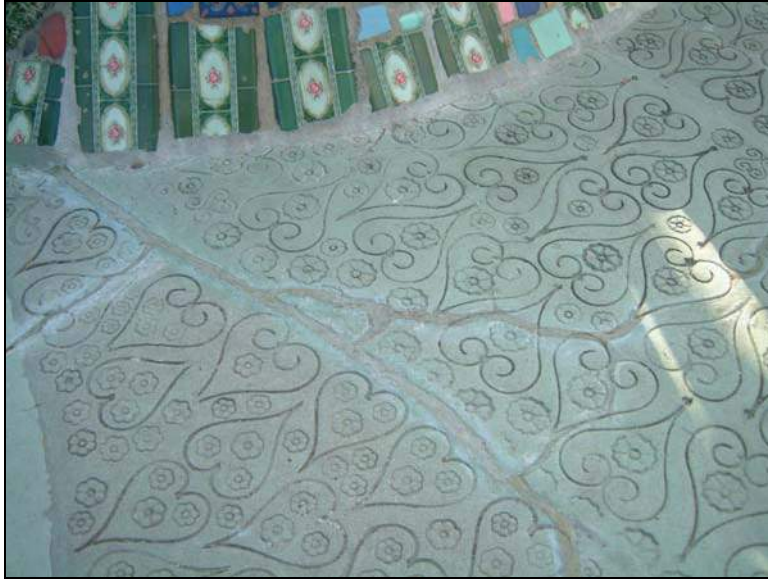
Photo 9. Repaired cracks in west portion of slab just west of West Tower.
