Documentation Synthesis and Materials Research

Draft Report

Watts Towers State Historic Park

Los Angeles, California

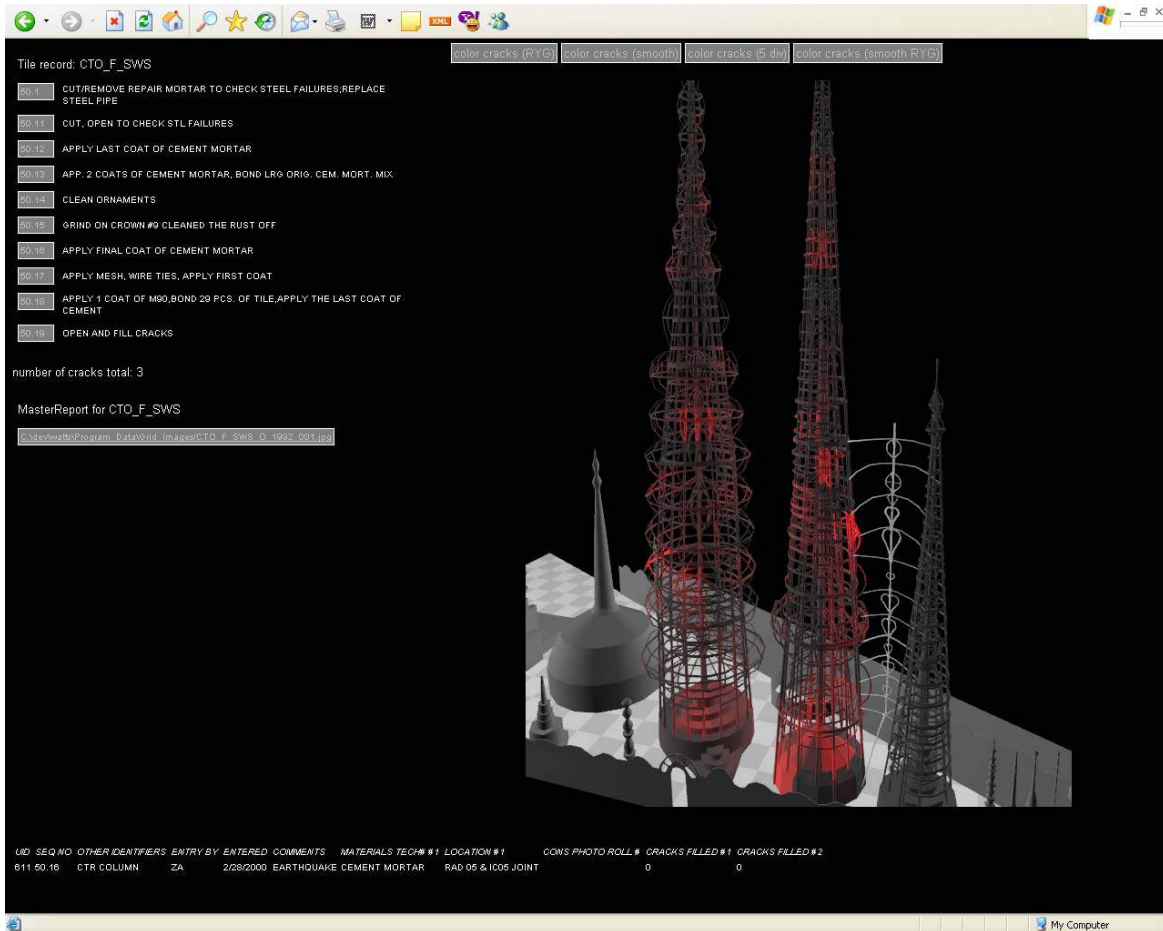
Figure 18 – The model can be color-coded based upon particular values in the database, such as cumulative number of cracks repaired per section.

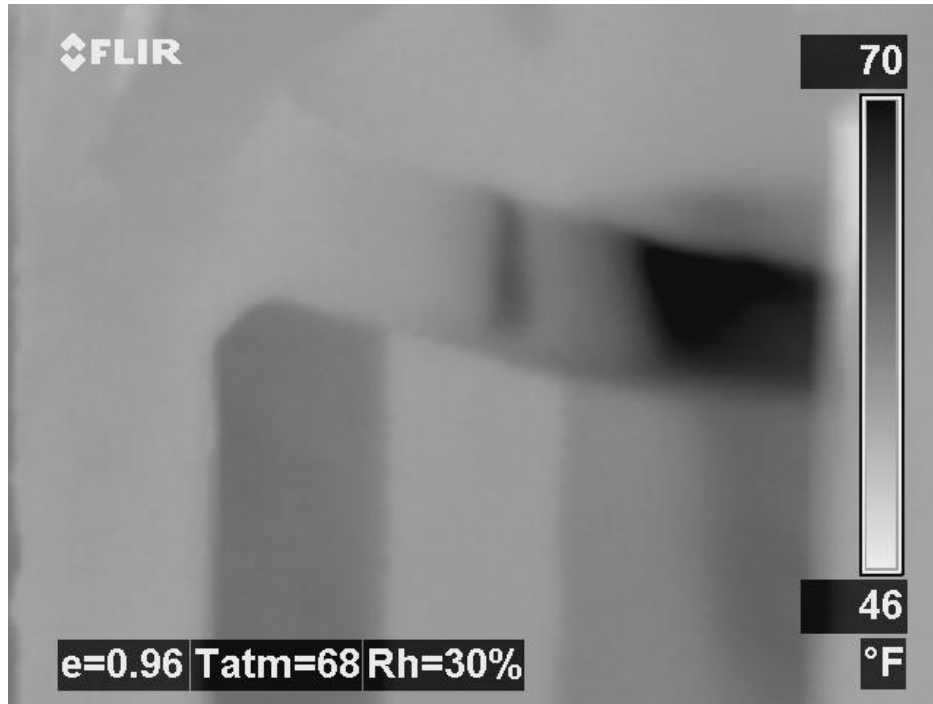
Figure 19 – ThermaCam Image. Dark areas show higher temperatures due to sun on surface. Light areas are in shadow and are cooler.

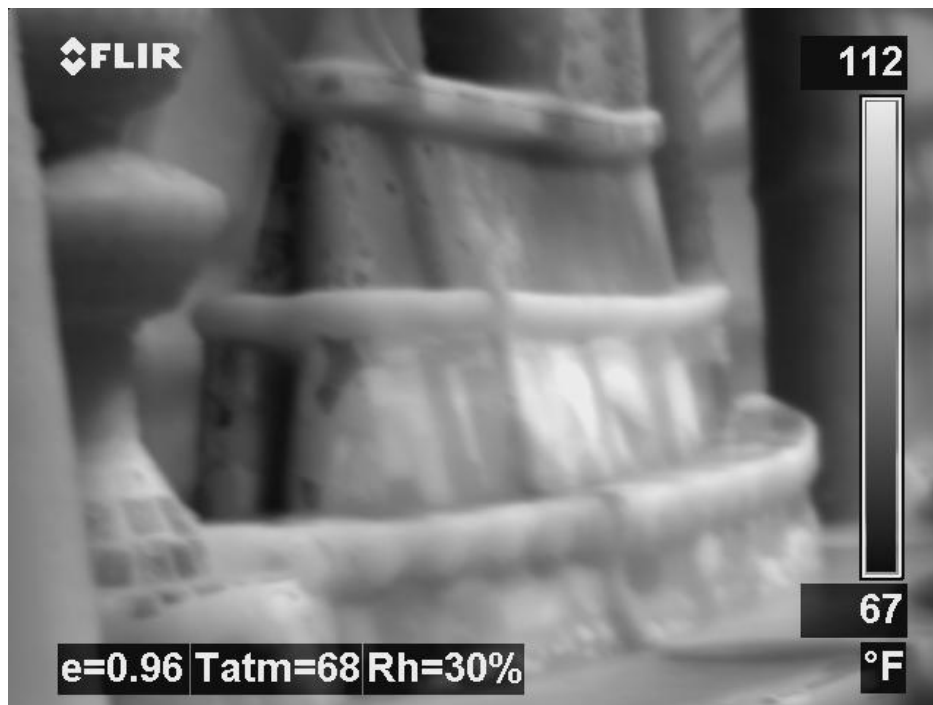
Figure 20 – ThermaCam Image at Ship of Marco Polo. Light areas are higher temperature. Glazed tiles reflect more energy than surrounding cement mortars. Tiles in foreground have cooler surfaces. Variations in mortar color are largely due to thermal variations from sunlight and shadows.

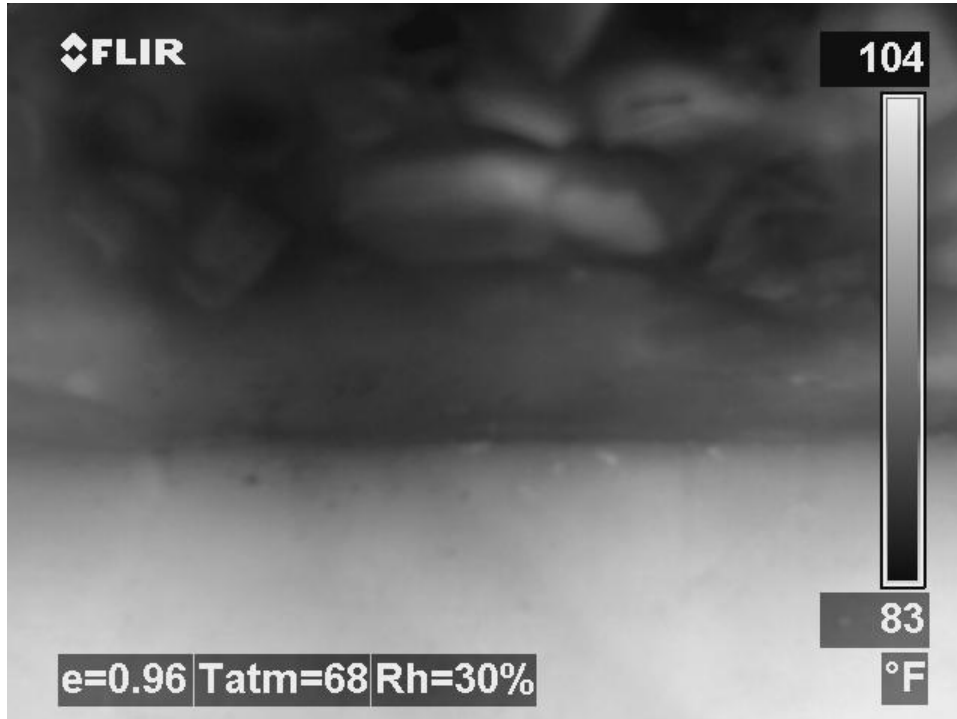
Figure 21 – ThermaCam Image of floor and interior wall. While the floor reflects a higher temperature, the wall has embedded rock that emits less heat. The darker area of the floor showed some moisture, which was more visible to the naked eye.

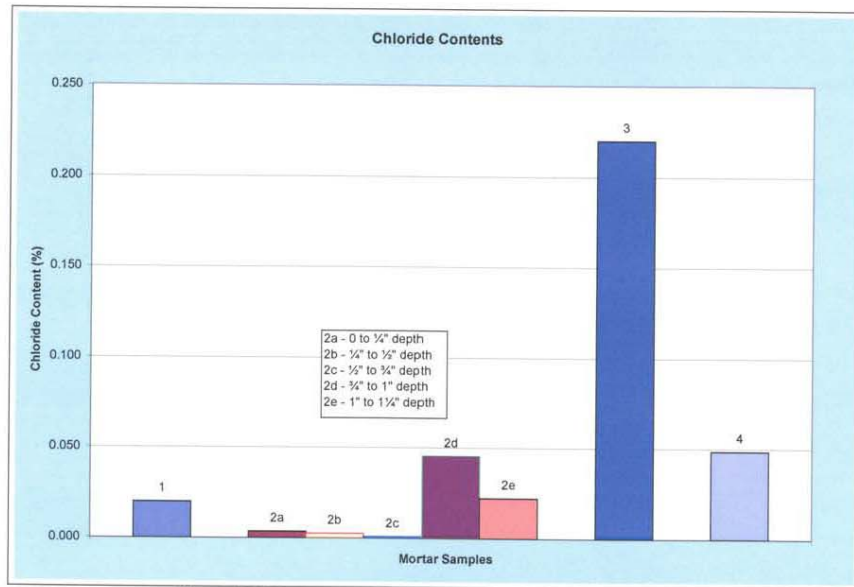
The suggested maximum acid-soluble chloride content for reinforced concrete (to minimize chloride-induced corrosion) is 0.025% by weight of concrete. (See conversions in AME report dated February 2, 2006 in Appendix D.) The 1982 samples are below the suggested maximum chloride level while some of the recent samples have much higher levels of chloride content.

Figure 1. Chloride Contents of Watts Towers Mortar Samples

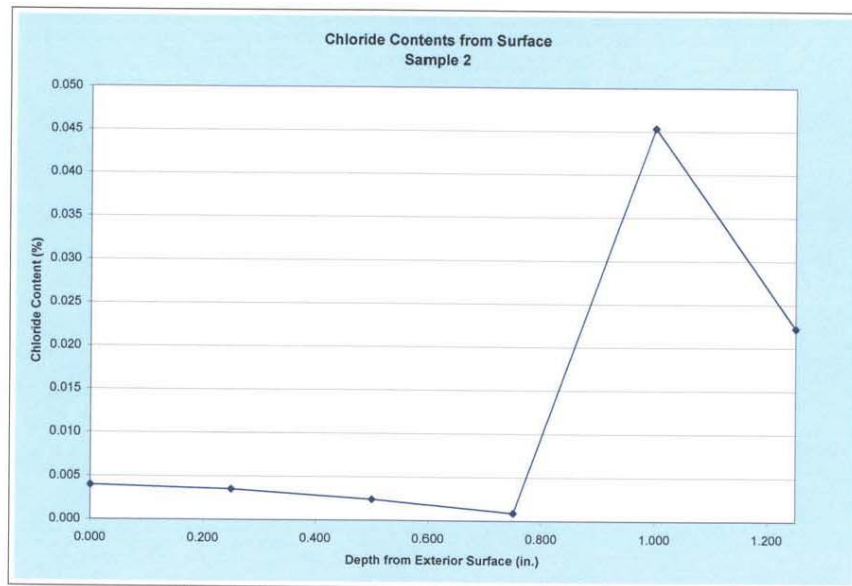
AME analyzed a profile of chloride content for one sample that showed a spike at 1" depth, corresponding to an interior elliptical crack around the sample's metal core about 0.2 inches from the metal.

Figure 2. Chloride Profile for Watts Towers Mortar Sample 2

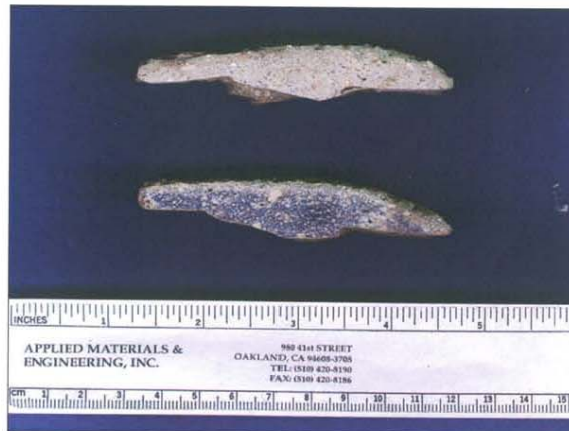
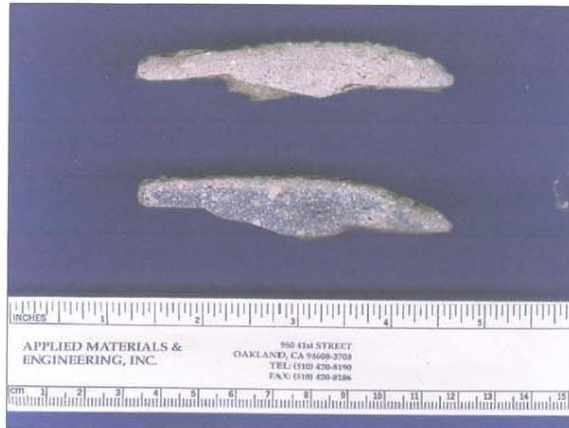
Photo 2. Sample 1 cross-sectional slices. The bottom section was treated with a pH indicator solution. The purple color of the paste indicates a pH greater than 13 (non-carbonated paste).

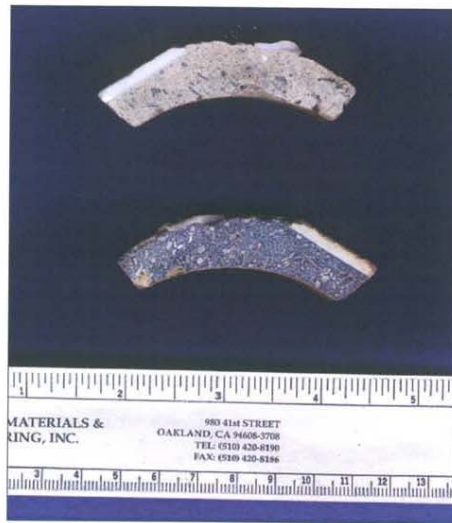
Photo 4. Sample 3 cross-sectional slices. The bottom section was treated with a pH indicator solution. The purple color of the paste indicates a pH greater than 13 (non-carbonated paste).

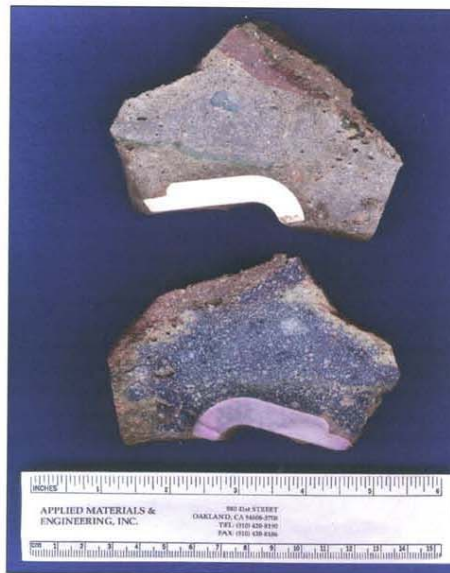
Photo 5. Sample 4 cross-sectional slices. The bottom section was treated with a pH indicator solution. The purple color of the paste indicates a pH greater than 13 (non-carbonated paste).

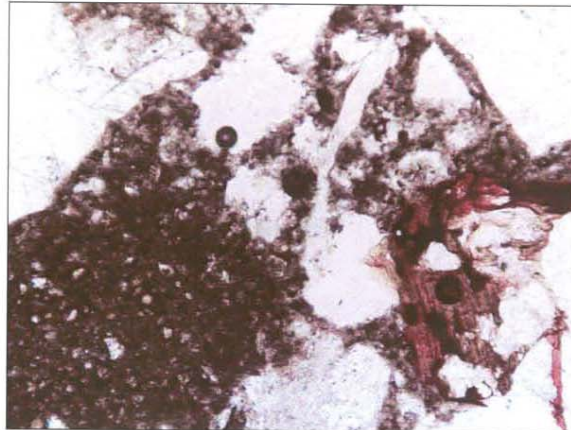
Photo 2. Photomicrograph showing the microstructure of Sample 2. The dark area in the lower left corner is an inclusion of neat portland cement paste. 100x magnification, plane-polarized light illumination

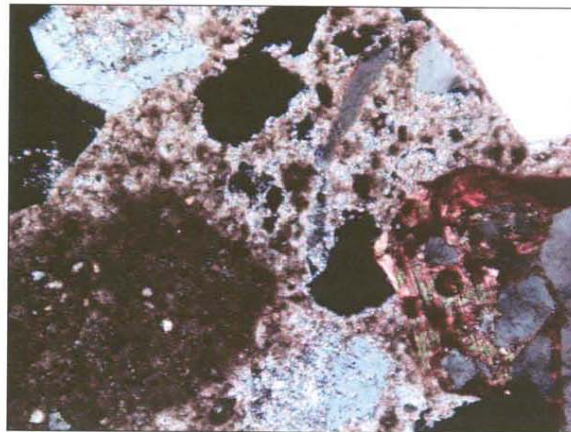
Photo 3. Same area as Photo 2 except viewed in cross-polarized light. The cement paste is completely carbonated (brightly colored area).

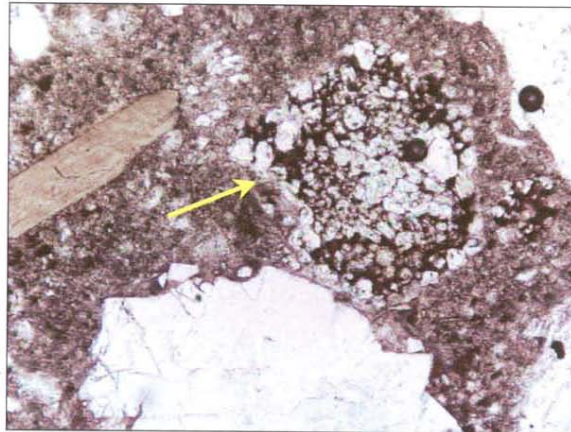
Photo 6. Photomicrograph showing the microstructure of Sample 4. The arrow points to a large unhydrated portland cement clinker particle (belite cluster). 100x magnification, plane-polarized light illumination

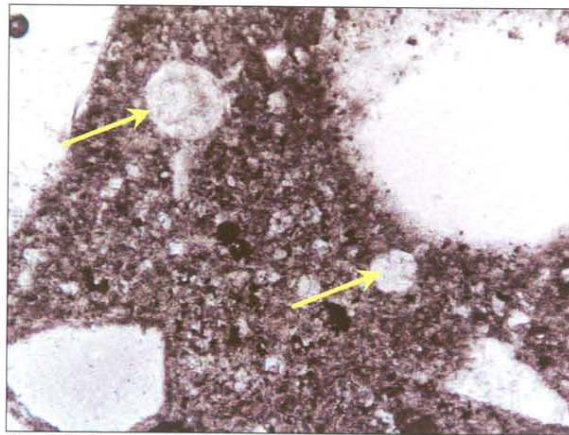
Photo 8. Another photomicrograph showing the microstructure of Sample 4. The arrows point to small spherical air voids filled with ettringite. 100x magnification, plane-polarized light illumination

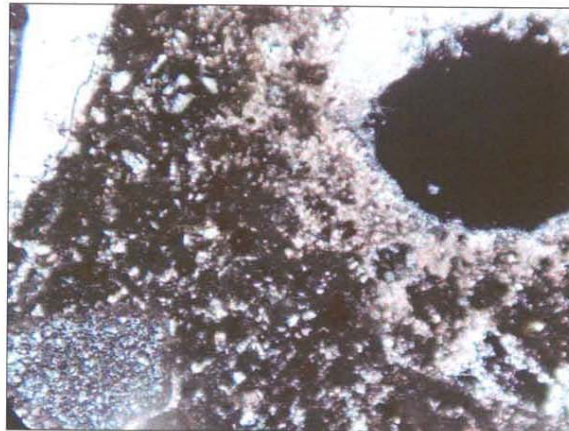
Photo 9. Same area as Photo 8 except viewed in cross-polarized light. The air void in the upper right corner is surrounded by carbonated cement paste.
