THE WATTS TOWERS
CONSERVATION REPORT

THE GAZEBO

June 1994

CONSERVATION OF THE GAZEBO
WATTS TOWERS CONSERVATION PROGRAM

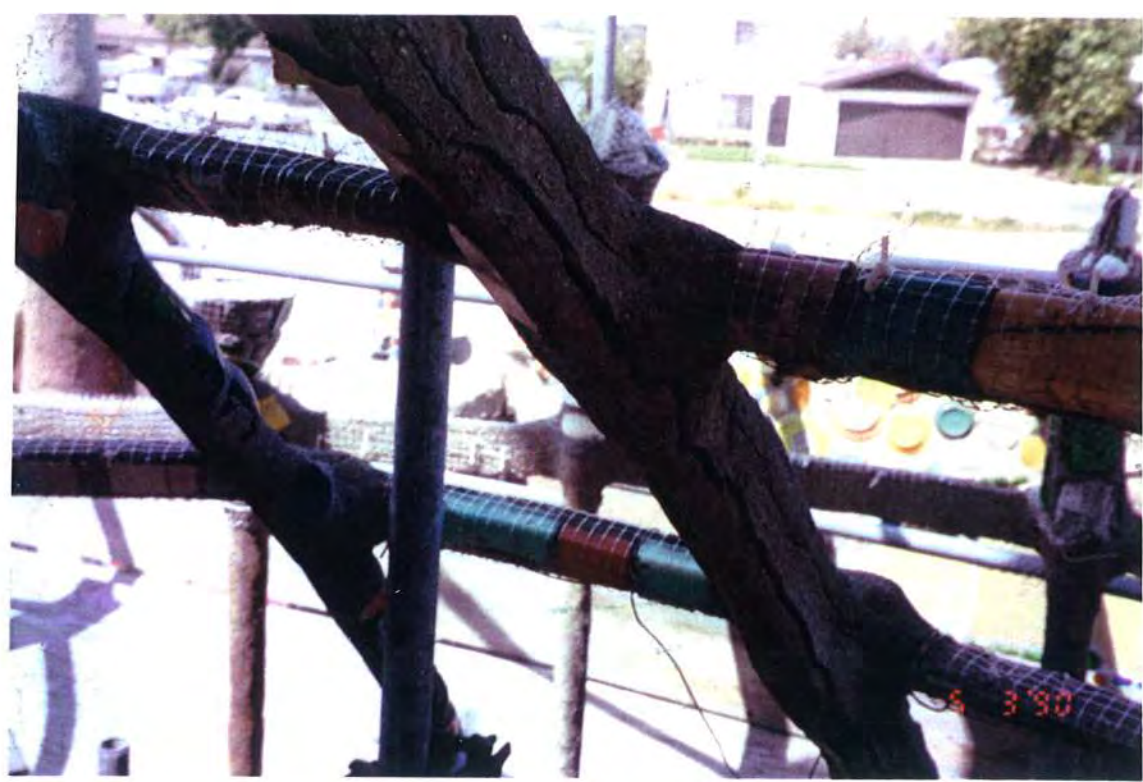
Figure 10.
Major crack in MajV02.
Mar 1990.

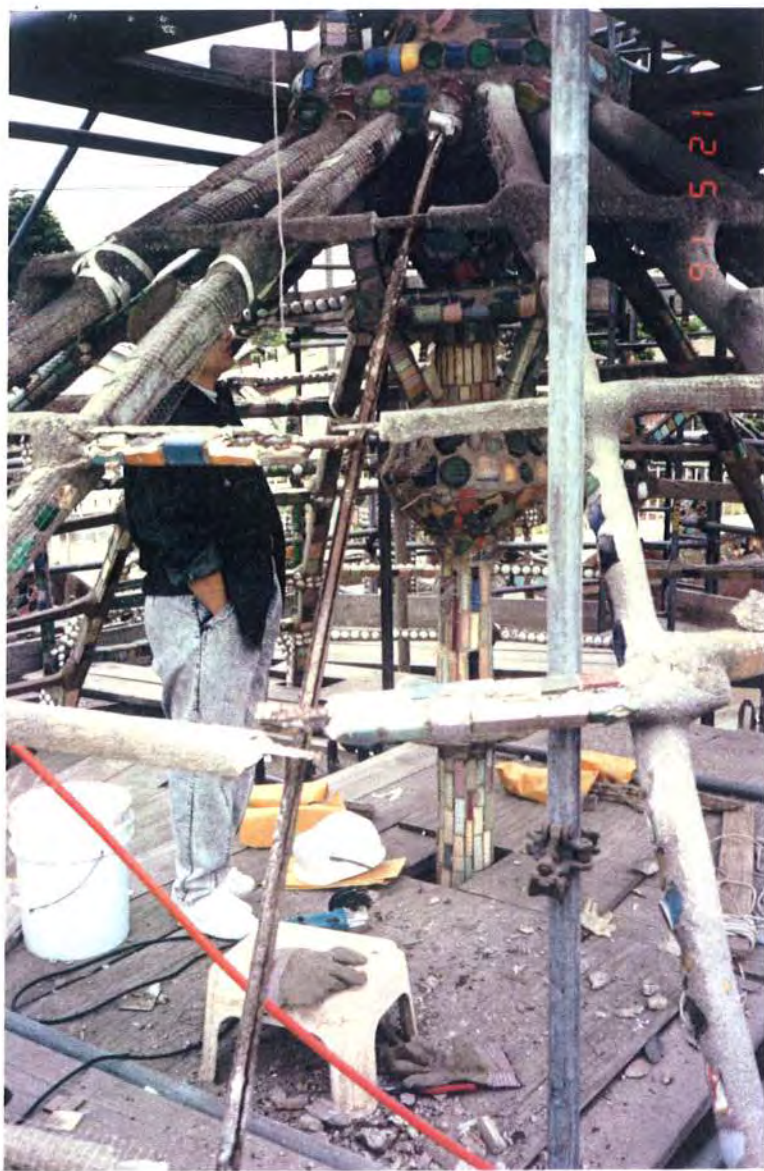
Figure 18.
Support MajV02 after removal of
cover showing rusted channel
and rebar nested in channel.
May 1991.

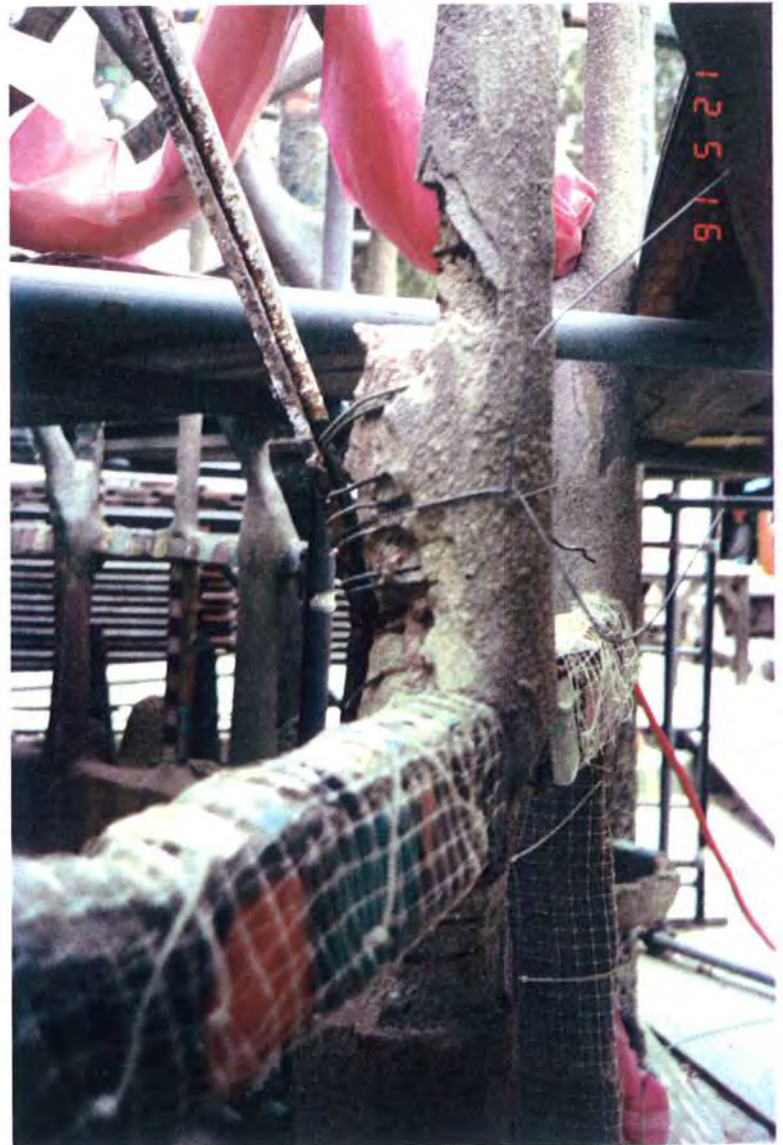
Figure 19.
Support MajV02 lower joint with
wire attachments exhibiting rust
and cracks.
May 1991.

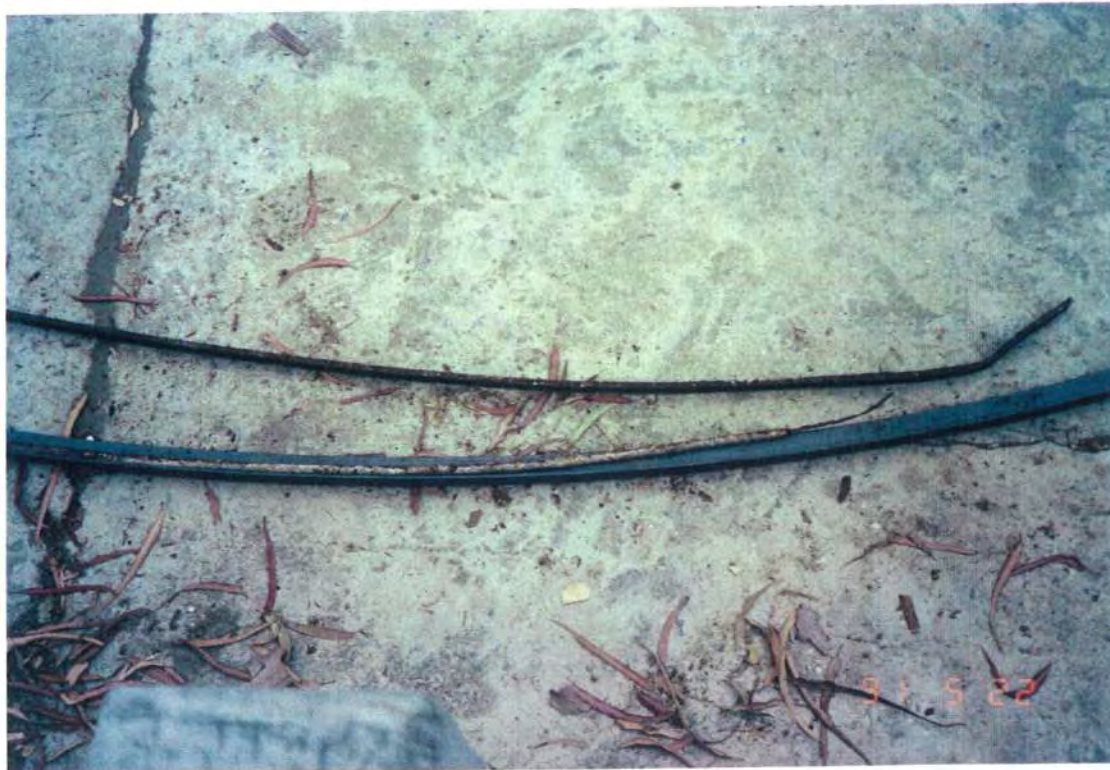
Figure 20.
Top-rusted channel, center-rusted
rebar, bottom-new 'T' section for
MajV02 reinforcement before
installation.
May 1991.

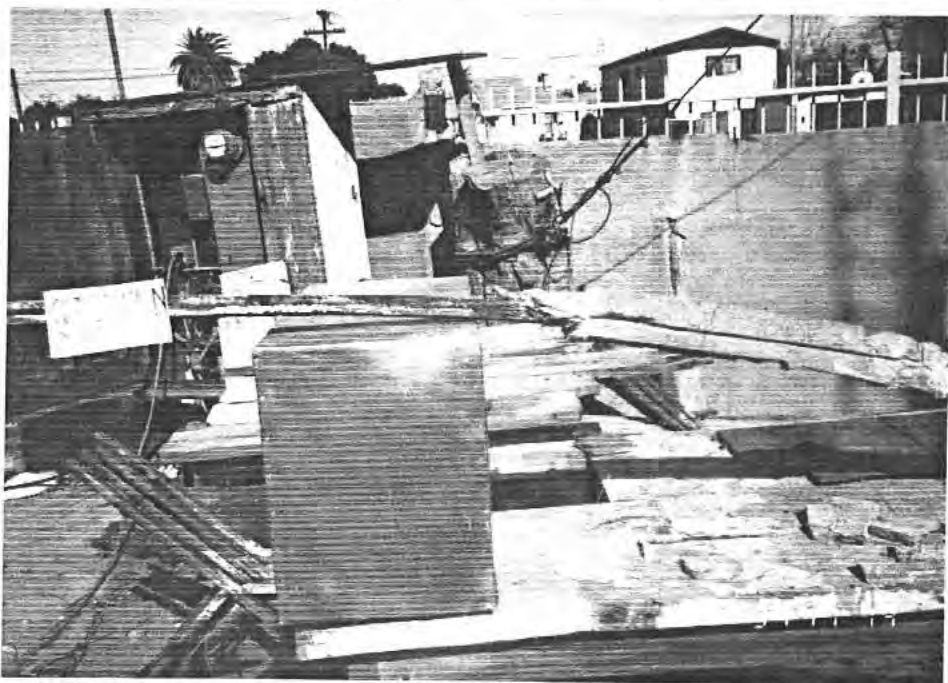
Figure 23.
Support MajV04 after removal
from Gazebo for conservation
work & to replace the rein-
forcement with a new 'T'
section. Nov 1991.

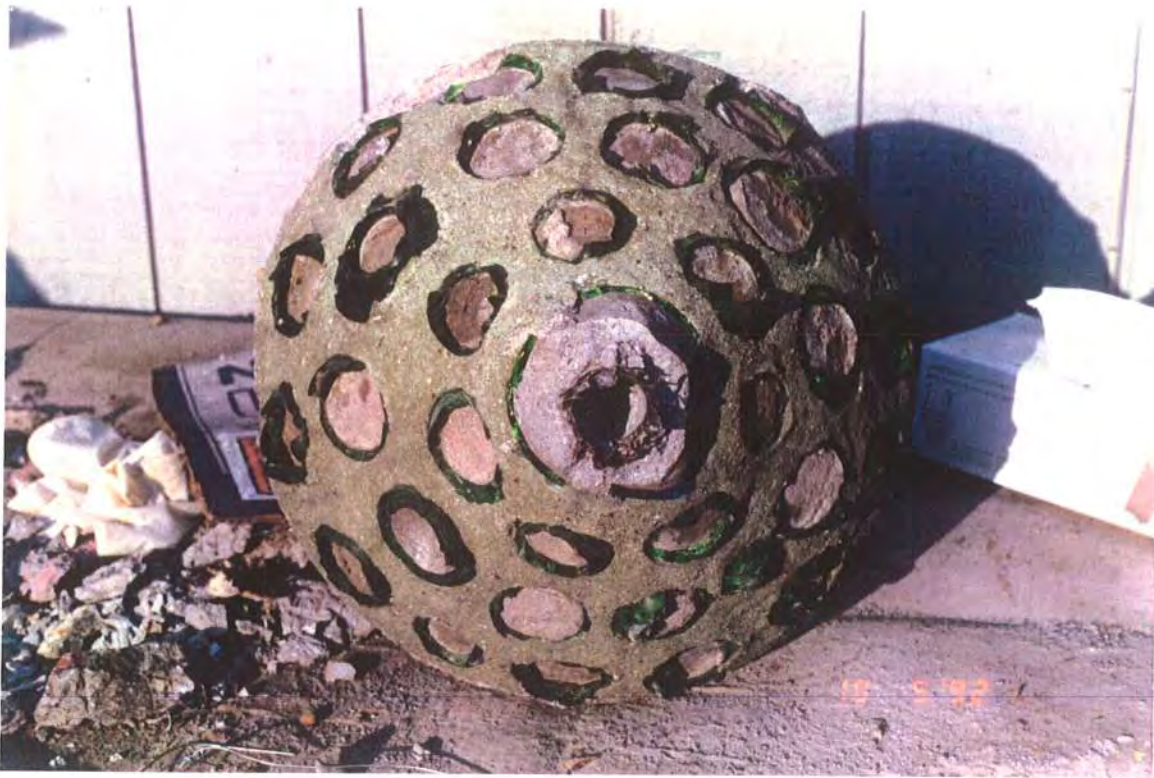
Figure 27.
Finial from top of damaged
outer vertical after removal.
Oct 1992.

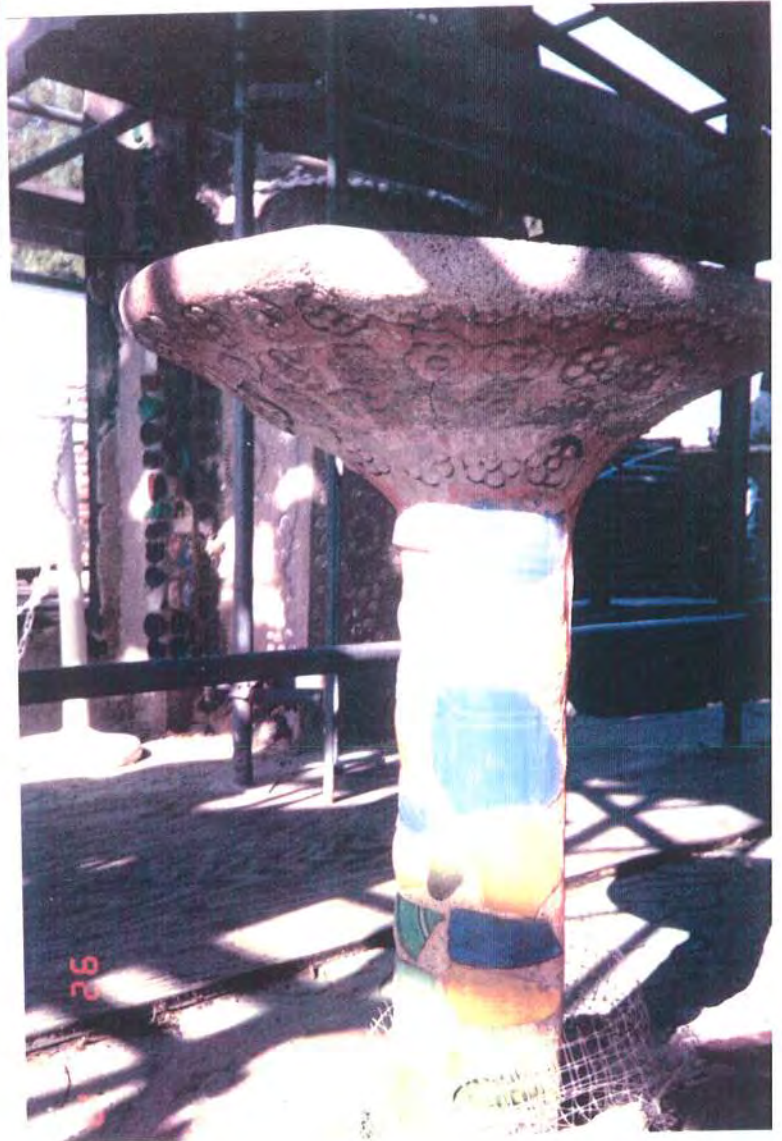
Figure 30. Damaged birdbath southwest of Gazebo. Jan 1992.

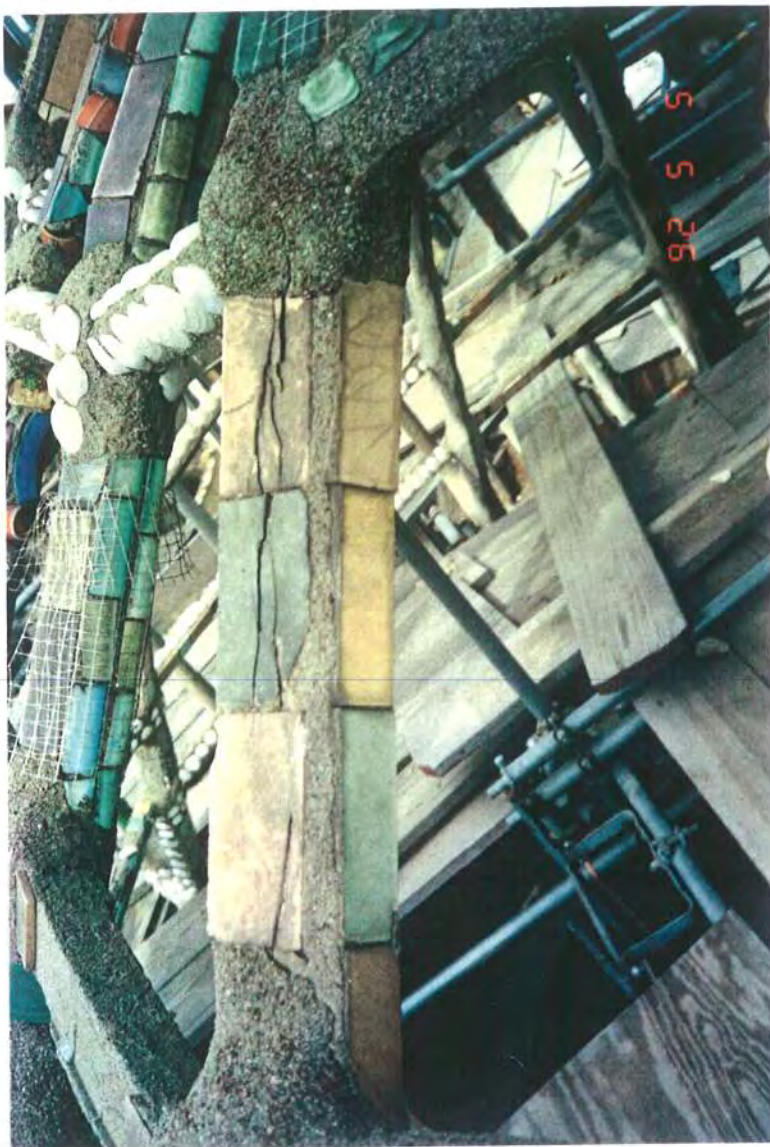
Figure 35. Cracks in third arched support before conservation work. May 1992.

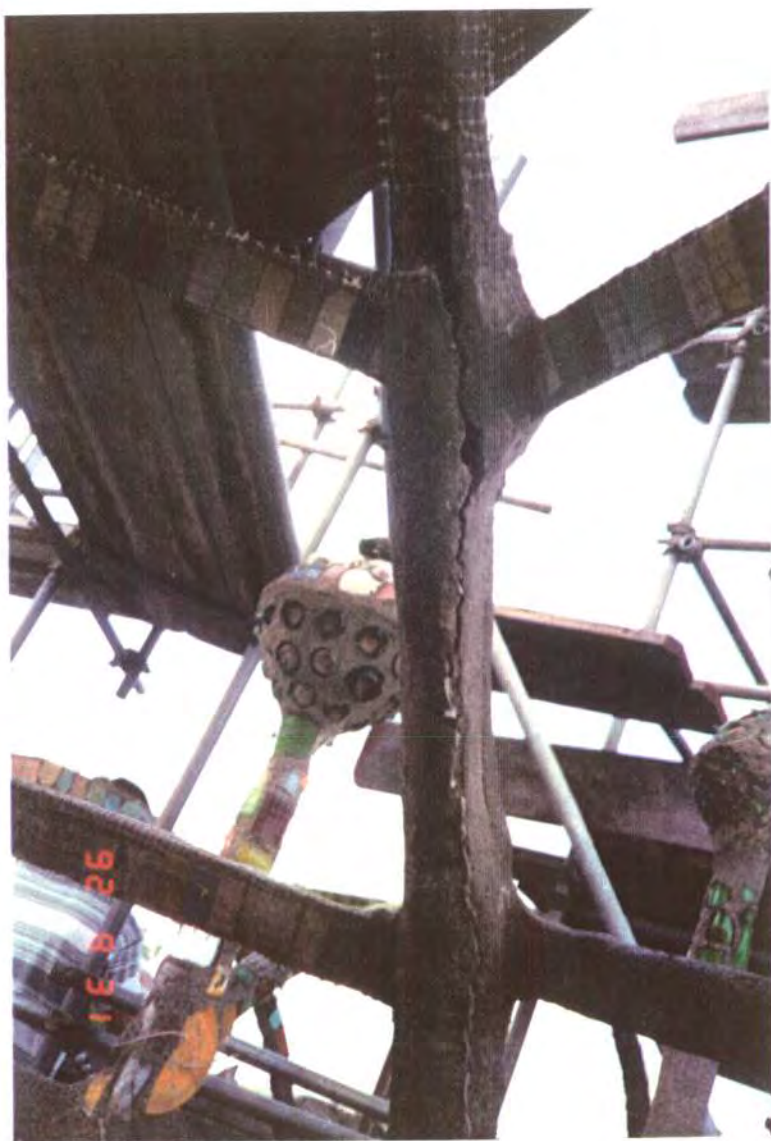
Figure 38. Cracks in fourth arched support before conservation work. Aug 1992.

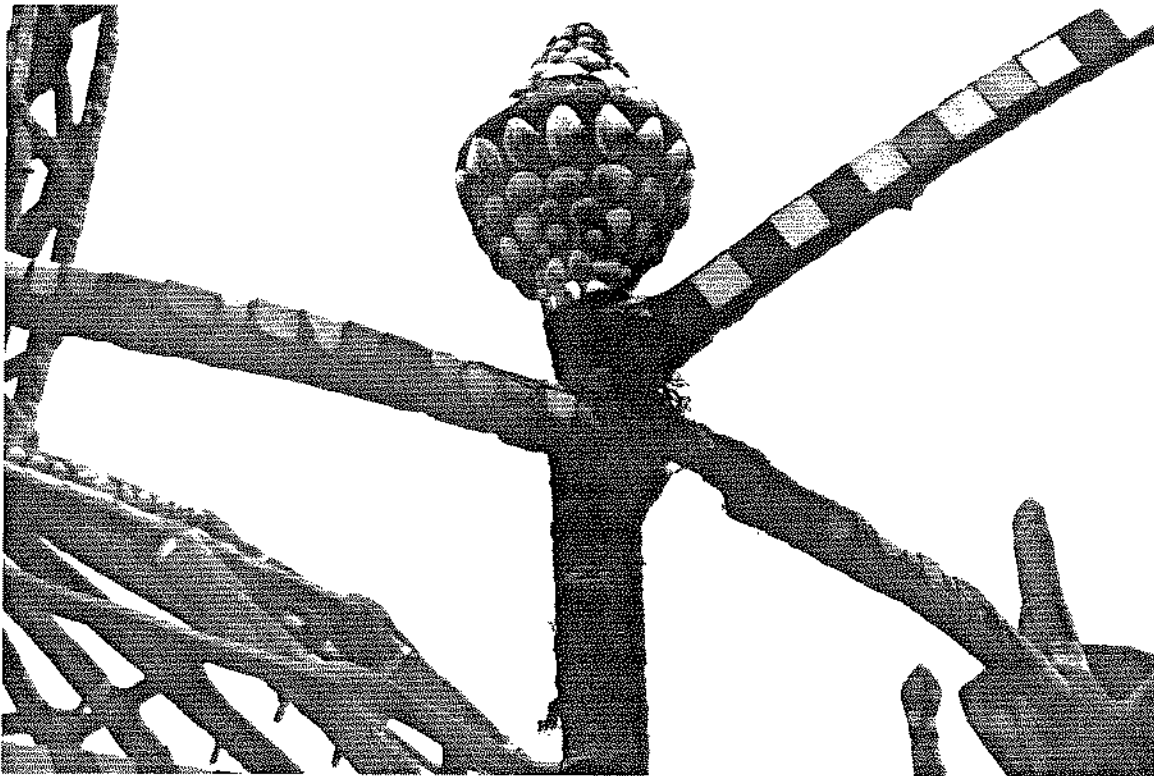
Figure 40. Damaged finial and
outer vertical and band.
October 1987.

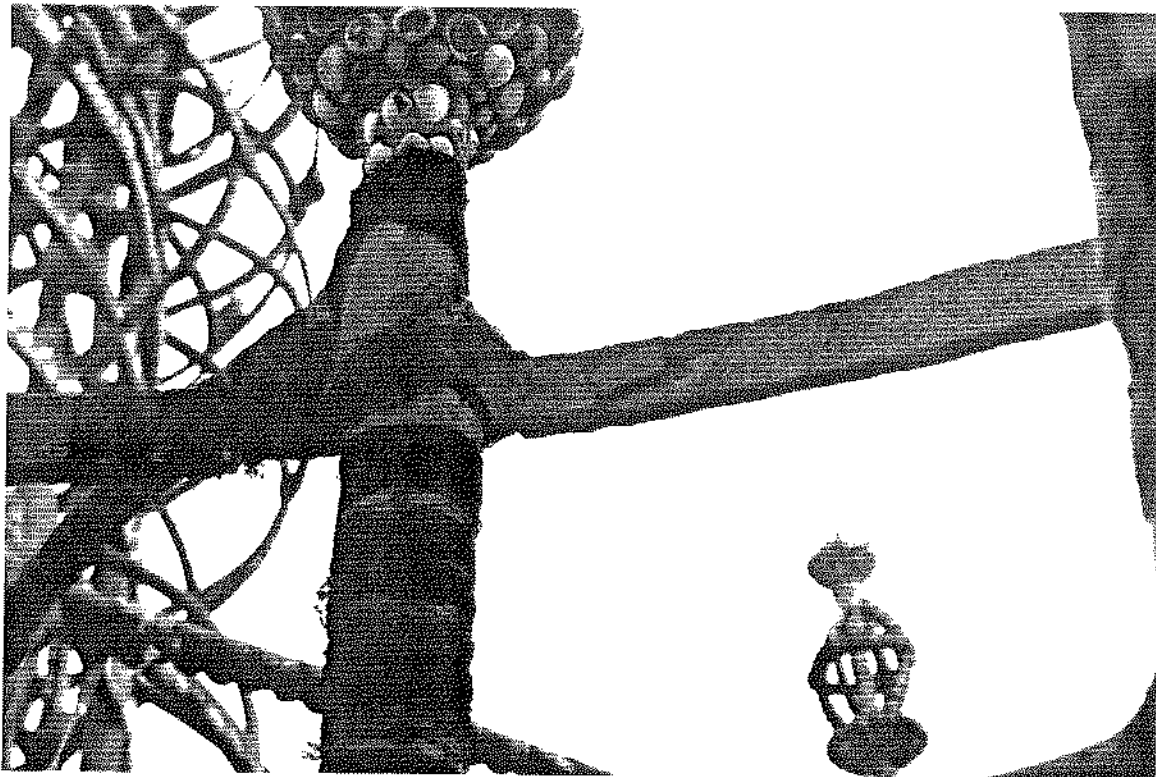
Figure 41. Damaged finial and
outer vertical and band.
October 1987.

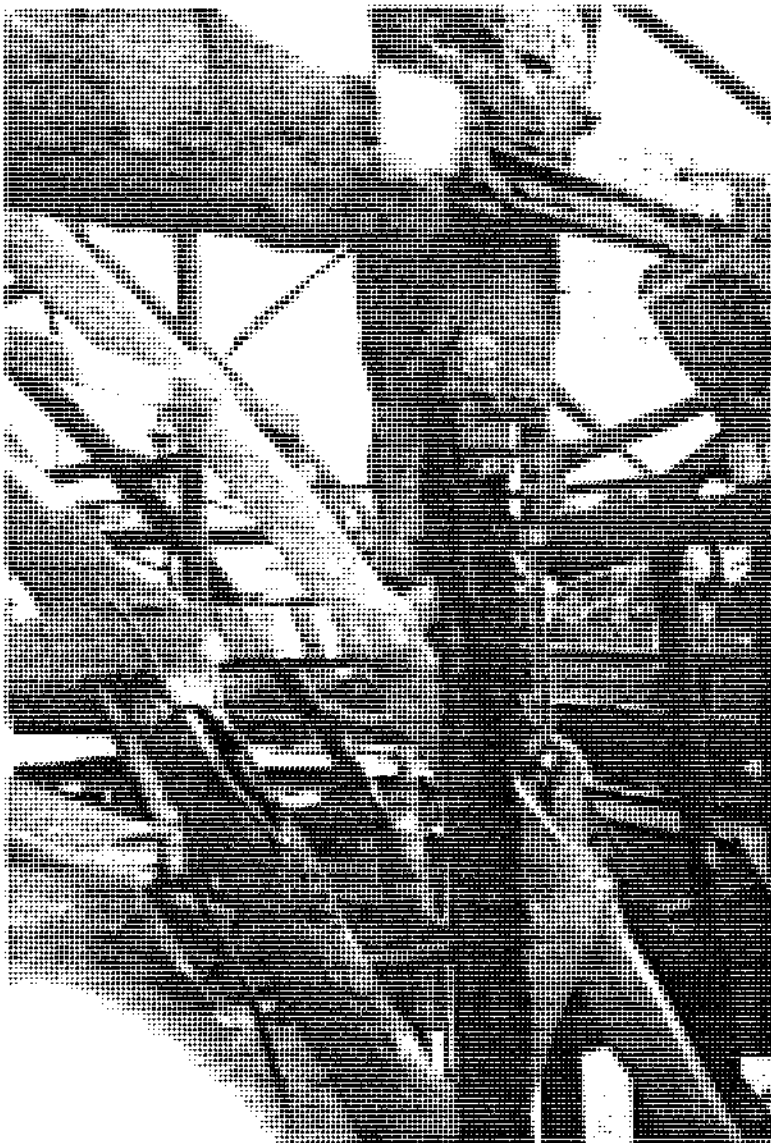
Figure 49. Rusted outer vertical 08 steel reinforcement. September 1992.

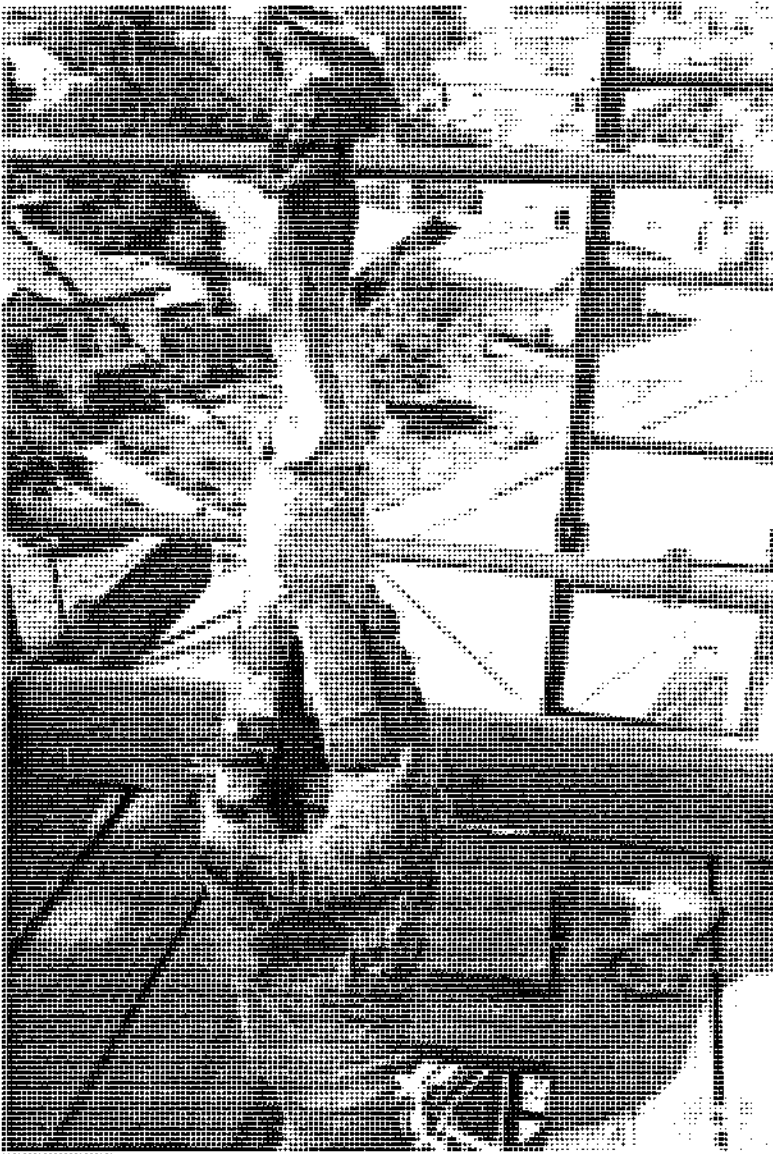
Figure 71. Statue on top of spire before repairs. May 1993.

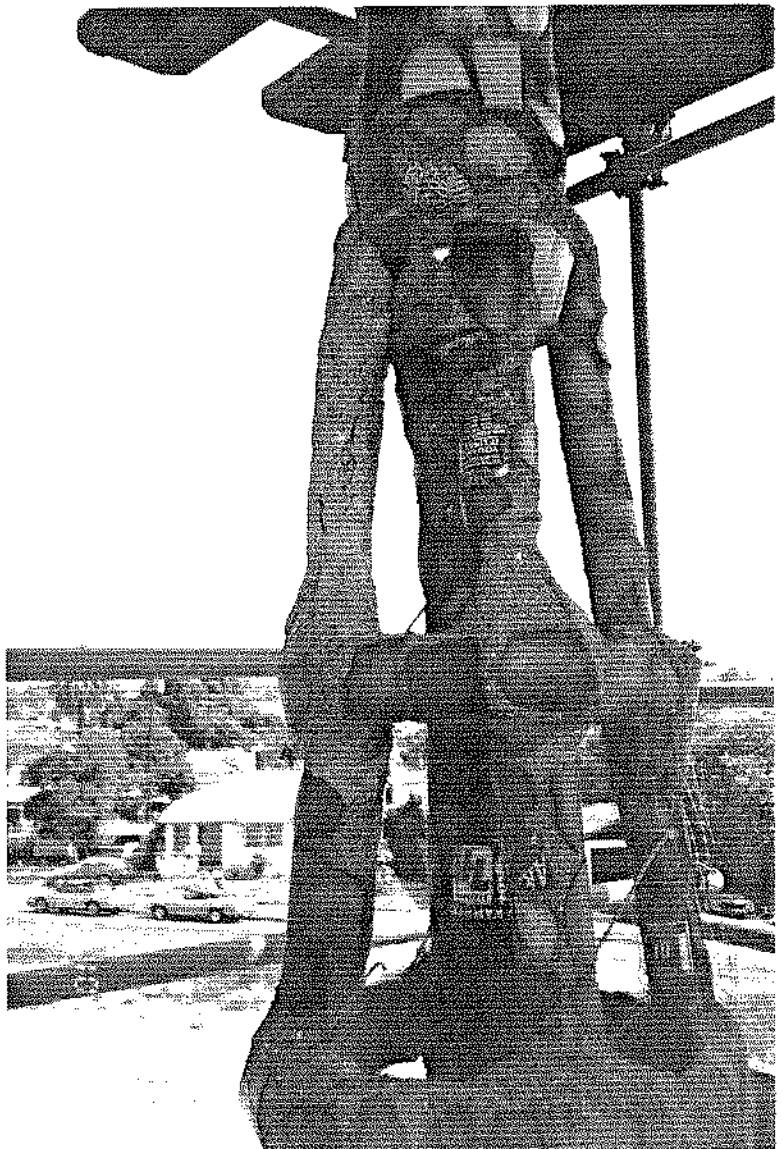
Figure 72. Damage to upper portion of spire (H level) before repairs. May 1993.

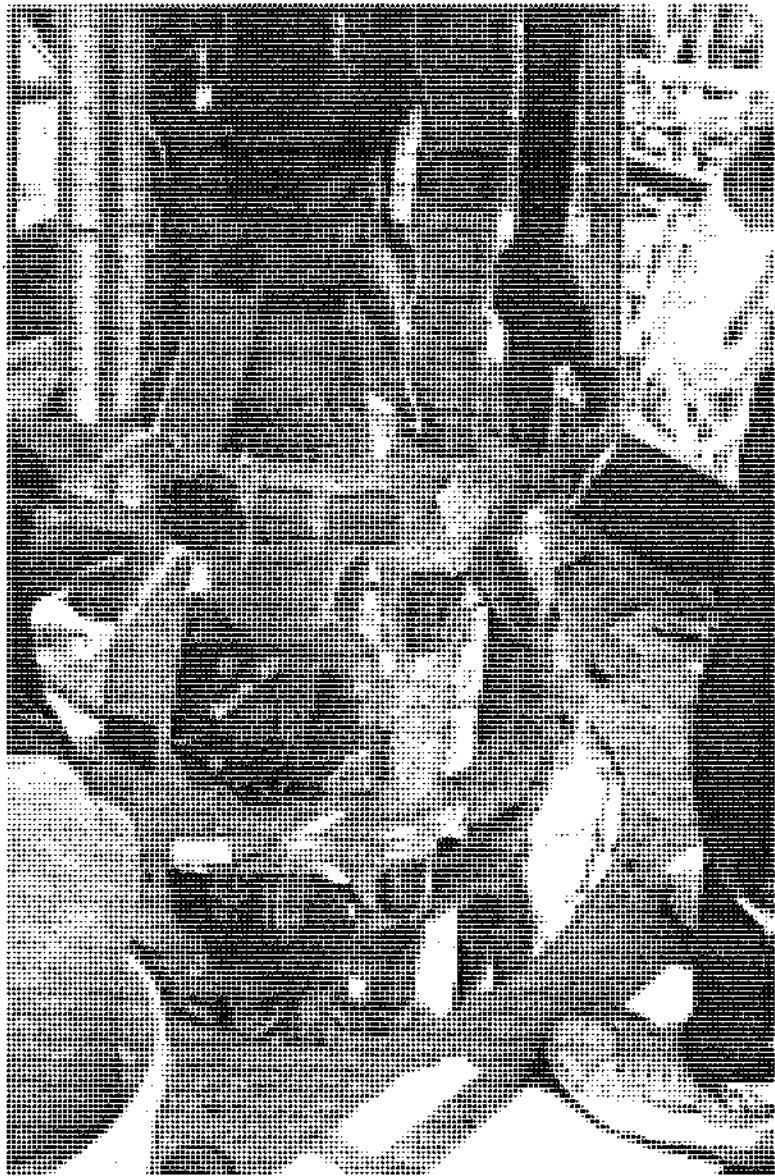
Figure 73. Horizontal band (#9 at G level) before detachment for removal of rust and mortar. July 1993.
