**REVIEW OF WATTS TOWERS  
NOVEMBER 12, 1996  
1765 E. 107TH STREET**

## **REVIEW INFORMATION NORTHRIDGE EARTHQUAKE DAMAGE TO WATTS TOWERS**

### **BACKGROUND & SUMMARY**

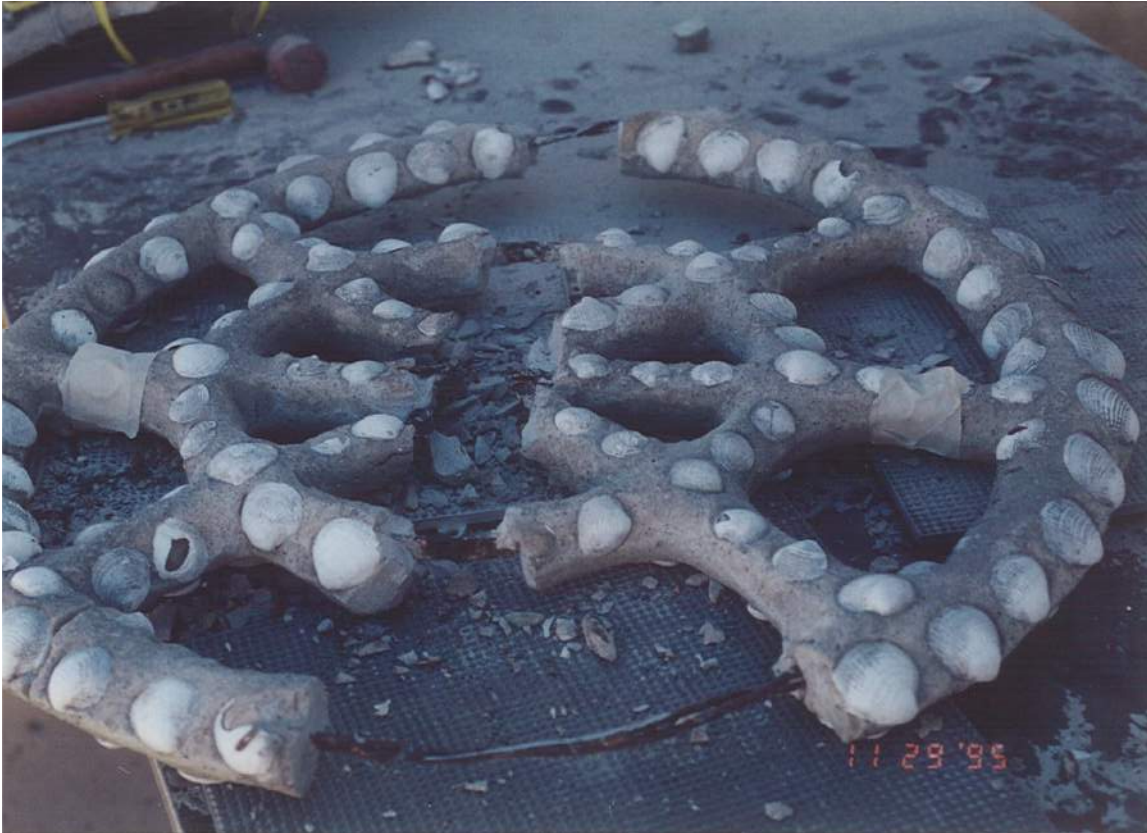
This damaged mortar wheel was removed from the sculpture and repaired on the ground. The upper photograph (Nov. 1995) shows the inside of the wheel under repair. The side of the wheel has fewer damage sea shells than the other side which faces 107th street and suffered vandalism.

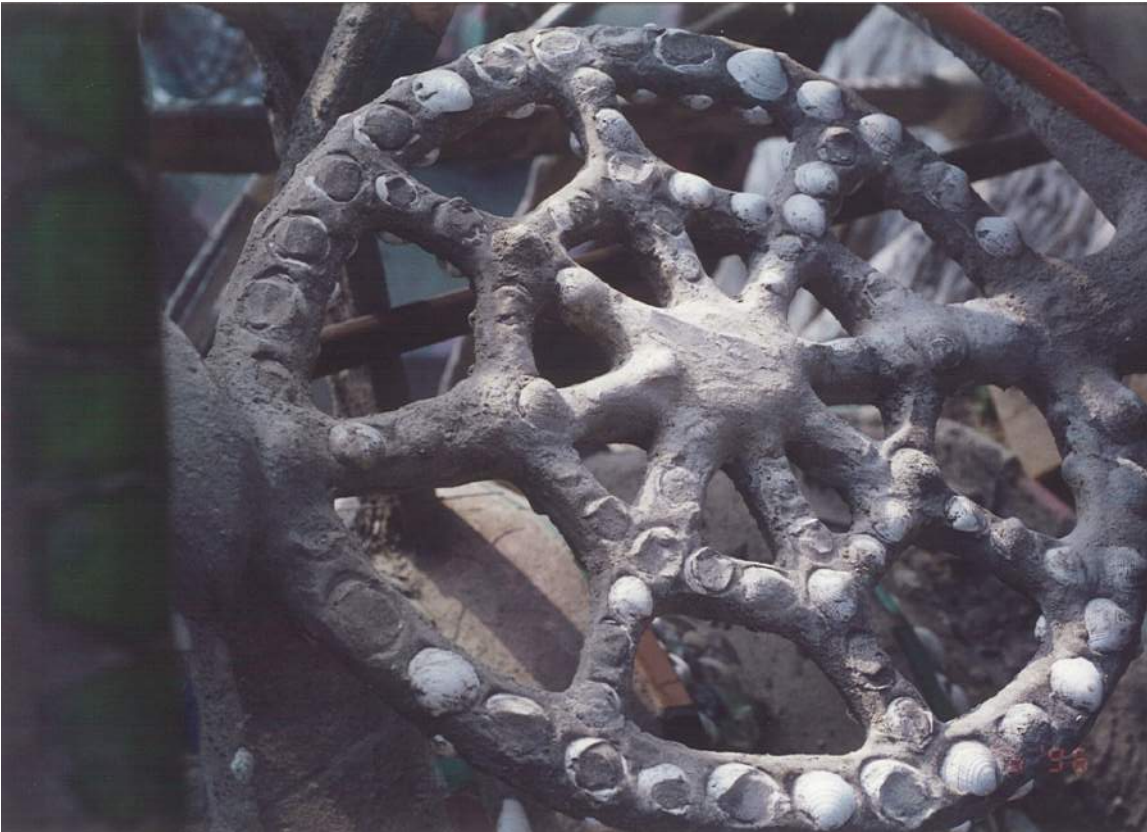
January 1996, the wheel after repair and ready for reinstallation.

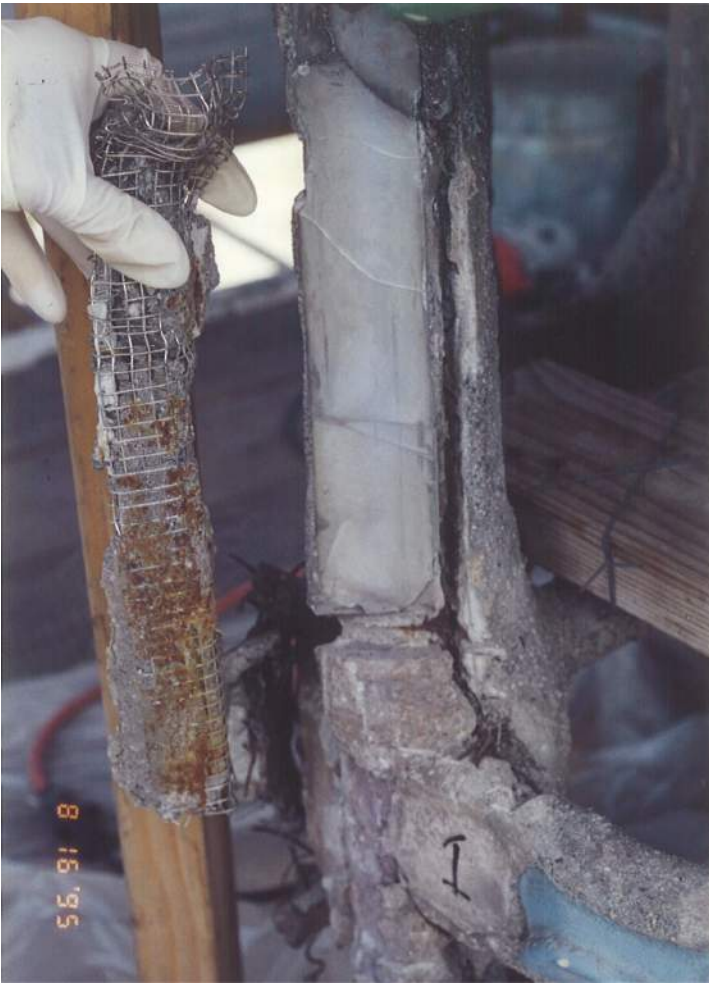
This mortar separation was found at the 74 foot level of the Center Tower. A previous repair c1981 had separated from the original mortar due to inadequate bonding. Top photo, August 1995.

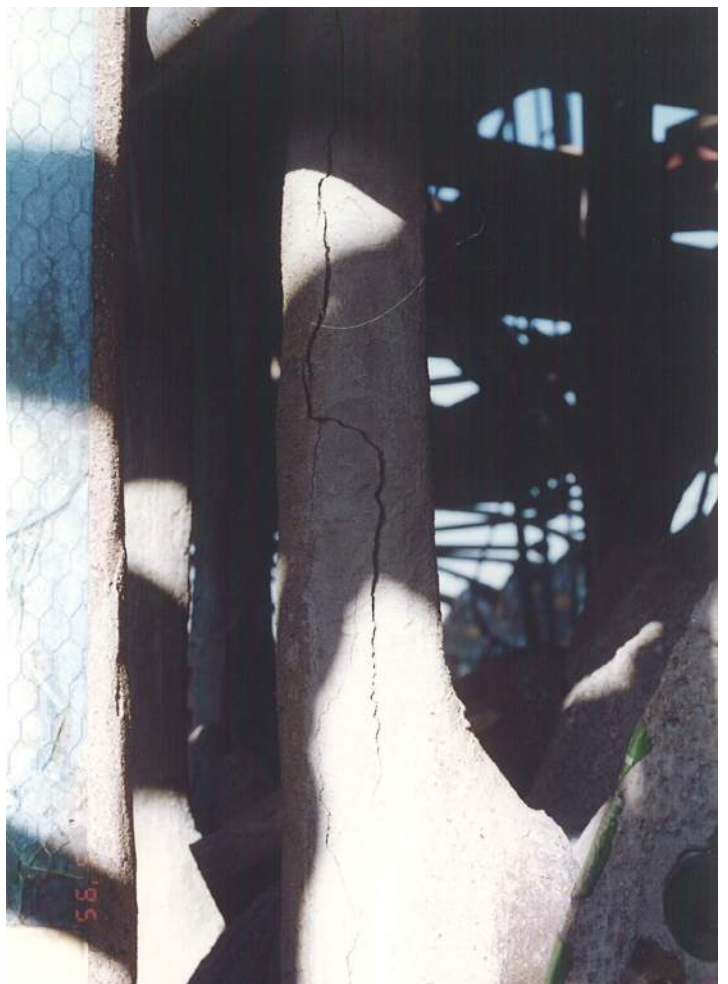
This vertical crack was the result of a major failure of a main support of the Center Tower. Bottom photo, December 1995.

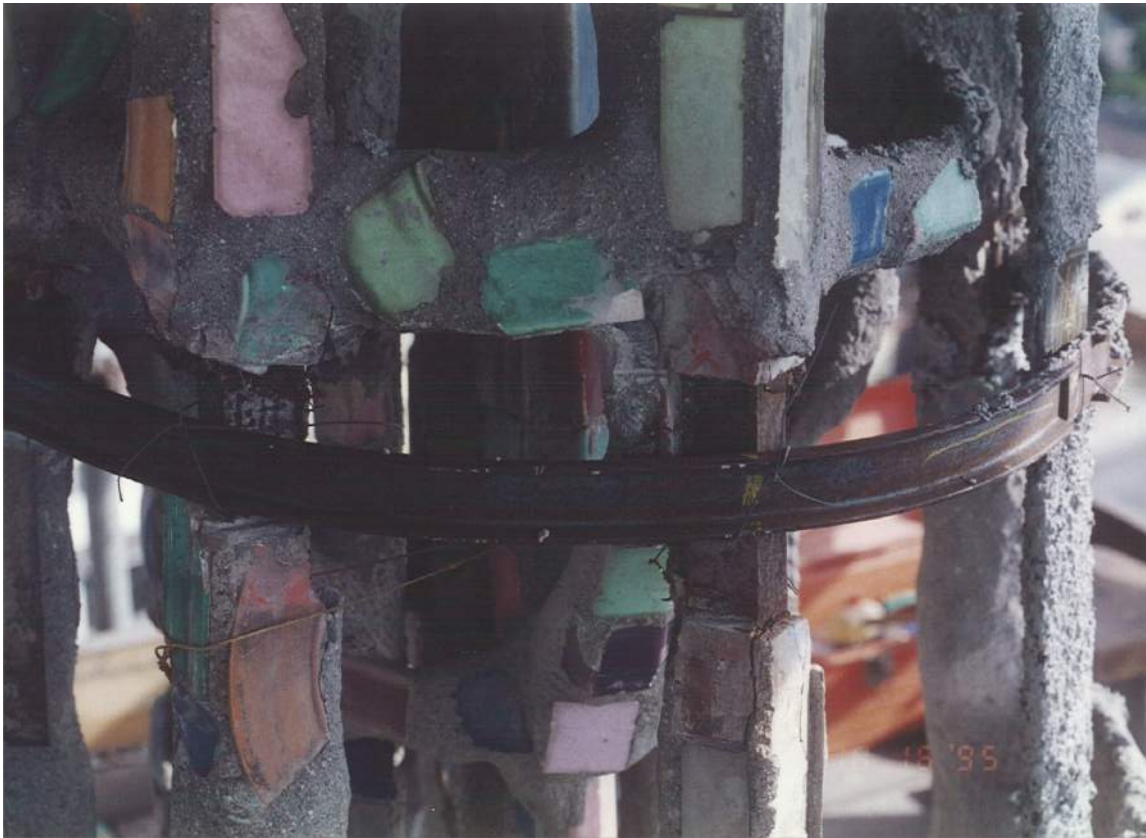
Severely damaged horizontal band and covering was removed completely around the Center Tower. The steel channel reinforcement replacement is shown in place before reattaching the original mortar on the band and intersecting vertical columns. Photo above. October 1995

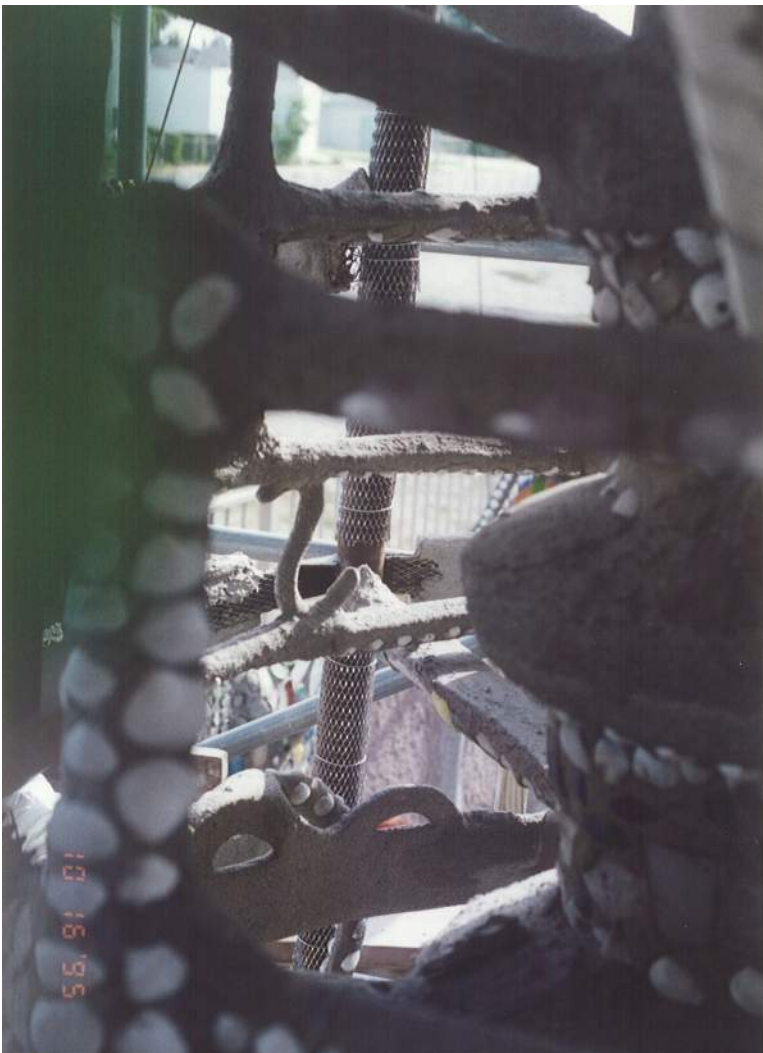
Entire steel reinforcement in a damaged 20 foot section of a column is shown after replacement and wrapping with steel mesh. Left photo. October 1995.

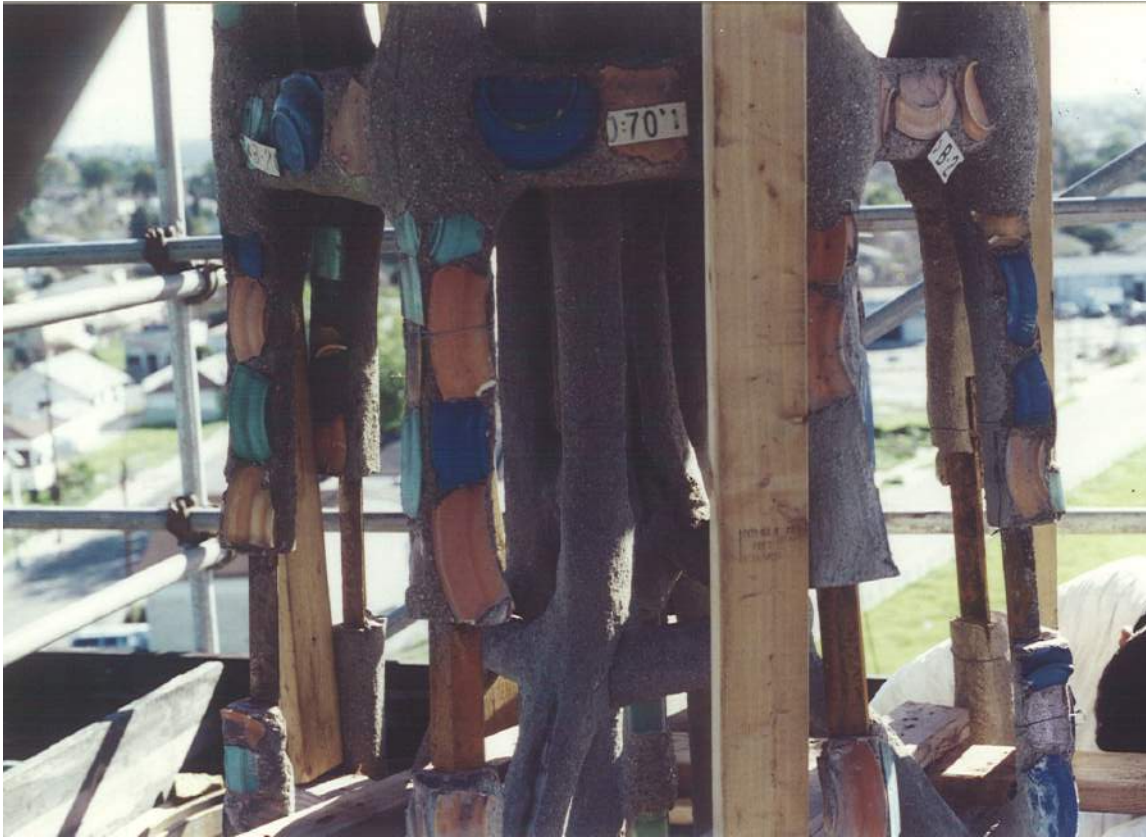
Upper photo shows exposed columns where damaged band #19 has been removed prior to installation of new steel channel. Wood beams support the upper ring to compensate for reduced strength in columns. February 1996.

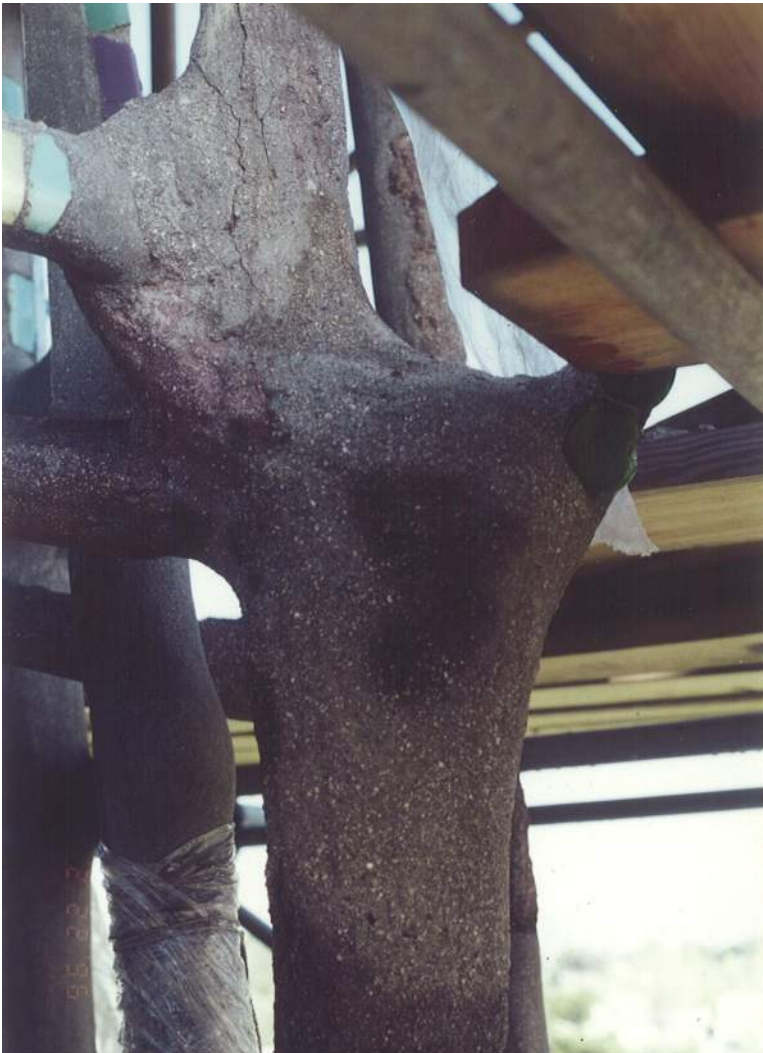
Darkened area shows water intrusion into Center Tower column about 75 feet elevation. Left photo. February 1996.

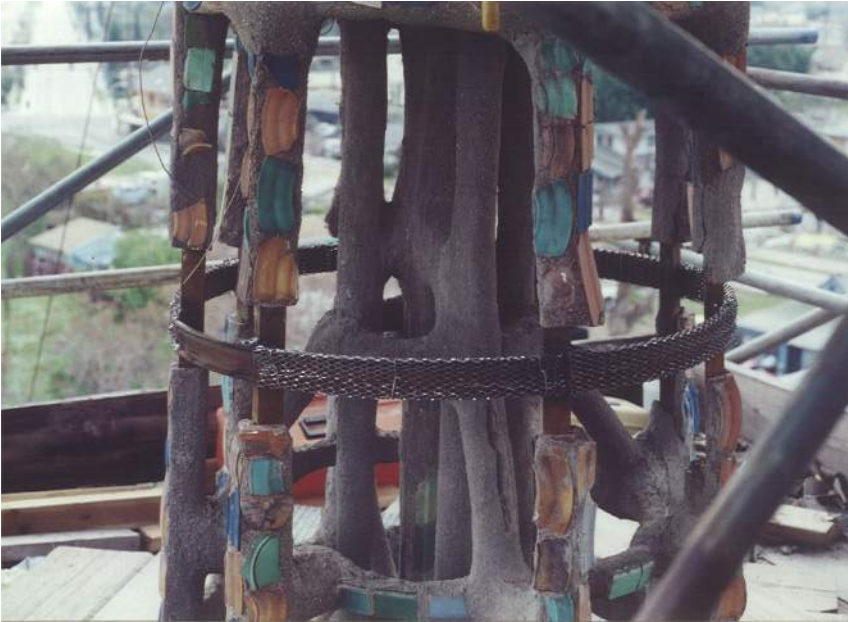
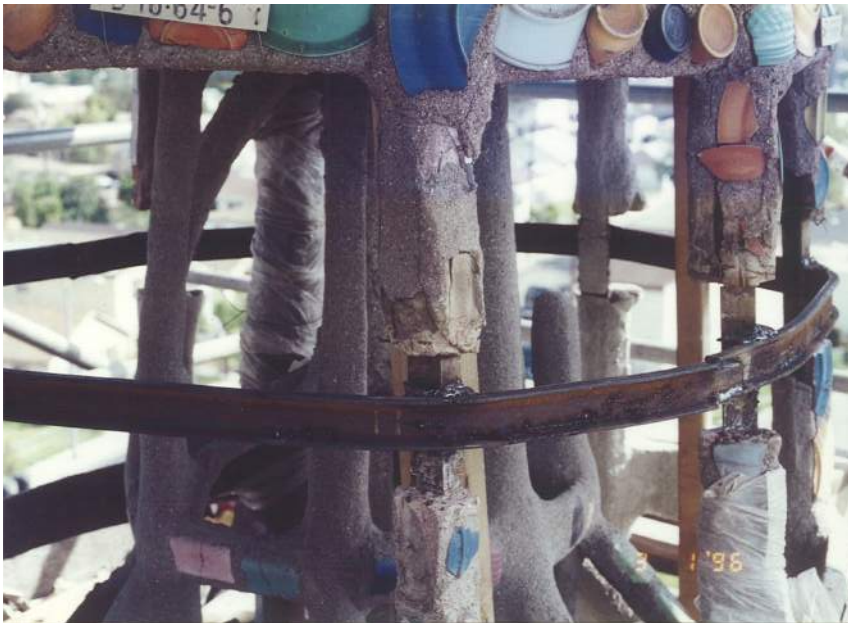
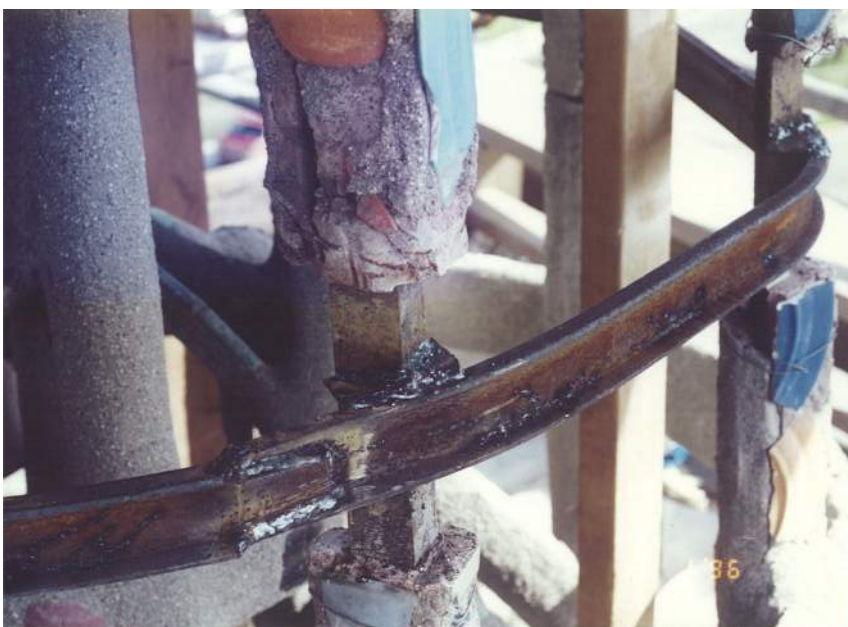
Three photos show new steel channel reinforcement installed to replace failed reinforcement in original band. Segments of the band are welded to each other and to each vertical column. Steel mesh has been wrapped around the channel in the top photo as Rodia did initially. March 1996.

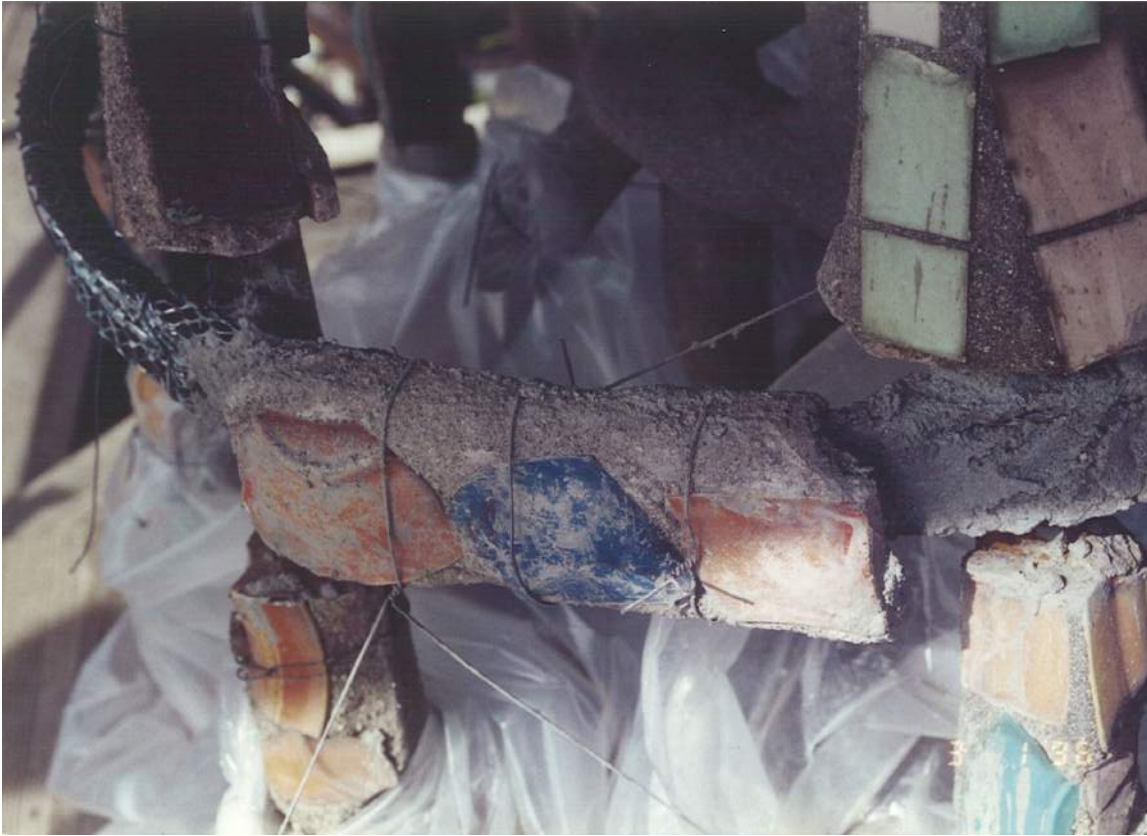
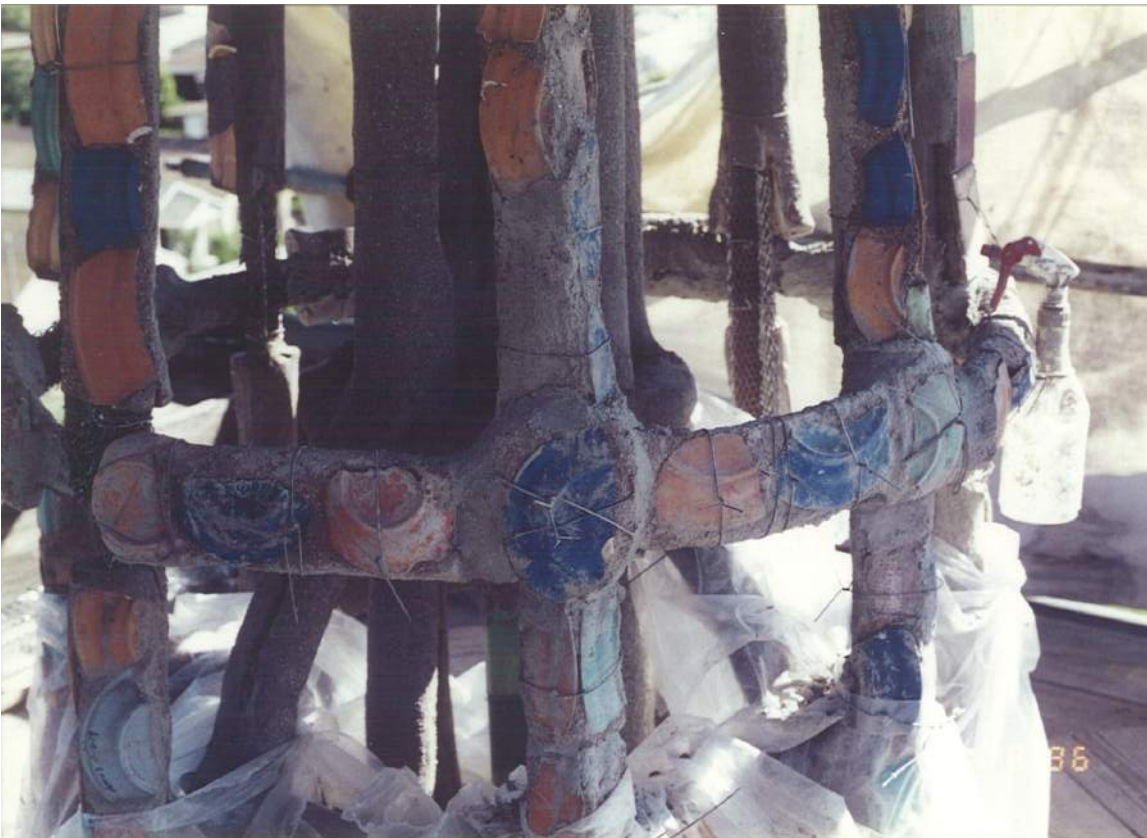
Band repair in progress. Rodia's coverings over each of the band segments are being reinstalled. New mortar was applied over the new reinforcement. Segments had been removed to install the new channel reinforcement. The segments were cut with a diamond cutter. Next they were thinned from the inside to maintain the original overall dimensions and now they are shown reinstalled over new cement mortar coverings. March 1996.

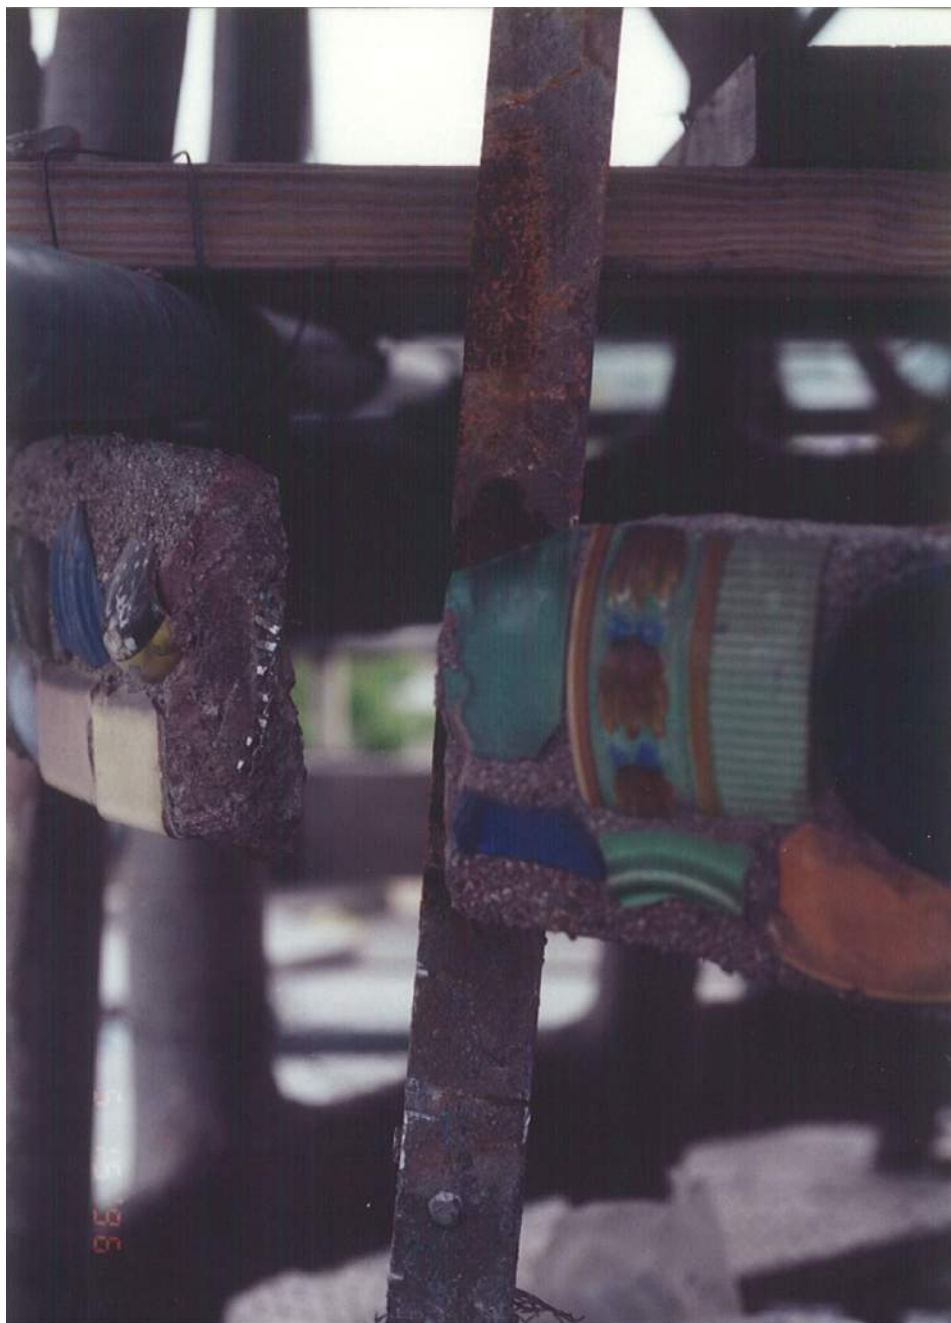
Repairs in progress. Exposed wire ends within horizontal band, left center of photograph and angle reinforcement in vertical column, center of photo. May 1996.

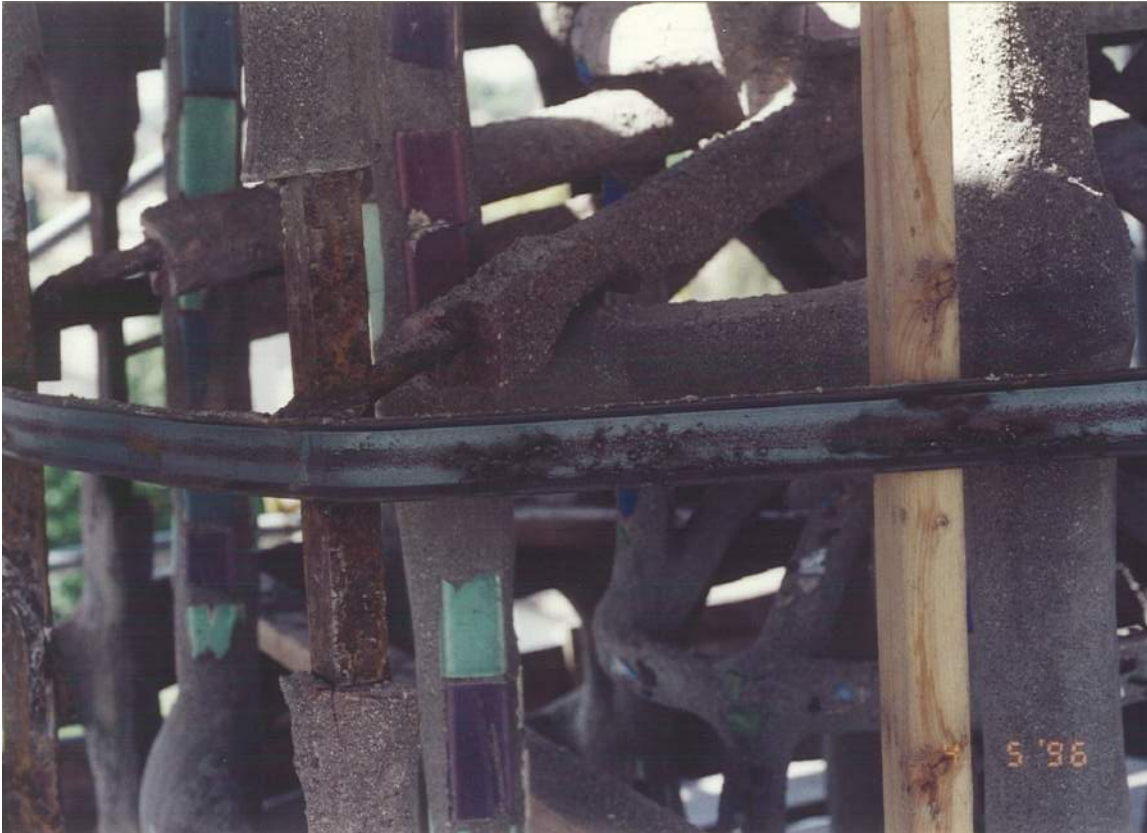
Repair in progress. New channel reinforcement for failed horizontal band and attachments design for columns to the band reinforcement and radials on the Center Tower. April 1996.

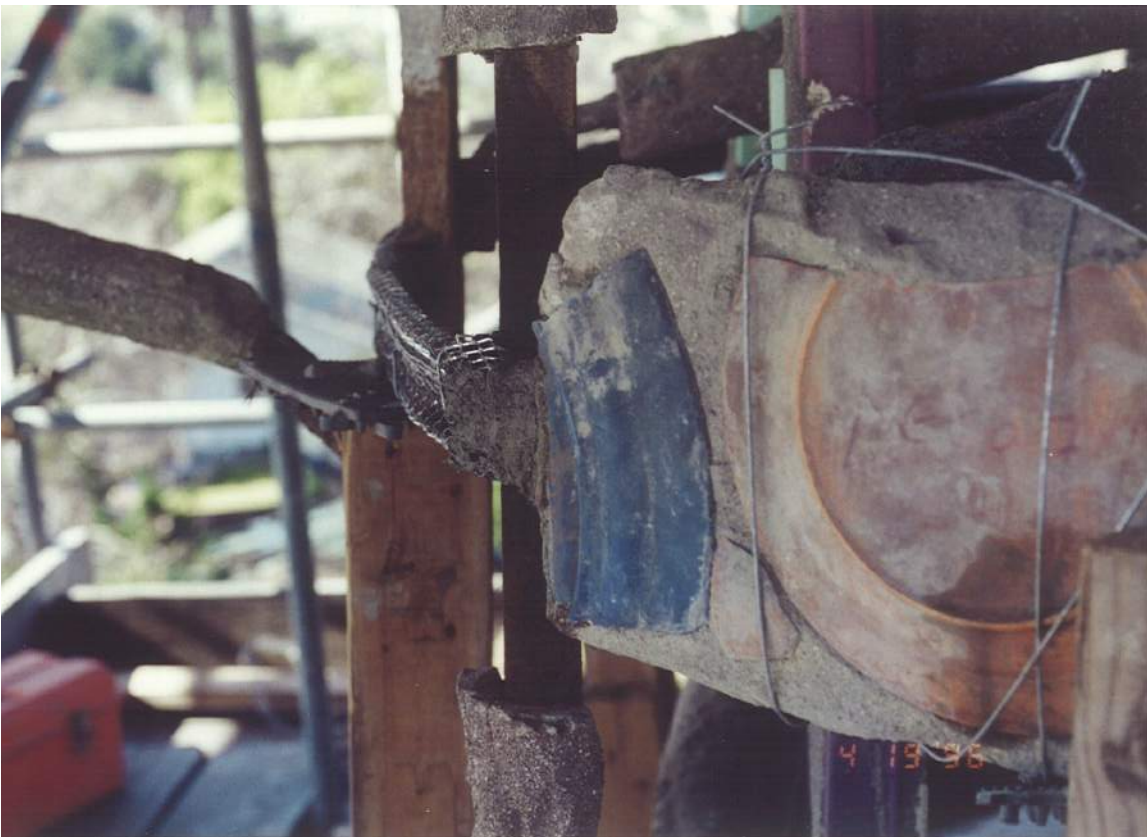
Repair in progress. Original band segments in place for installation over new reinforcement, right of photo. Major connector between Center Tower and East Tower shown at center left of photo. This connector is to be welded to column reinforcement, center of photo. April 1996.

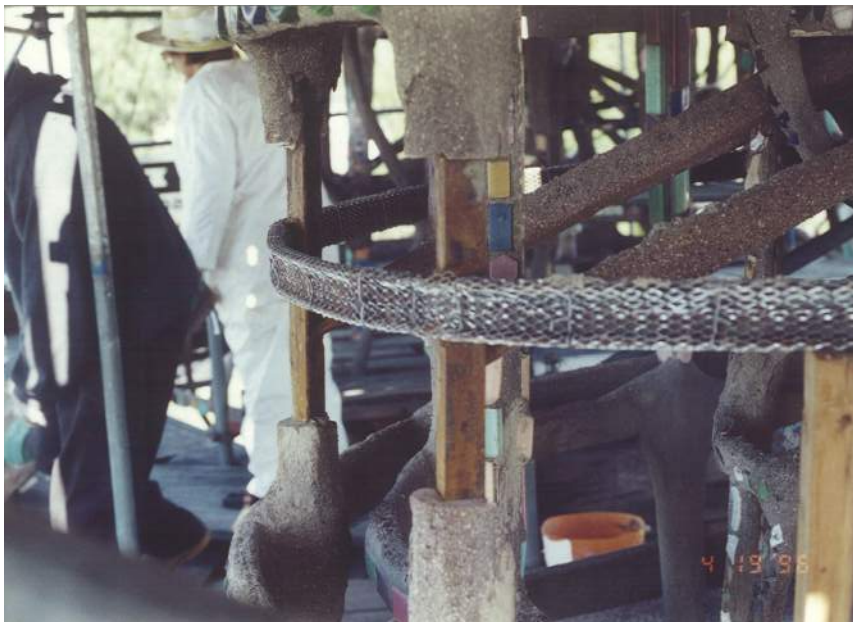
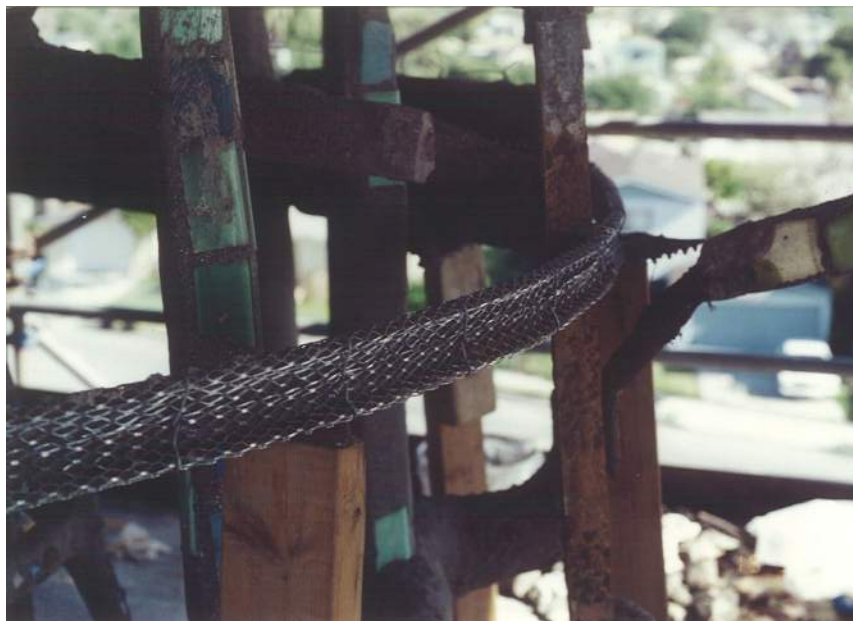
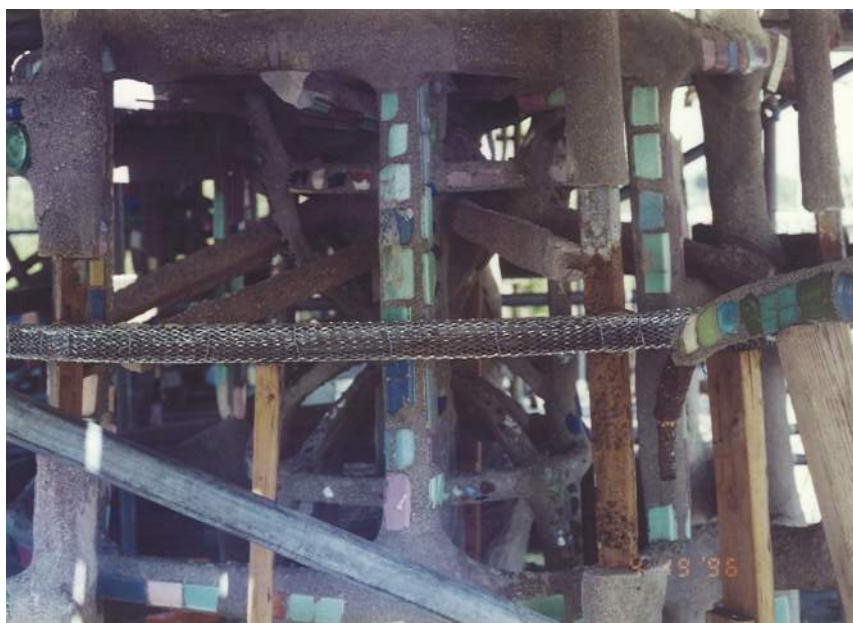
Repair in progress. New steel channel for band has been welded in place to column reinforcements and wrapped with mesh in preparation for reinstalling Rodia coverings. April 1996

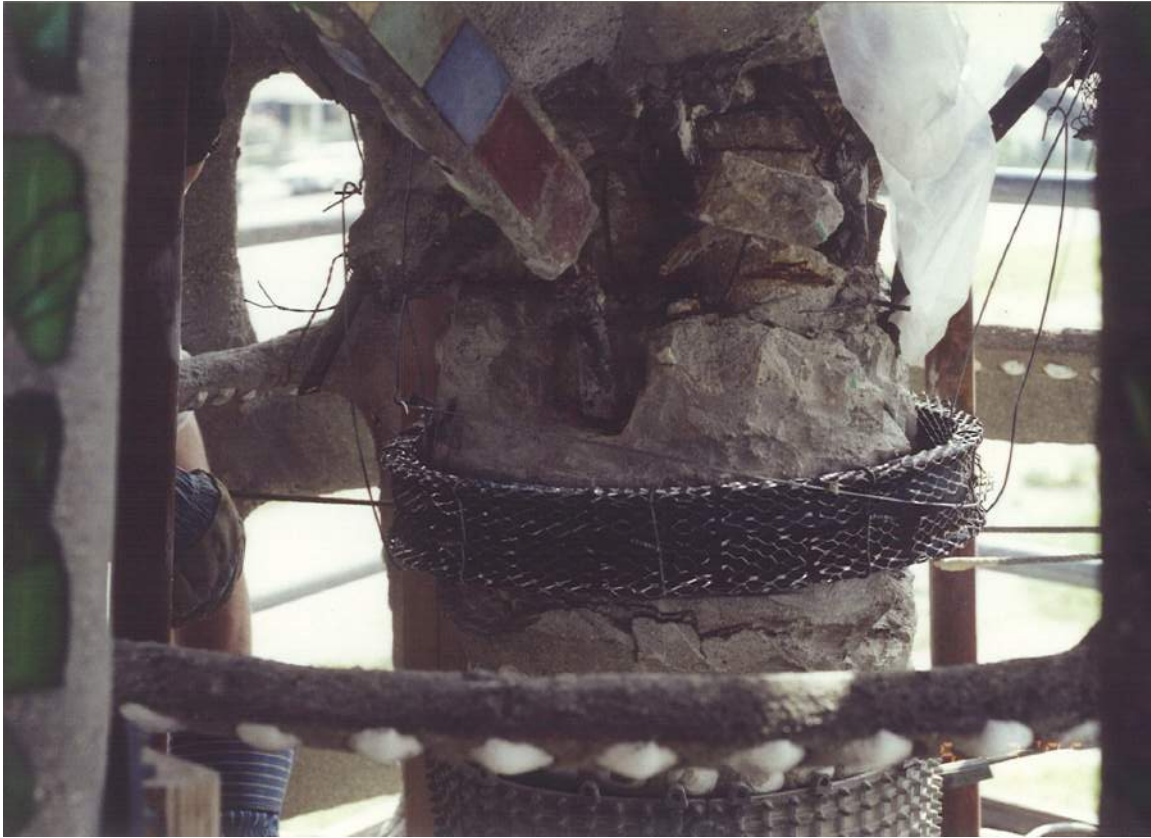
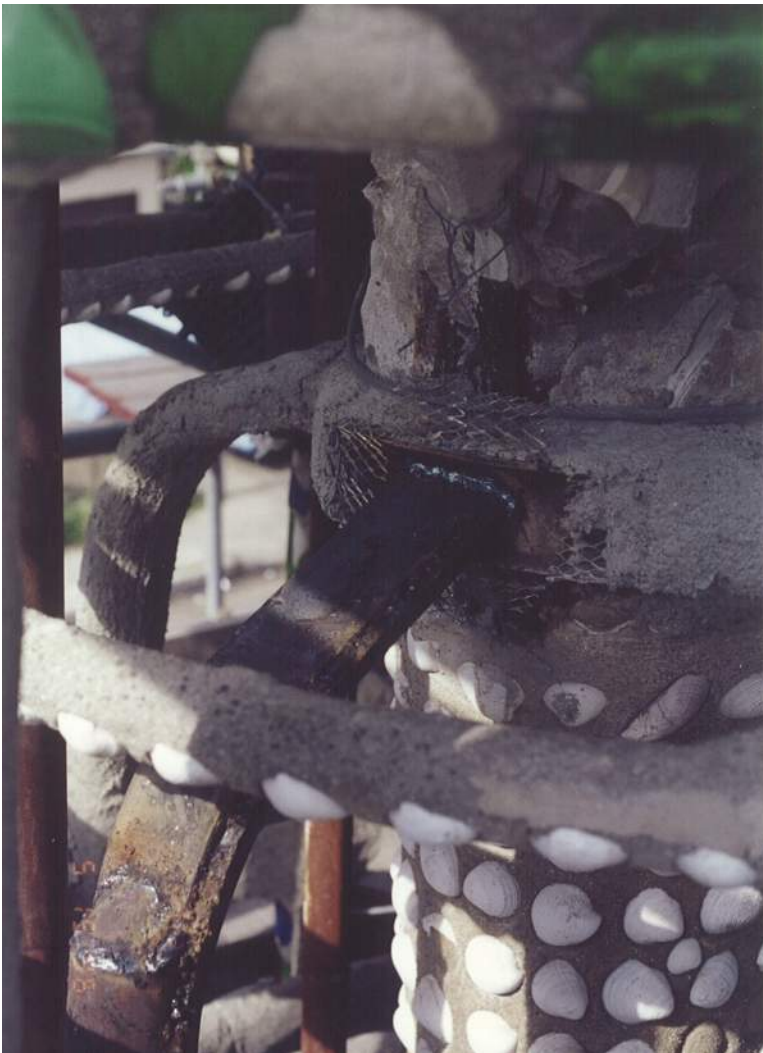
East Tower damage required repairs or replacement of reinforcements in five of six columns. At a critical junction, 19 feet above the base, the columns join the center column. The upper photo shows a typical steel collar around the center column and the lower photo shows a column reinforcement welded to the collar. The original Rodia covering was later restored. May 1996.

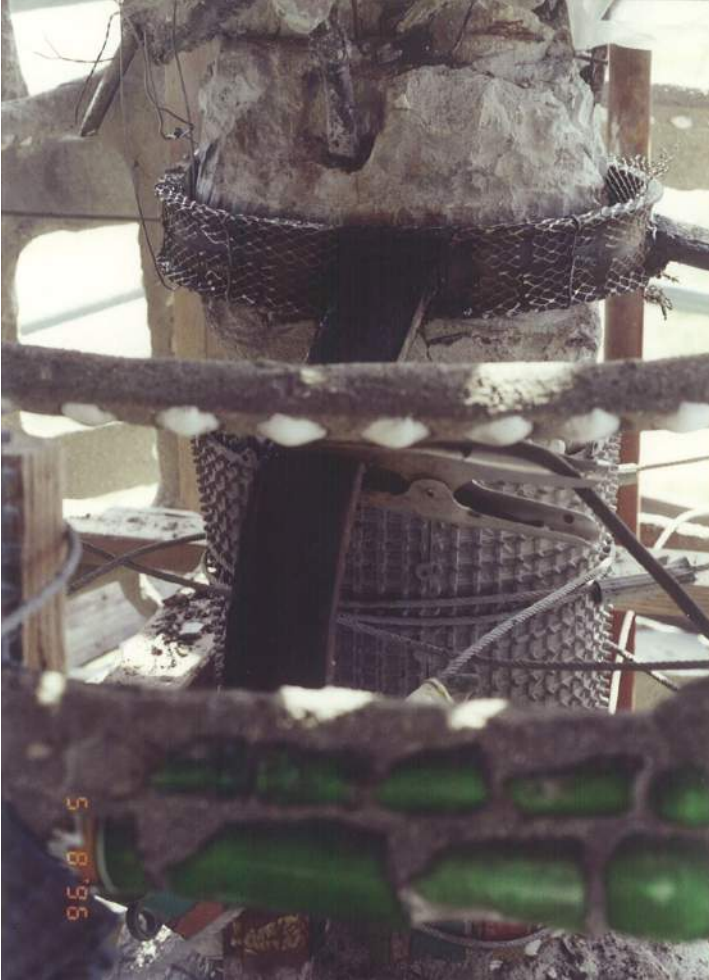
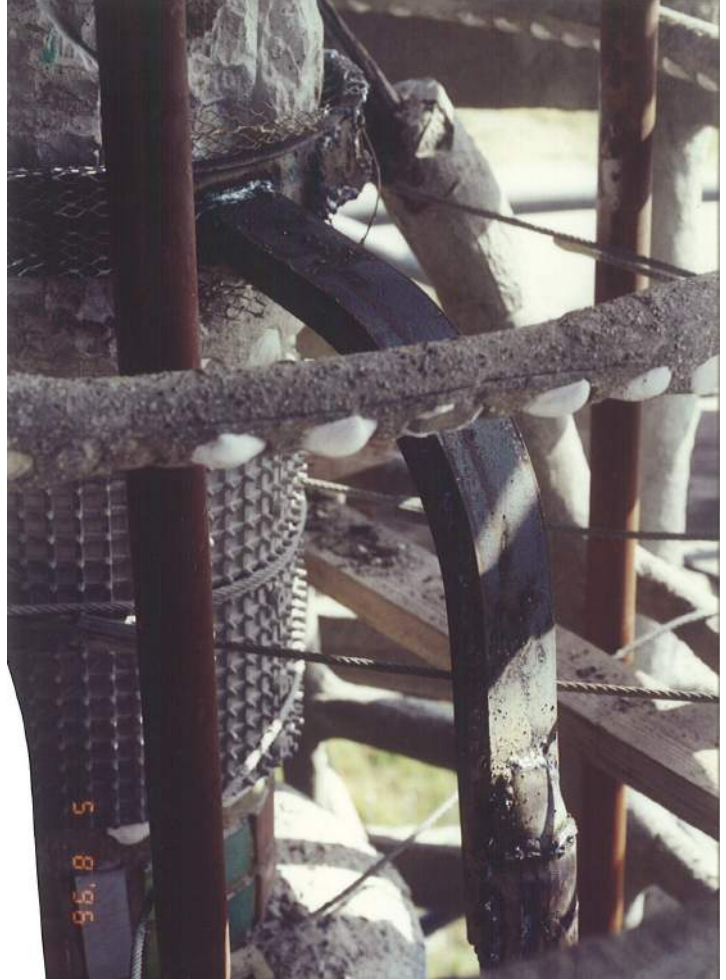
East Tower damage required repairs or replacement of reinforcements in five of six columns. At a critical junction, 19 feet above the base, the columns join the center column. The photo on the left shows a typical steel collar around the center column and the photo on the right, shows a column reinforcement welded to the collar. The original Rodia covering was later restored. May 1996.

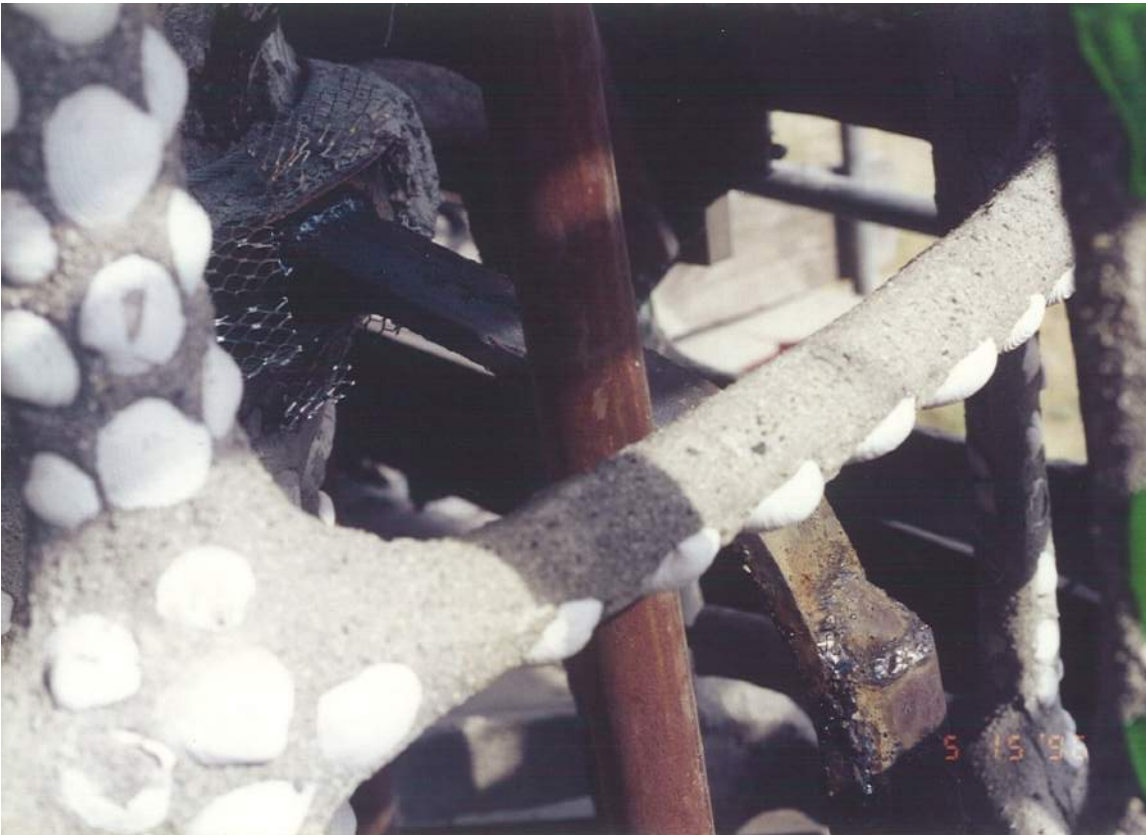
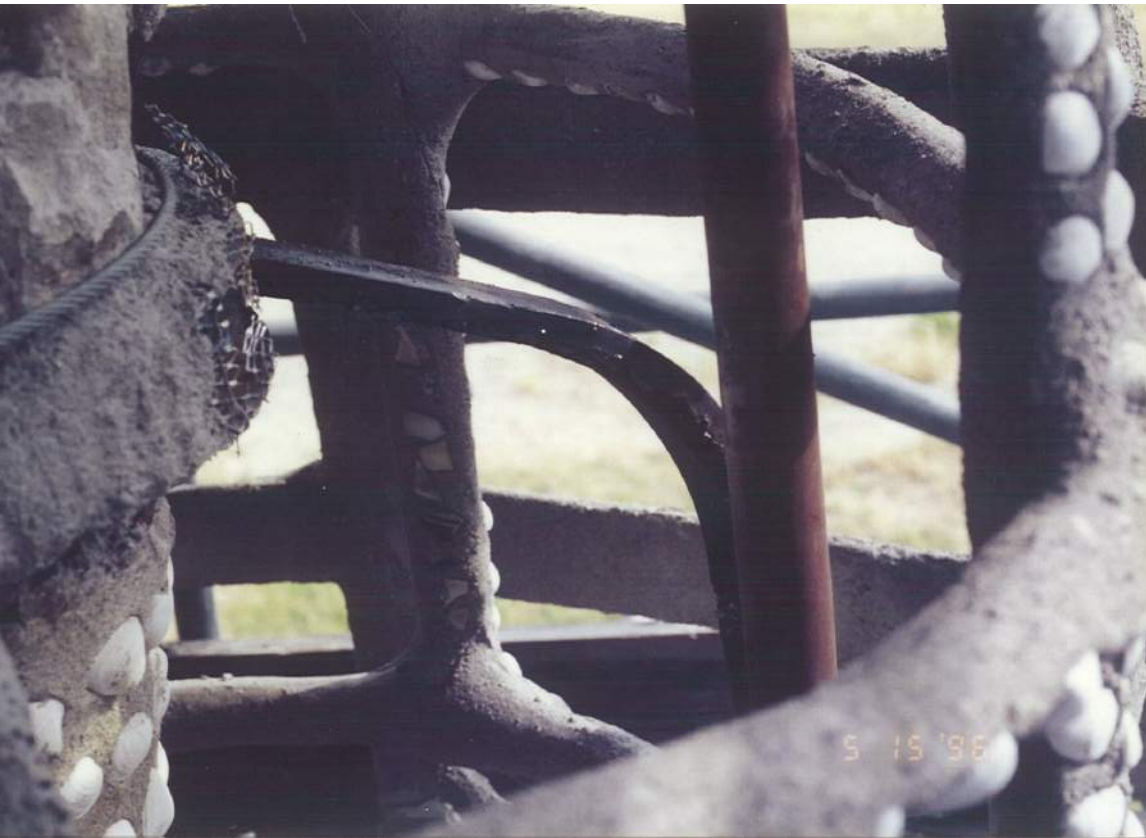
East Tower damage required repairs or replacement of reinforcements on five of six columns. At a critical junction, 19 feet above the base, the columns join the center column. The photographs depict the steel around the center column welded to the reinforcements in the vertical columns. The original Rodia covering was later restored. May 1996.

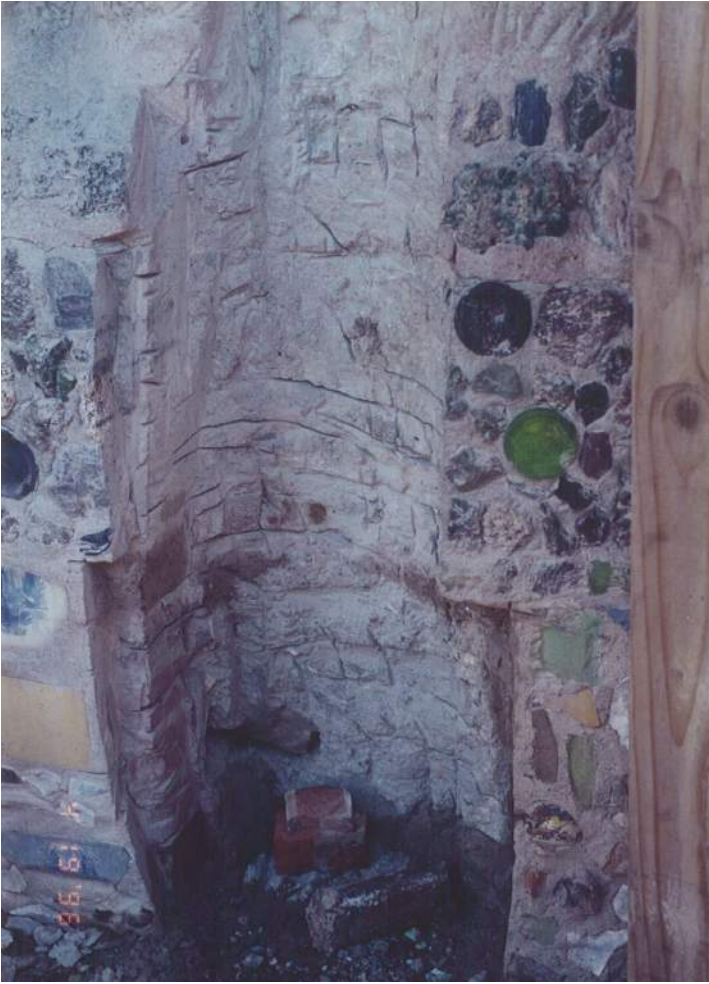
A portion of the Center Tower base was opened to remove a damaged vertical column. Top photo. April 1996.

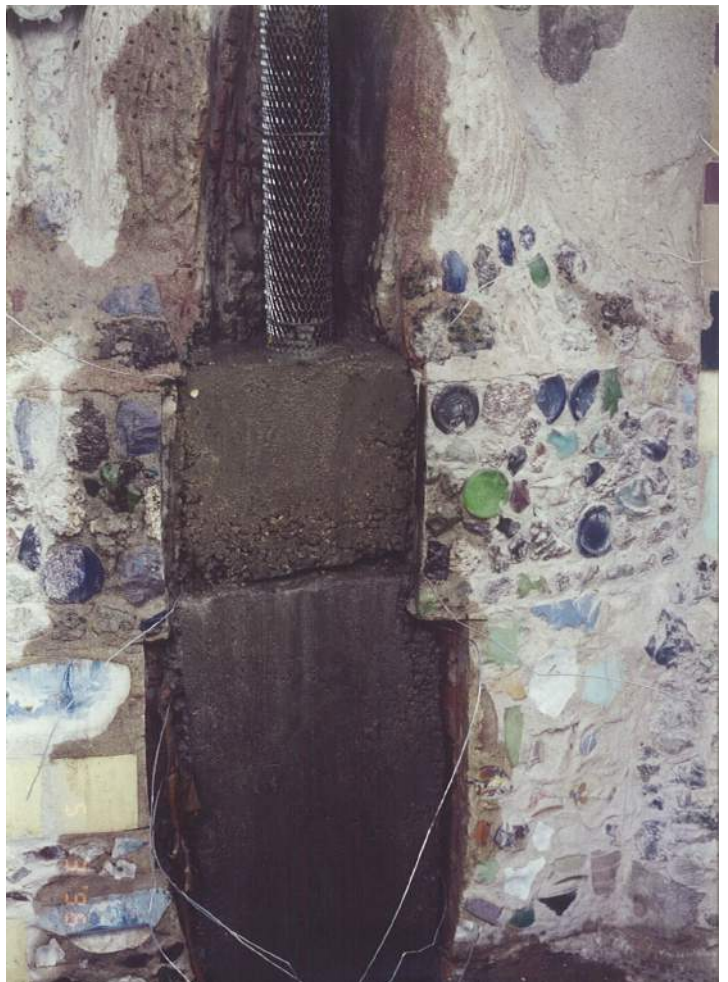
A new reinforcement was installed and welded to the original steel protruding from the base. Mesh was wrapped around the reinforcement and cored with cement mortar. Bottom photo. May 1996
