**REVIEW OF WATTS TOWERS  
NOVEMBER 12, 1996  
1765 E. 107TH STREET**

## **REVIEW INFORMATION NORTHRIDGE EARTHQUAKE DAMAGE TO WATTS TOWERS**

### **BACKGROUND & SUMMARY**

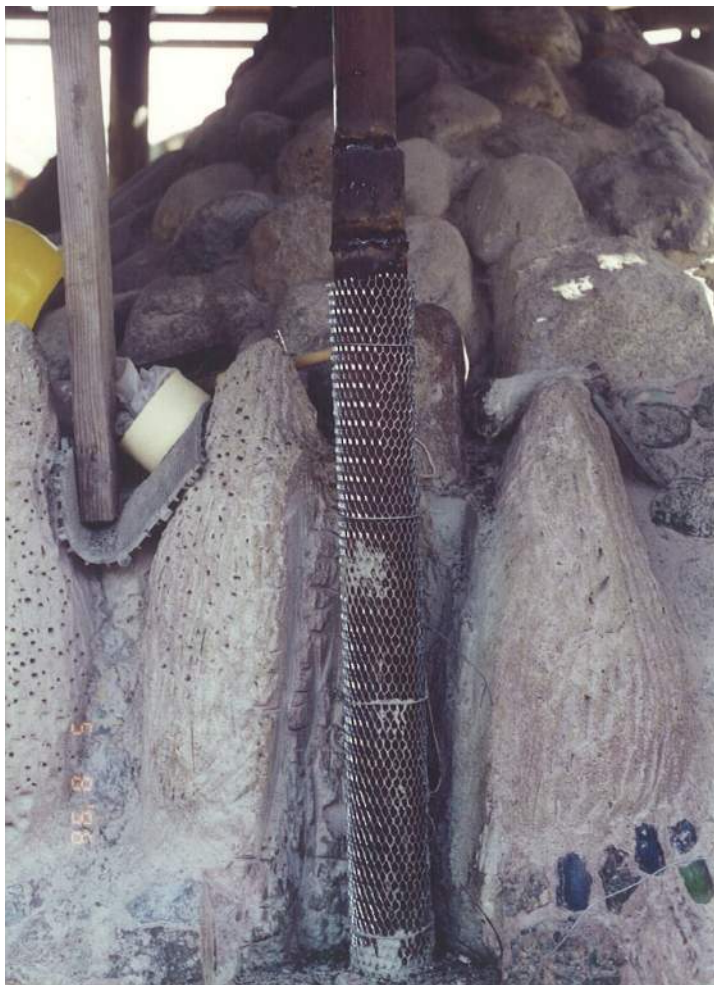
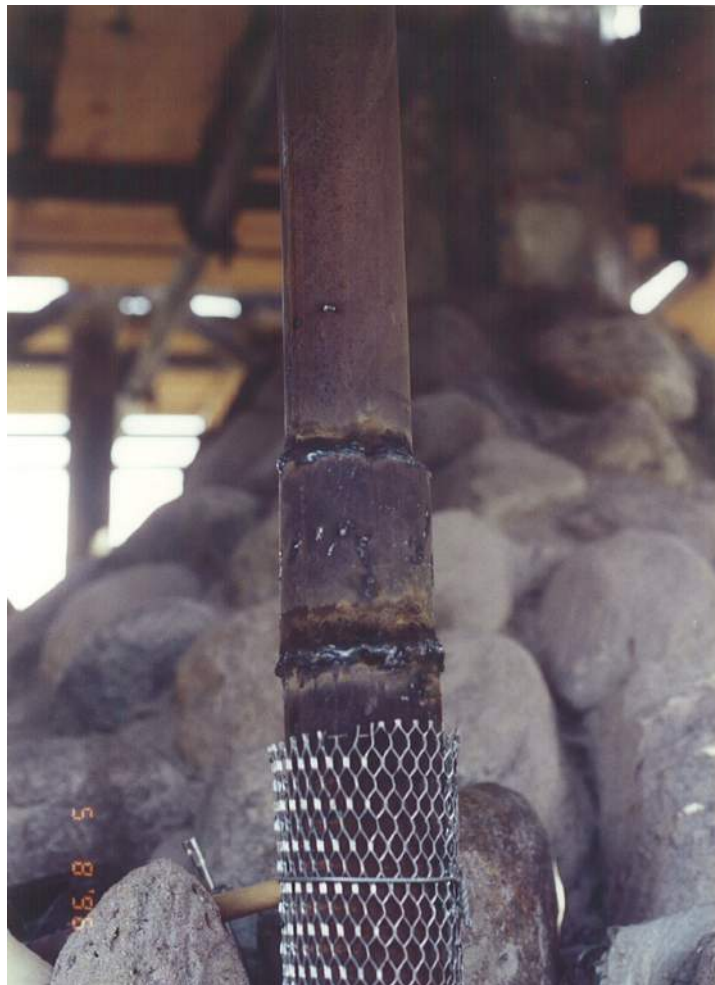
New steel reinforcement installed in Center Tower above base. Mesh has been wrapped around the pipe (left photo) and the pipe has been welded to another pipe directly above it (right photo). May 1996.

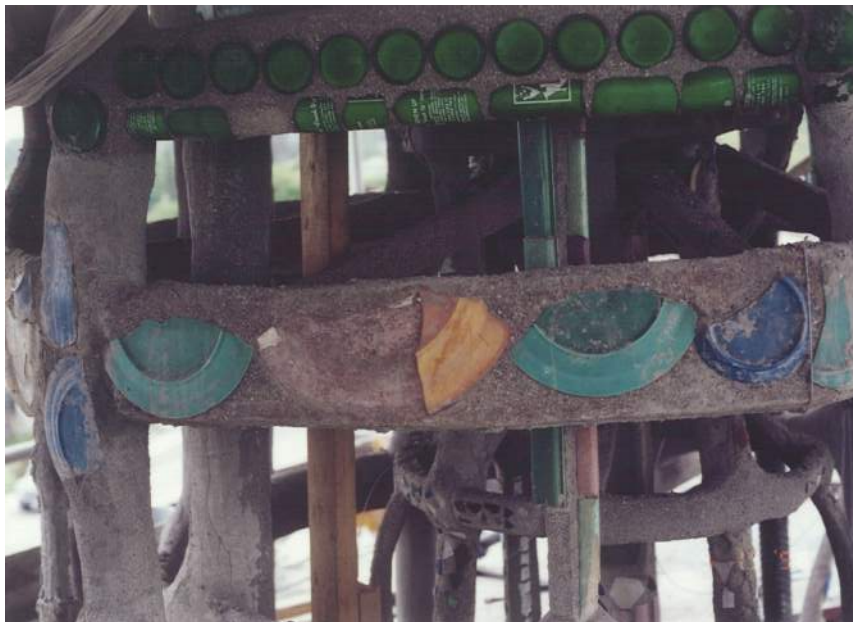
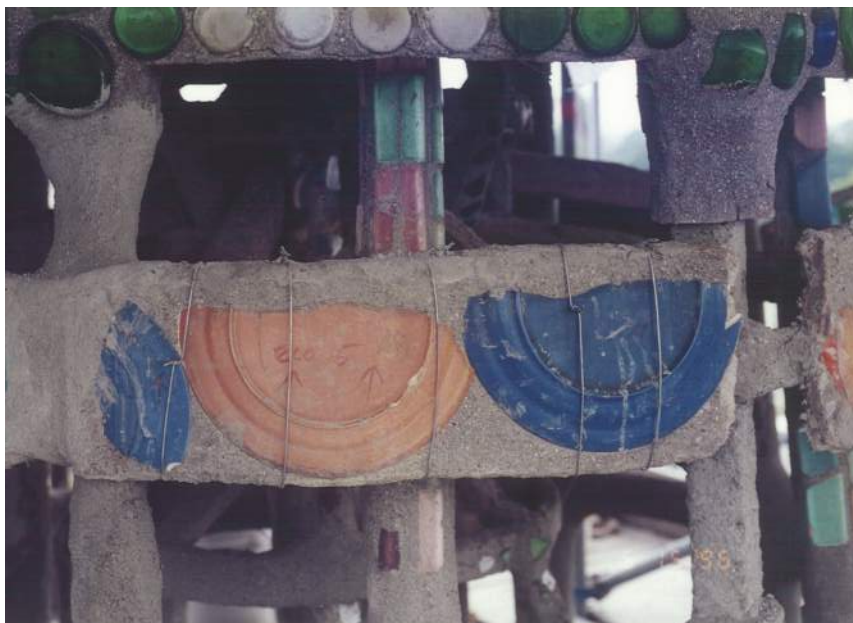
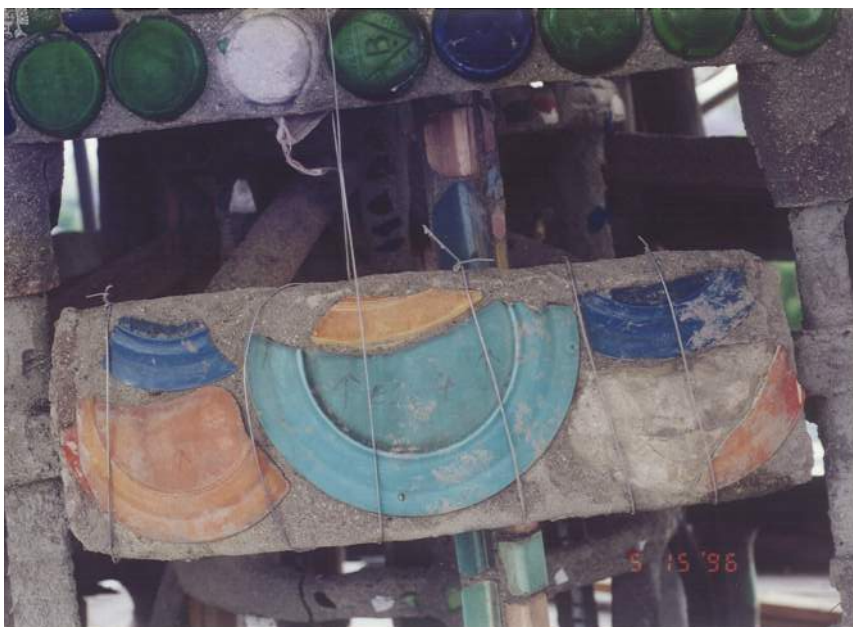
Original band coverings ready for reinstallation over new steel channel reinforcement, wire mesh and cement mortar. Center Tower, May 1996.

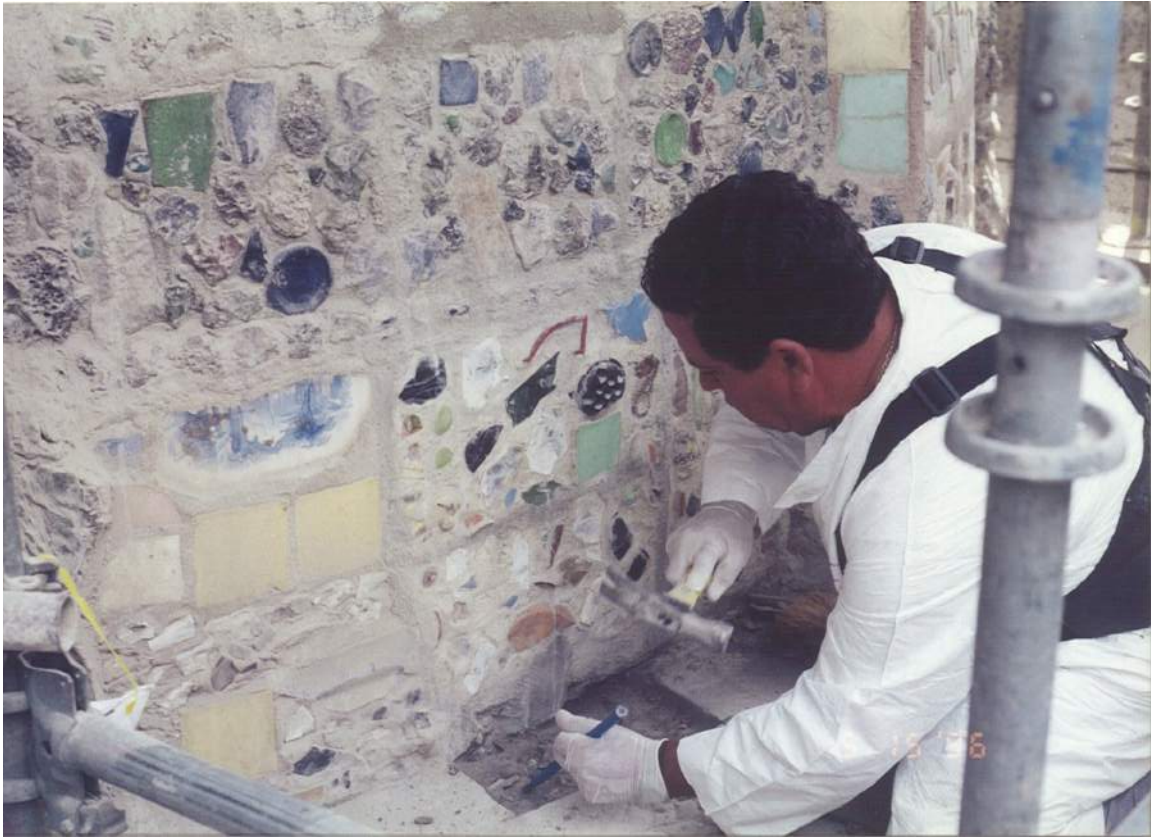
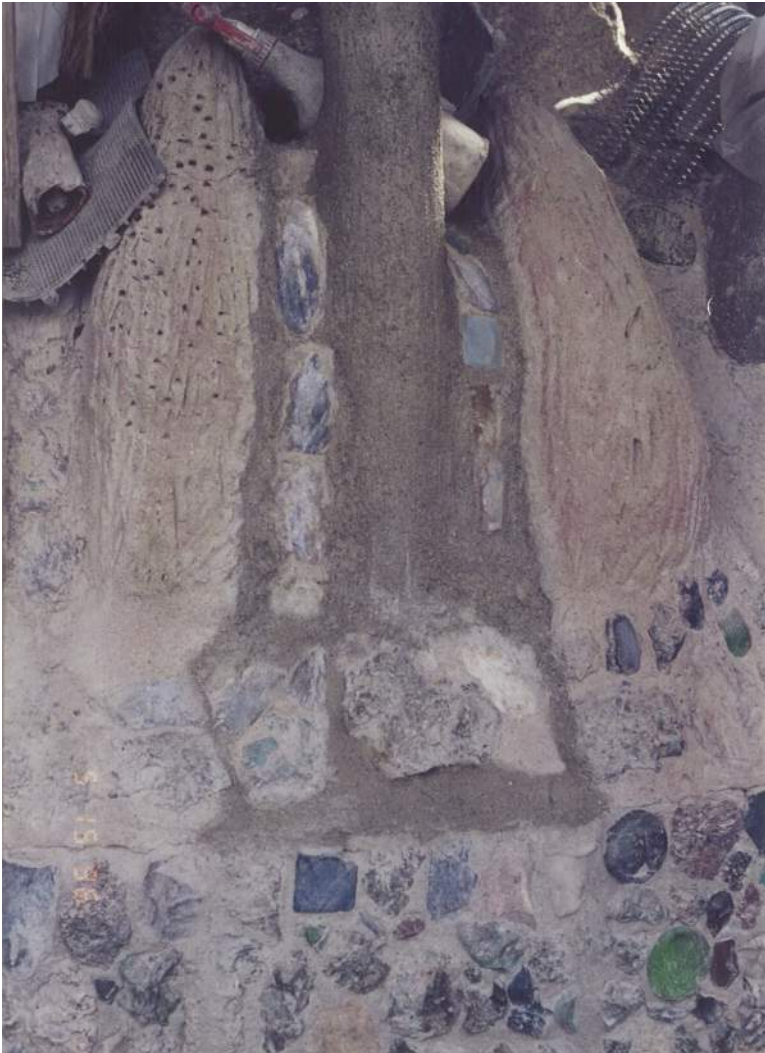
Installation nearing completion for Center Tower base (photo above) and vertical column repairs (left photo). May 1996

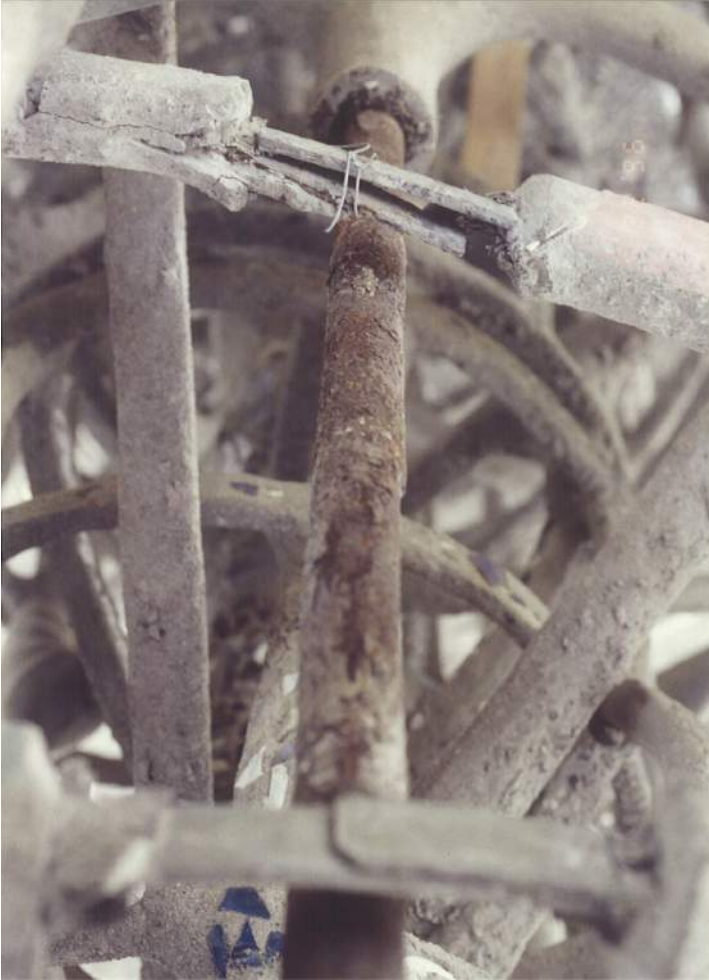
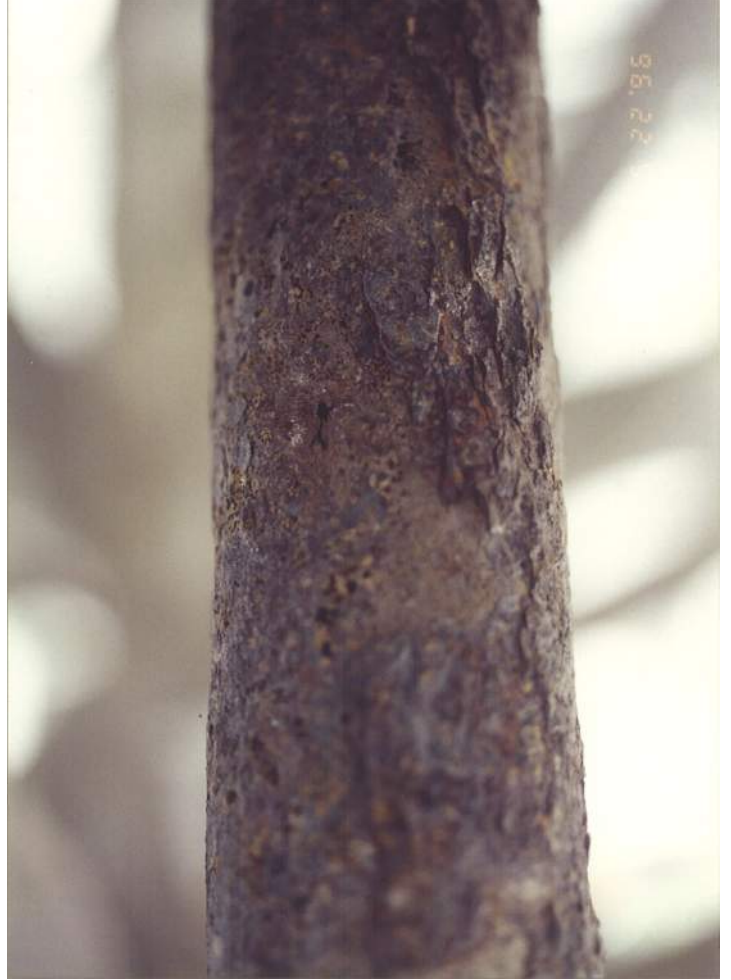
Original column and band reinforcement after opening failed coverings. May 1996

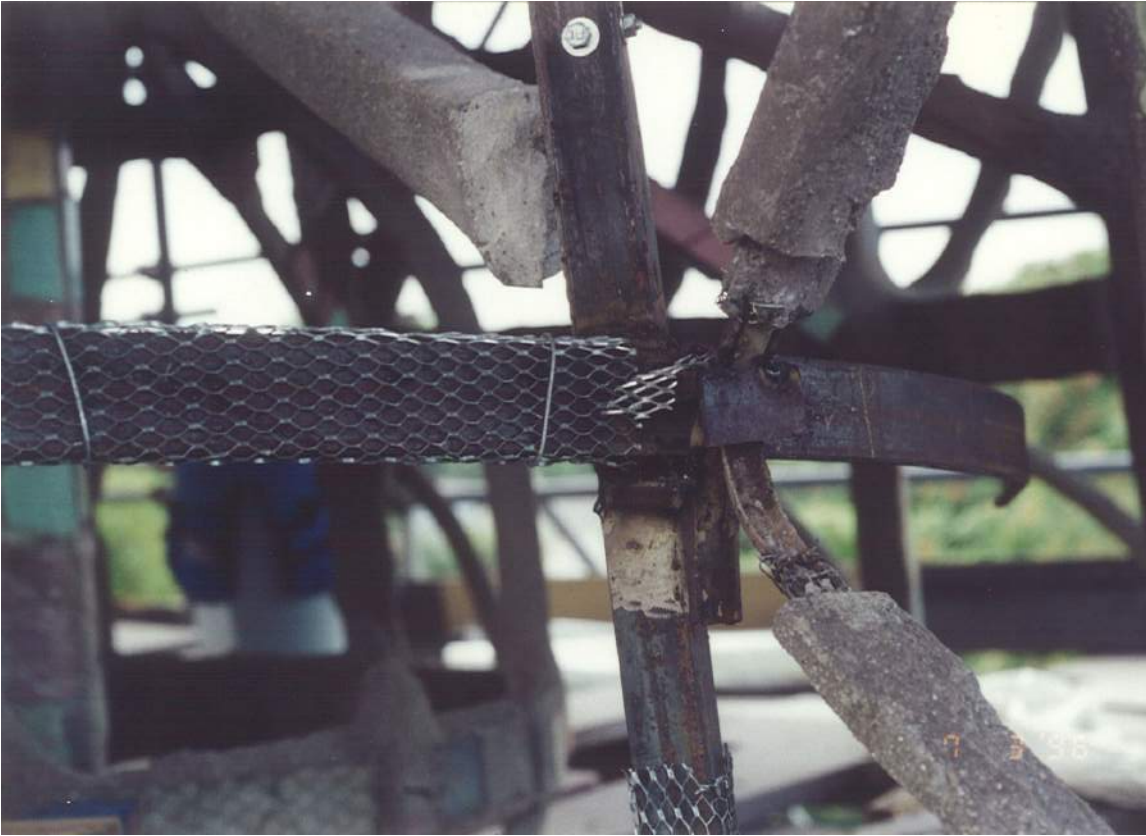
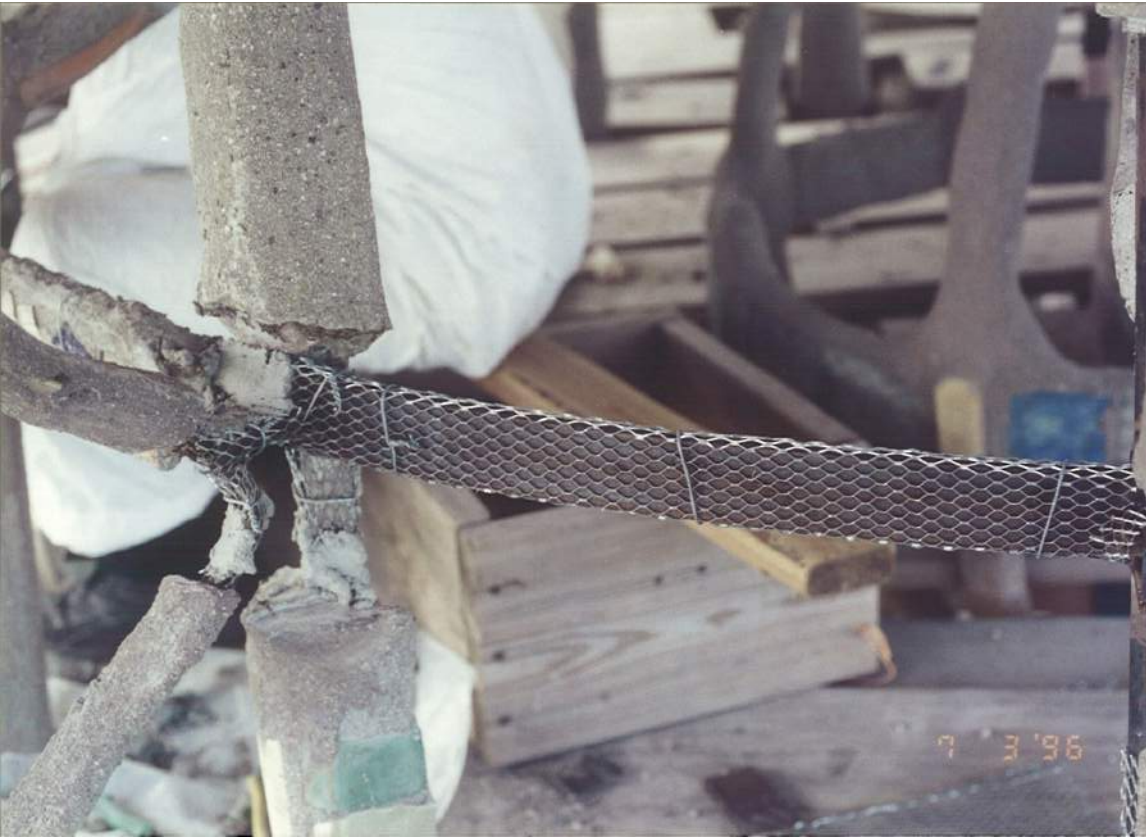
Typical preparation for repairs to failed columns, bands and joints. The damaged covers have been removed, reinforcements either repaired or replaced, wrapped with mesh and welded or bolted to adjacent members. July 1996.

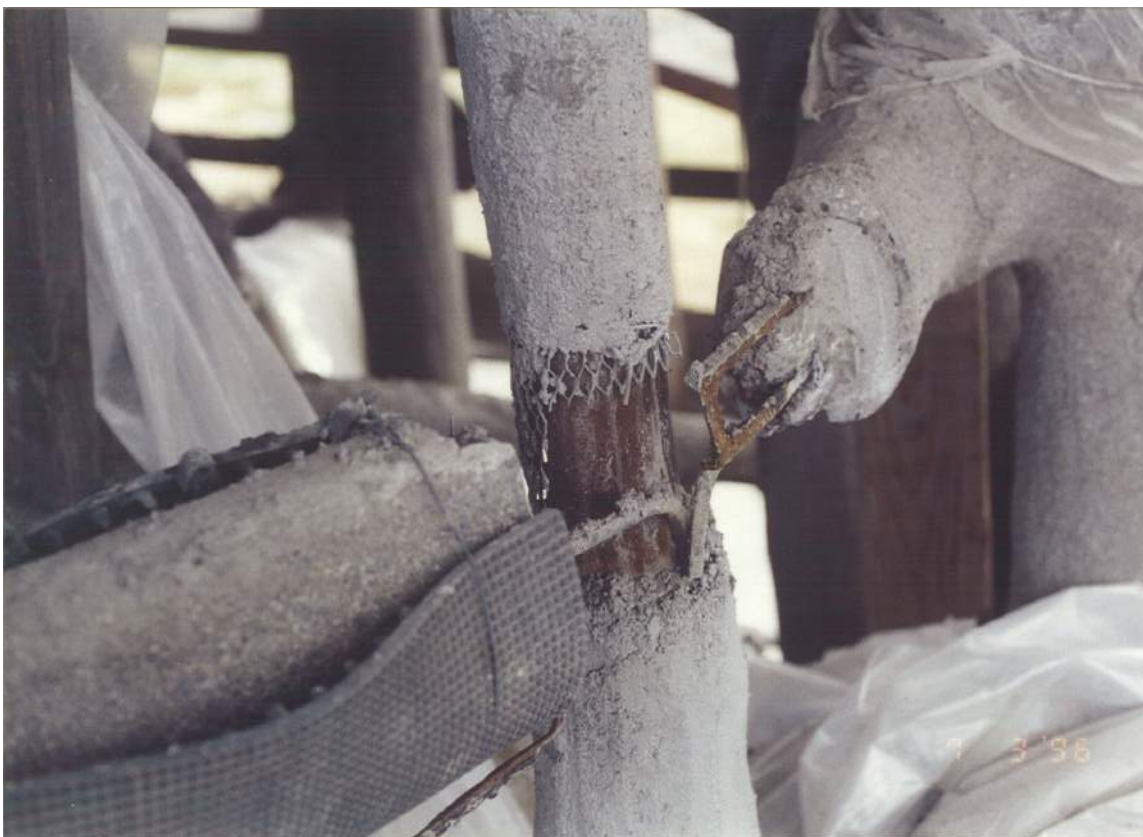
Exposed joint showing failed horizontal band reinforcement at joint with vertical column. July 1996.

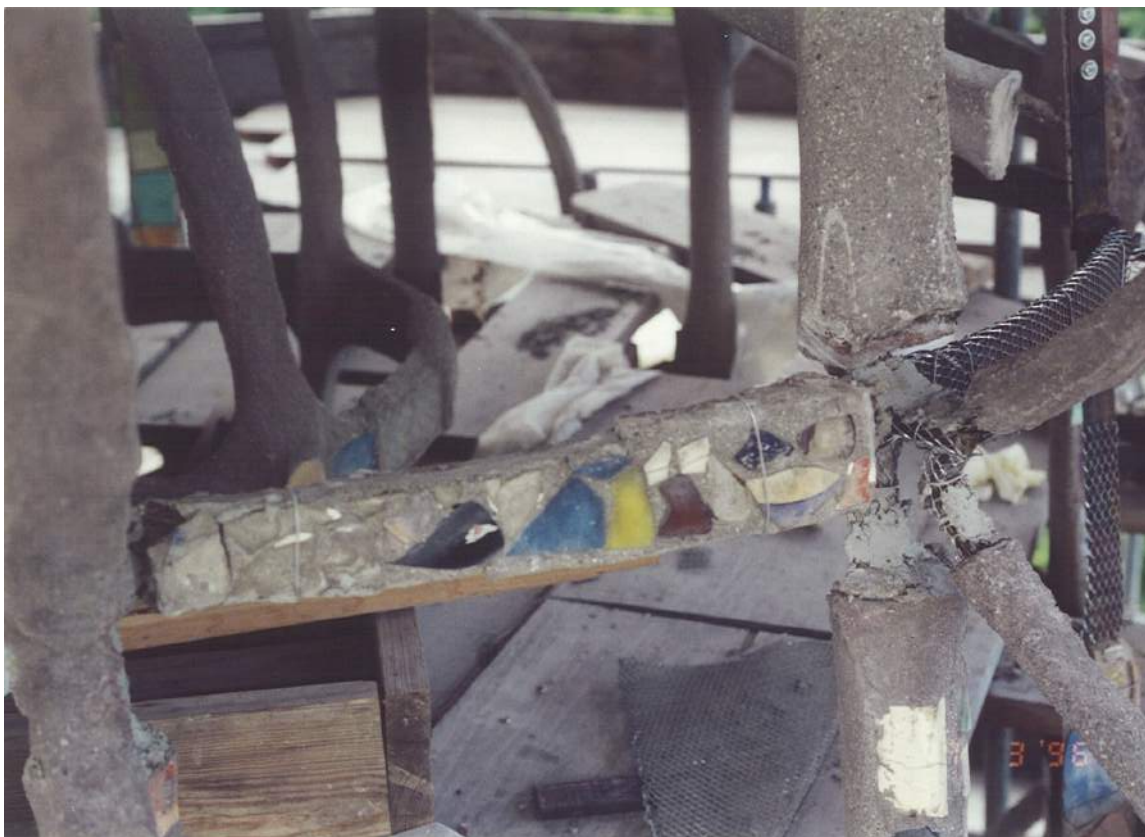
Original band covering with ornaments re-installed over repaired band reinforcement. July 1996.

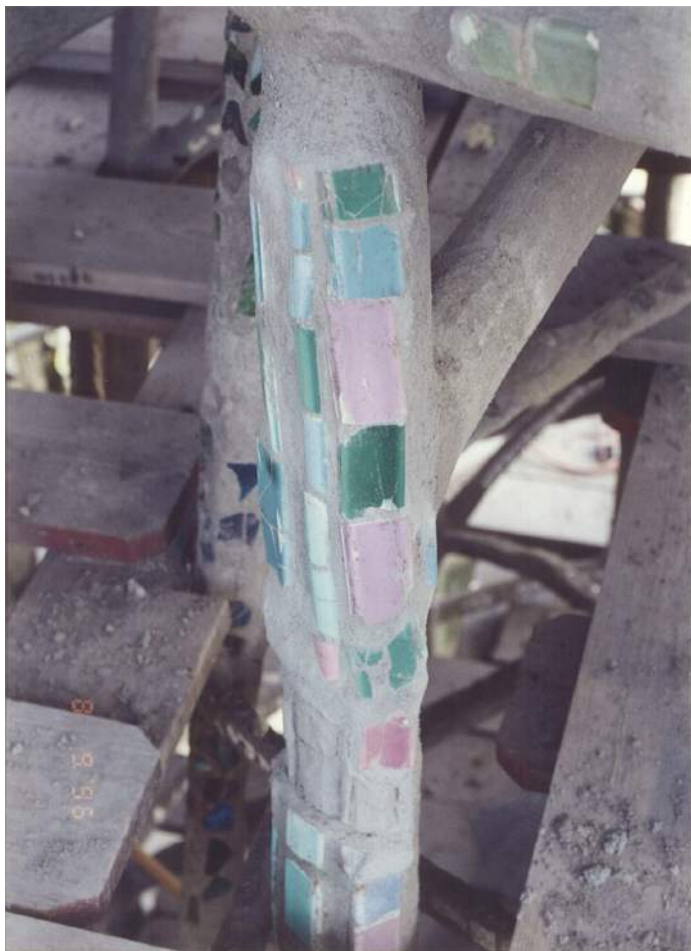
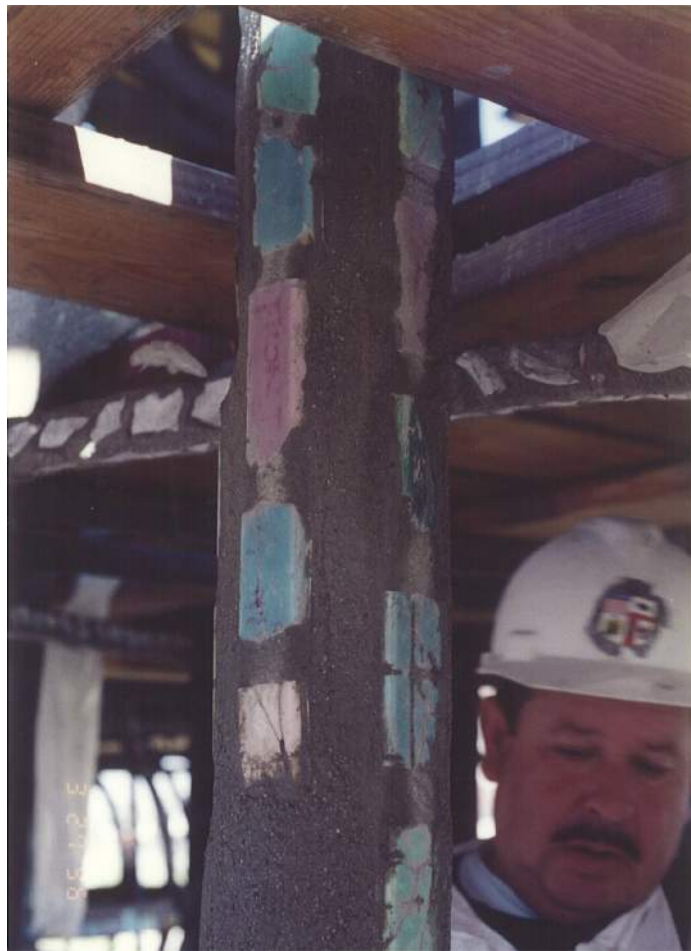
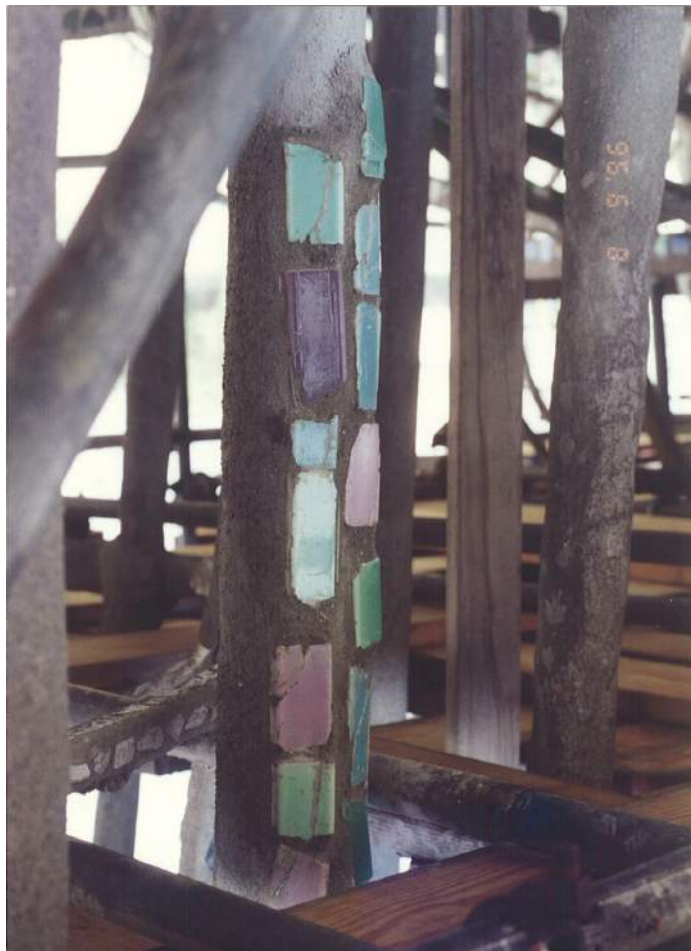
Completed vertical columns. Ornaments had been covered by subsequent applications of repairs by Rodia and/or State. May and August 1996.

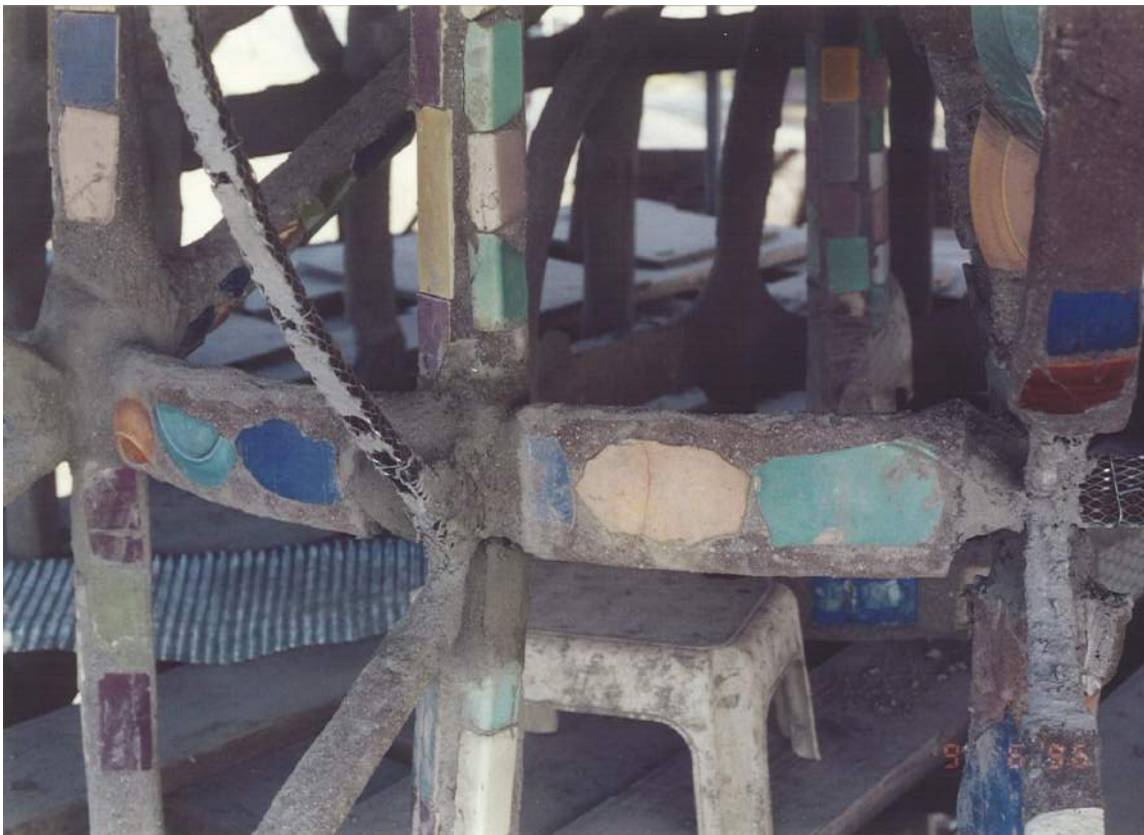
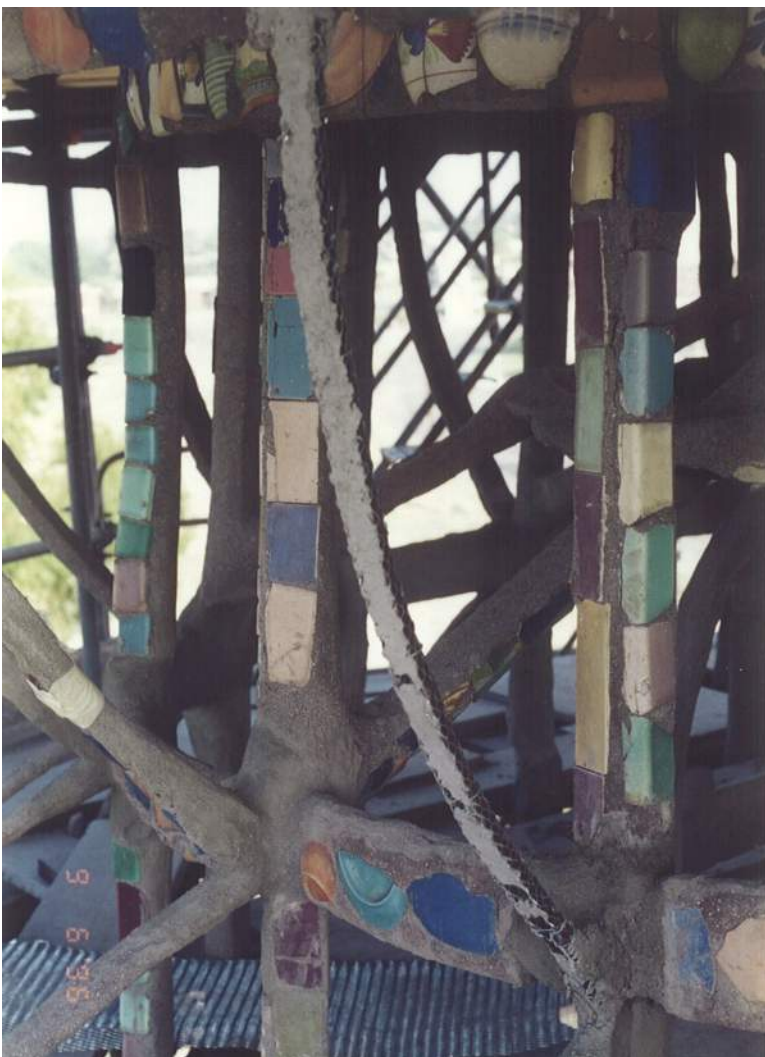
Repairs in progress on horizontal band and joints with vertical columns, radials to the center column and to outer arcs on the West Tower. September 1996.

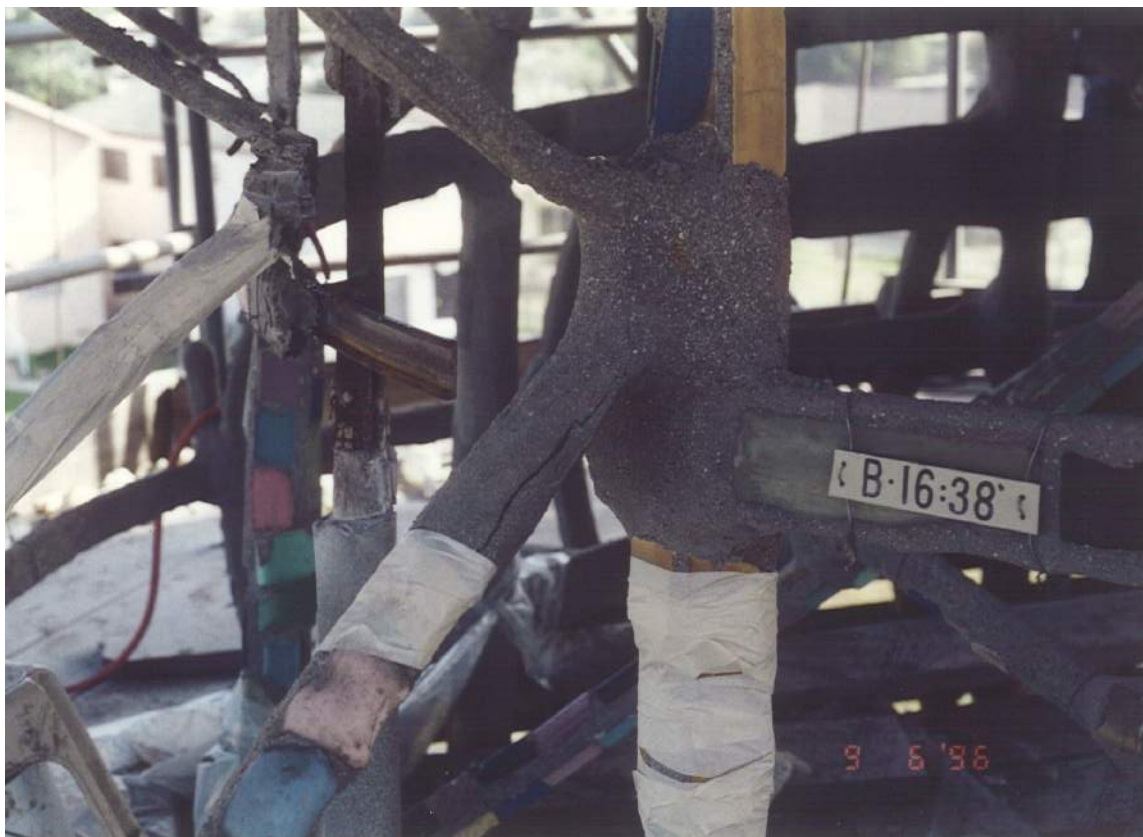
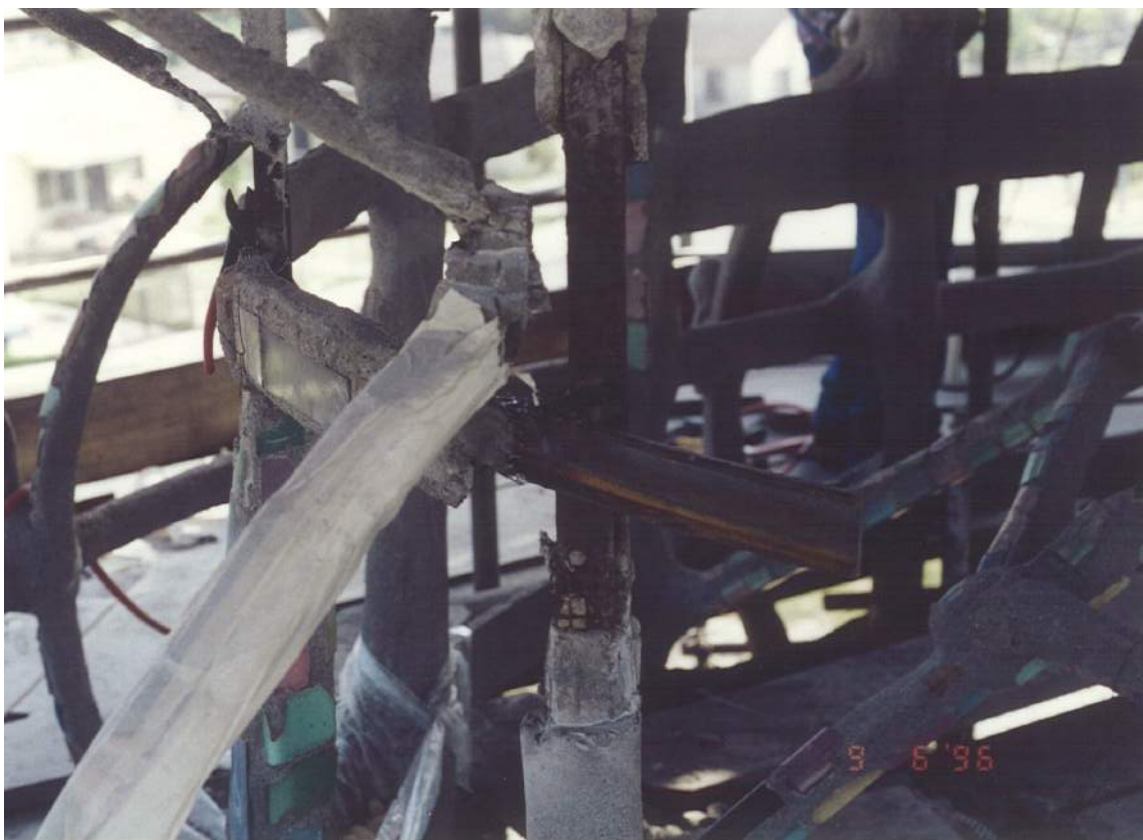
Repairs in progress on horizontal band and joints with vertical columns, radials to the center column and to outer arcs on the West Tower. September 1996.

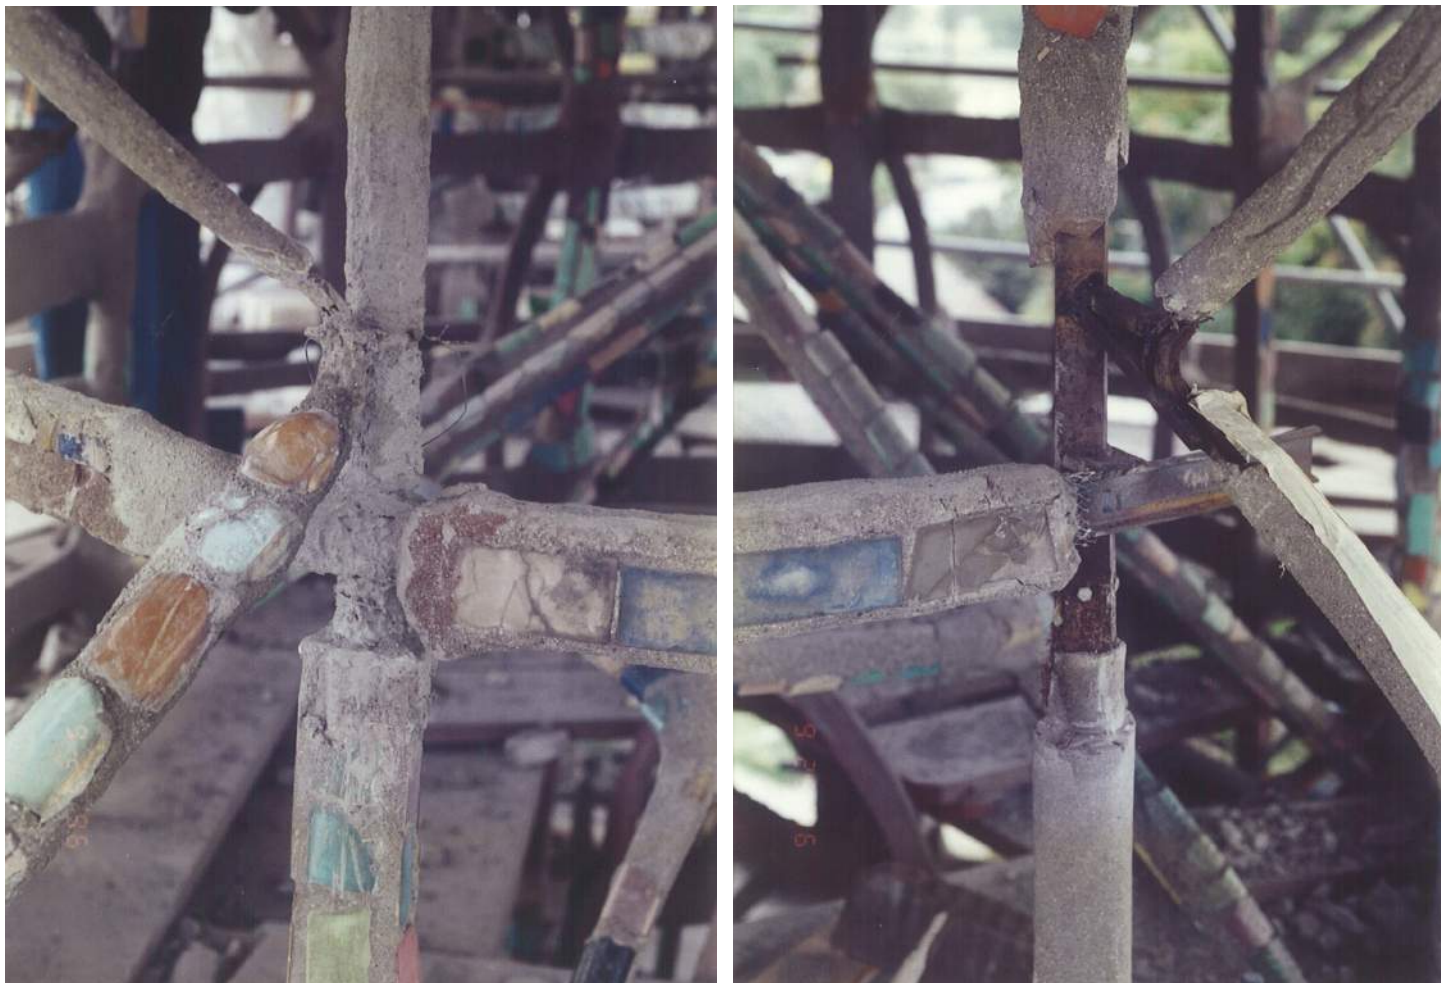
Repairs in progress on horizontal band and joints with vertical columns, radials to the center column and to outer arcs on the West Tower. September 1996.
