**Review of Past and Current Inspection and Maintenance Practices at the
Watts Towers**

Prepared for:

State of California – Department of Parks and Recreation

August 17, 2003

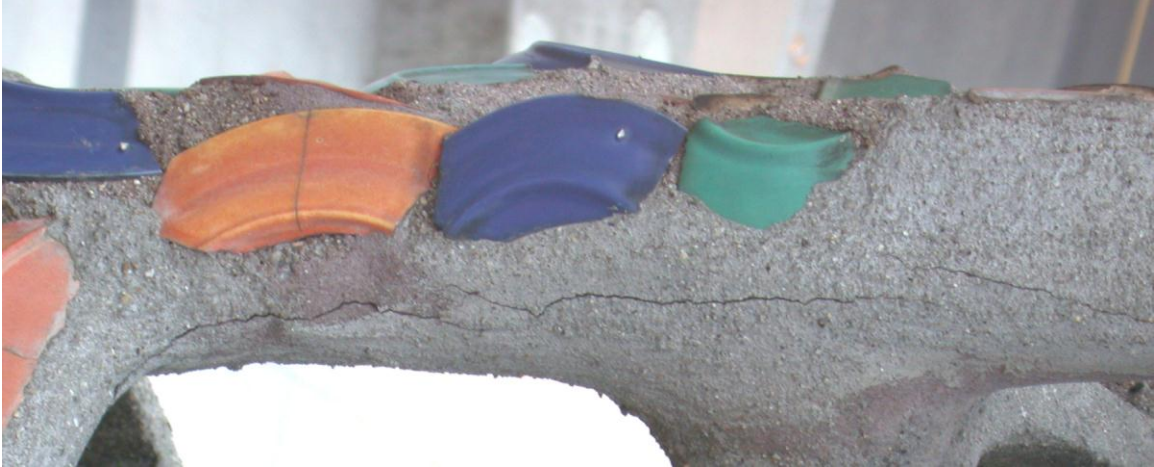
One can observe cracks of varying width throughout the monument (photos 2 to 4). Some of them are clearly in repaired areas and are probably partially due to faulty craftsmanship or the choice of inadequate materials.

Photo 2: crack in higher elevation

At present the cracks appear not to pose an immediate threat to the stability of the monument, but since they provide access to water and pollutants (with possible corrosion of the iron underneath) they should be carefully observed, and ultimately closed in the appropriate manner.

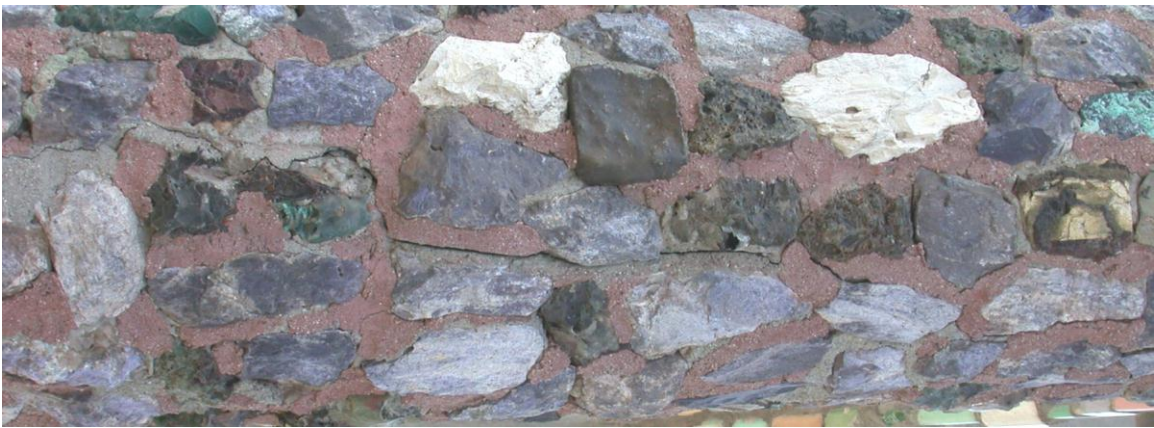
Photo 3: crack in lower elevation

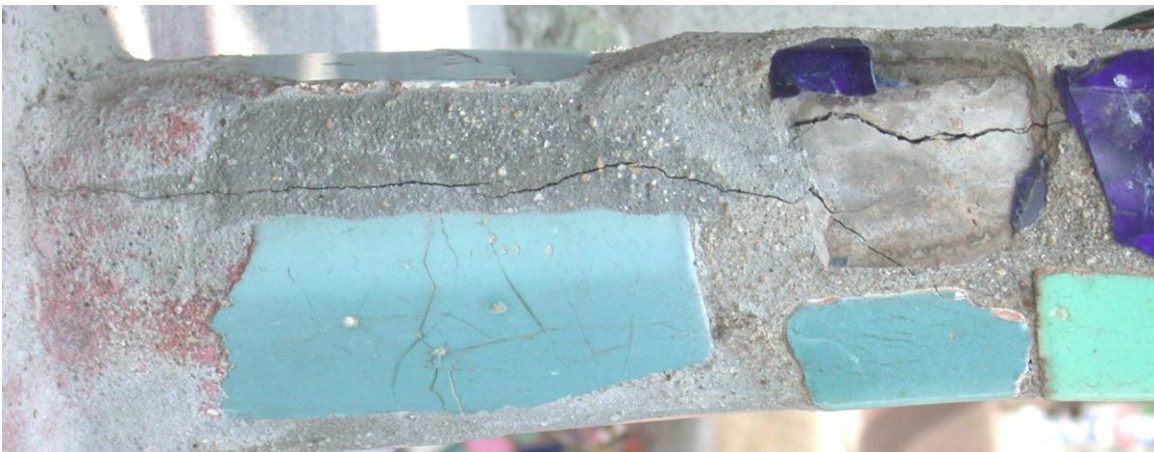
Photo 4: crack in lower elevation

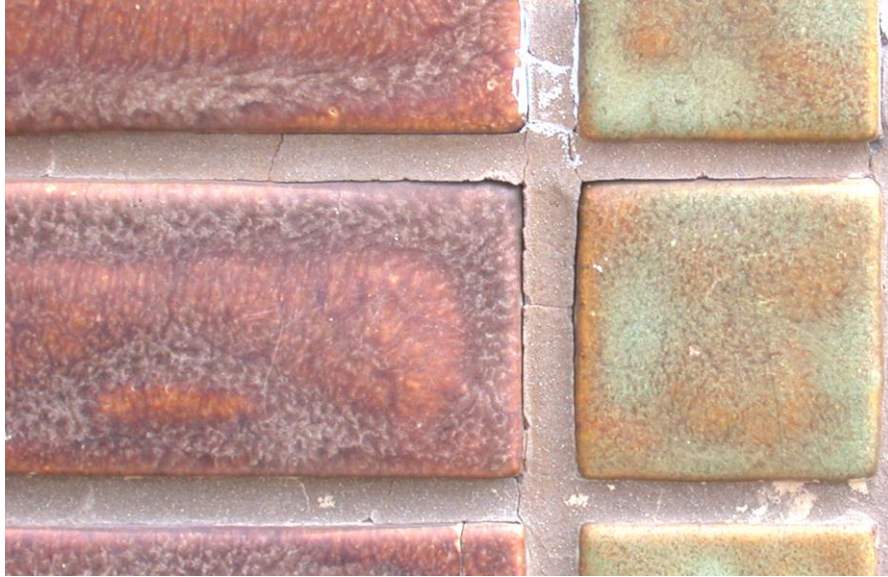
Photo 5: separation of modern re-pointing

Separated re-pointing (photo 5) should be replaced since it provides access of water and pollutants behind the tiles and other decorative elements.

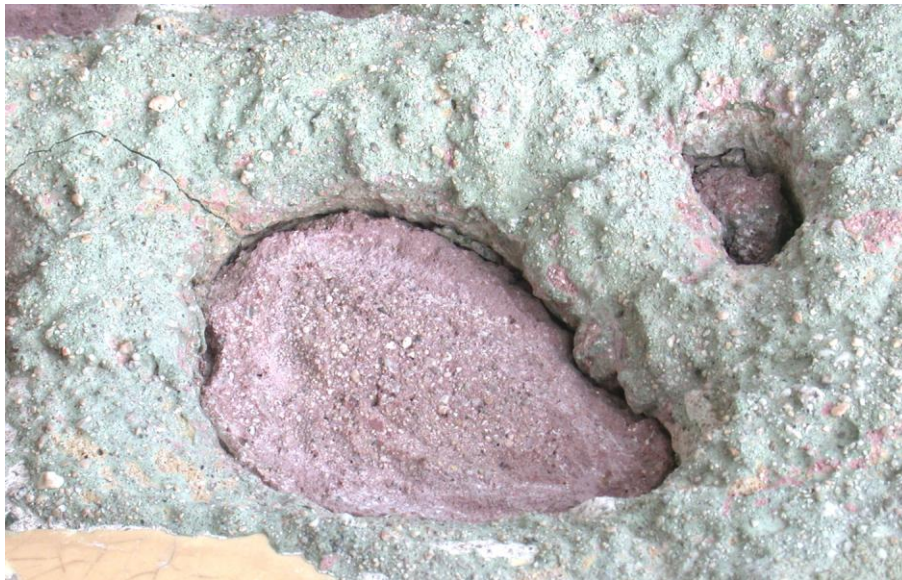
Photo 6: cracking and water access in plaster

Areas of lost decoration (photo 6 and 7) should be filled and/or sealed. Floor cracks (photo 8) should be immediately repaired before the problem gets more serious.

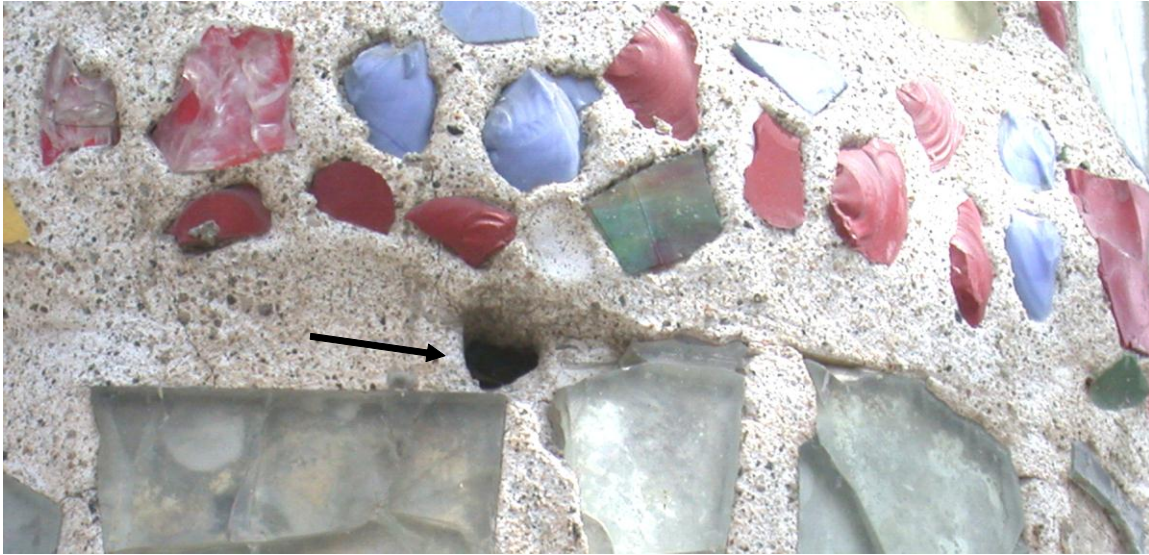
Photo 7: opening providing water access

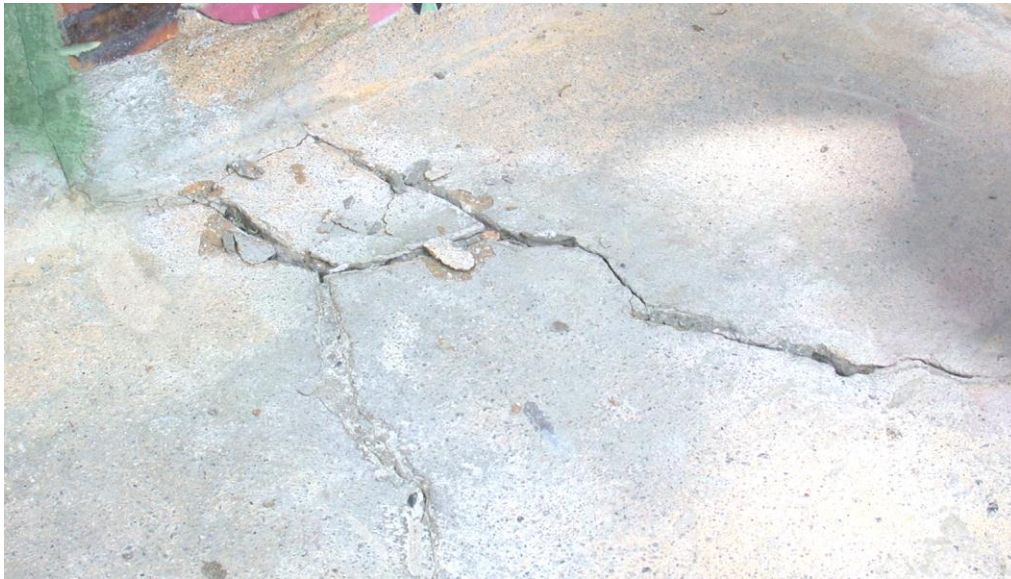
Photo 8: cracking of floor

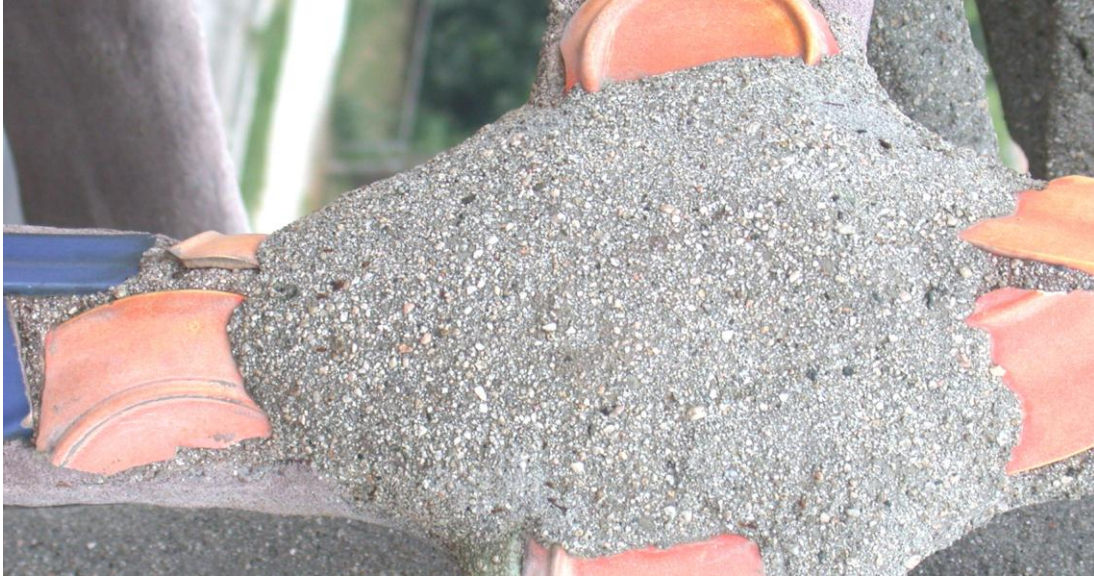
The original plasters and the restoration plasters of the different periods also show to varying degrees erosion by wind and water (photo 9).

Photo 9: eroded plaster

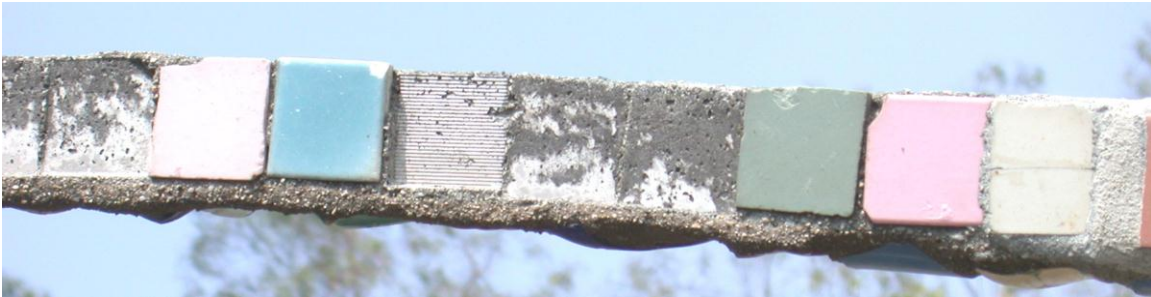
Photo 10: lost decoration

It was not possible during the review period to obtain reliable quantitative information about the rate of loss of decorative elements (photos 6, 7, and 10 to 12). While some stated that pieces fall from the towers on a regular basis, others say that it is not very frequent. It will be important to monitor this issue and enter the information (as far back in time as possible) about time and location into a database to determine if there is a pattern and/or an increase in frequency. This could point to a larger problem. The detachment of decorations is to a large degree an inherent vice since many of the materials do not adhere well to cement. Fallen pieces (photo 12) should be well documented and stored until they can be re-attached.

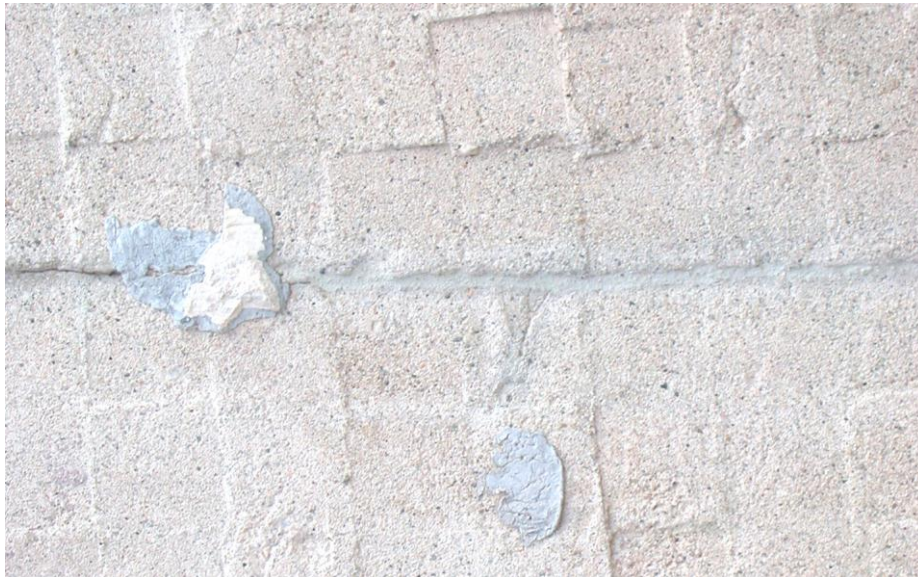
Photo 11: re-attached decoration lost (wrong adhesive)

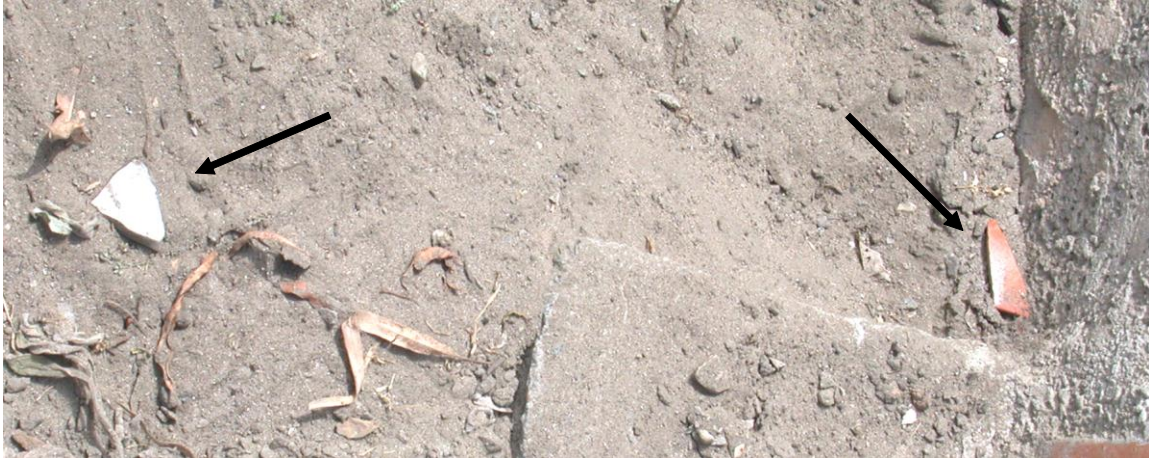
Photo 12: fallen decorations on the ground

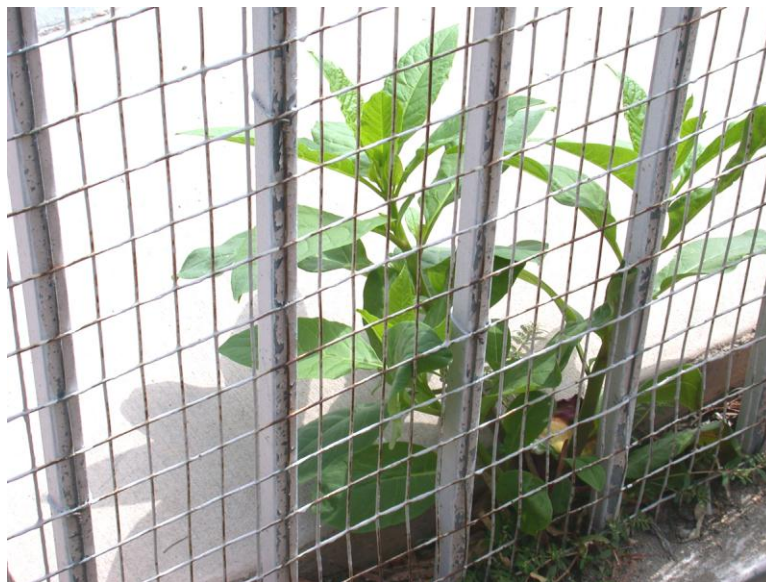
Photo 13: plants growing close to the wall

All plants (photos 13 and 14). should be mechanically (no chemicals) removed from the proximity of the monument. There should be no irrigation close to the monument and a drainage system should be considered.

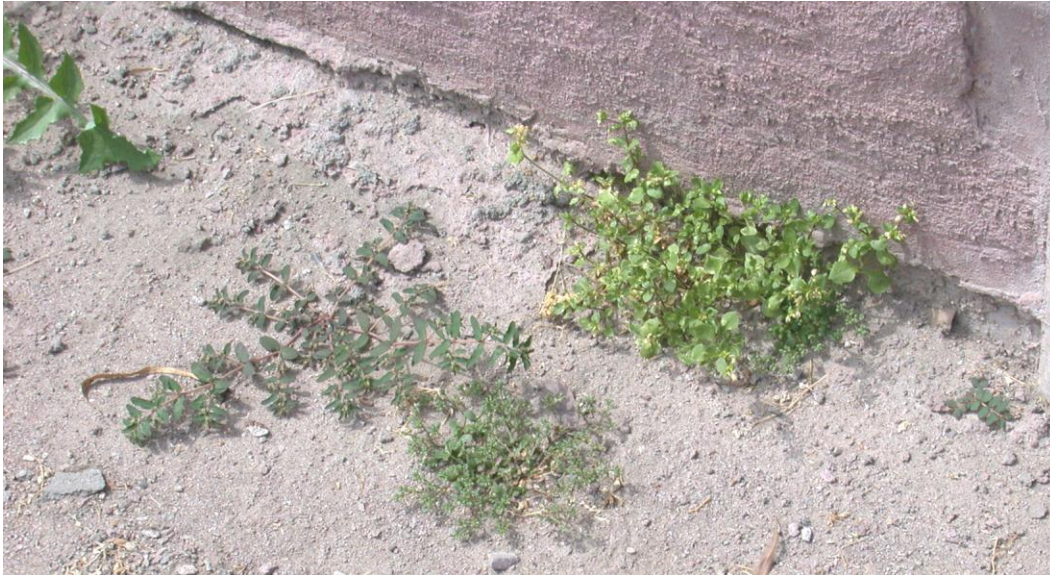
Photo 14: plants in proximity of the wall

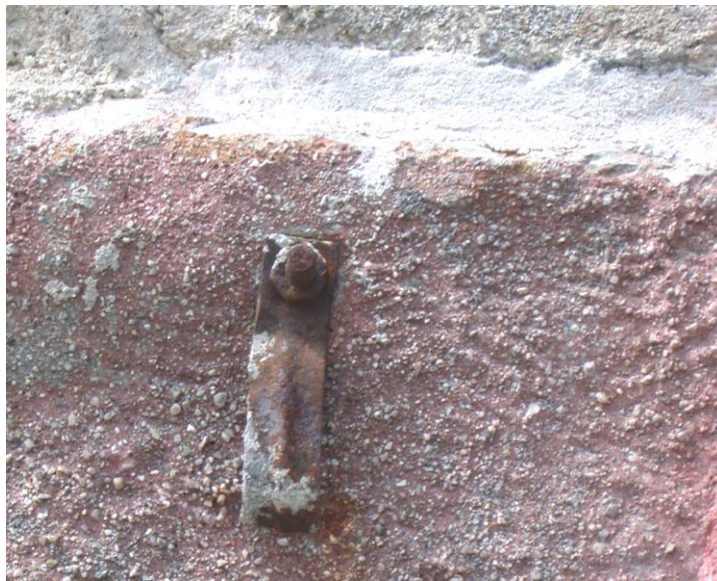
Photo 15 corroded iron anchor and mismatched patching

Iron screws and nails (photo 15) should be removed and, if needed, replaced with stainless steel. When the iron cannot be replaced (photo 16) it should be

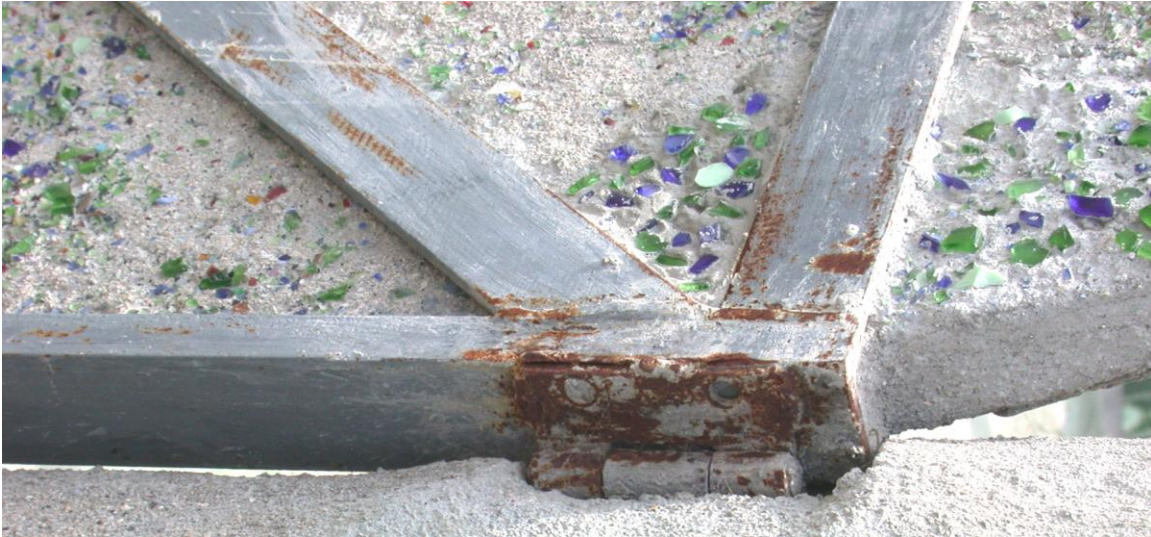
Photo 16: corroded iron door with plaster fill

thoroughly de-rusted, painted, and sealed so that water cannot penetrate between the iron and the plaster.

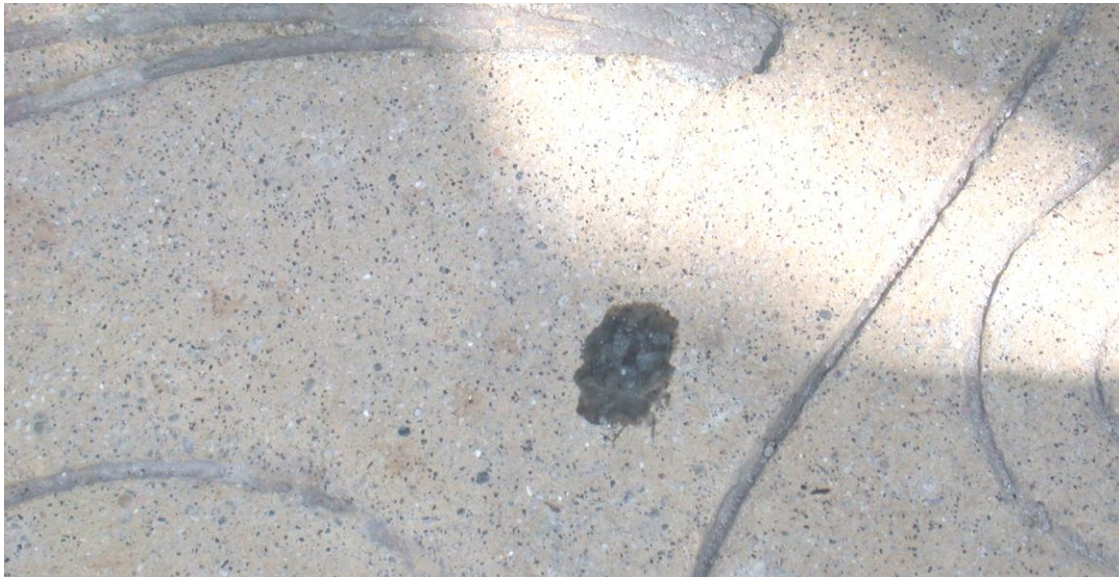
Photo 17: chewing gum

Visitors put stress on any monument and frequently cause damage. At the Towers visitors walk on the decorated floor, climb on the lower parts of the monuments, touch the monuments, spill drinks and food, and even chewing gum (photo 17). The tour guides need better training, didactic signs have to be improved, and rules established (like no food, no drink, no chewing gums).
