Comparison of 1987 and 2011  
Photographs of Watts Towers Sculptures

Interior South Wall

April 18, 2012

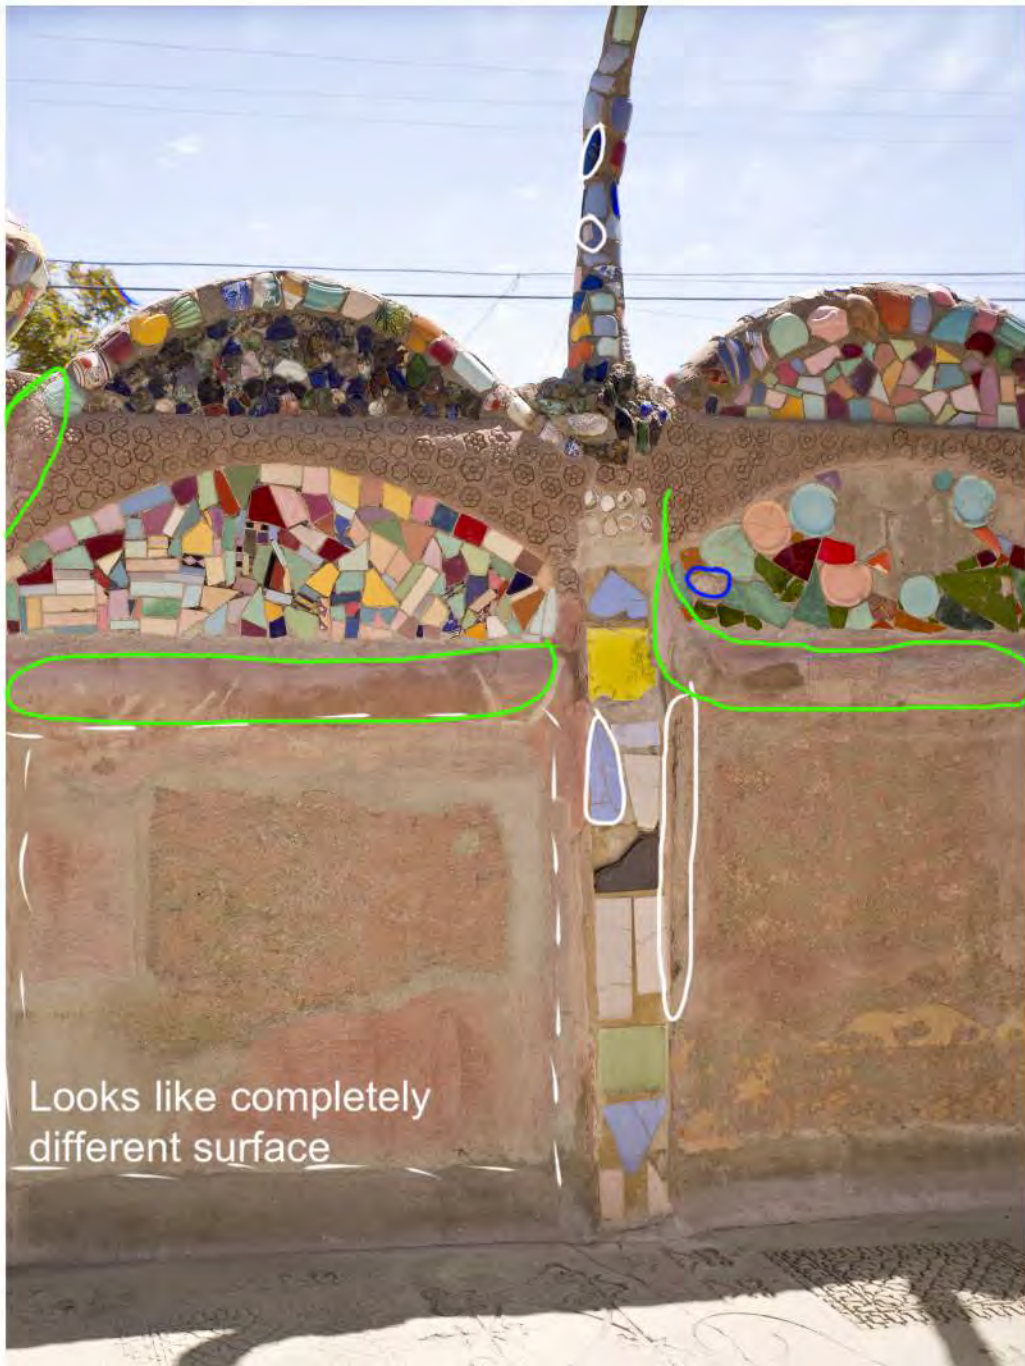
Interior South Wall  
 Panel 10 and 11  
 2011

Looks like completely different surface
