**LACMA, DCA, and Watts Towers**

**Second Quarterly Report (April-June 2011)**

**Prepared for the DCA, City of Los Angeles, by Frank Preusser, Mark Gilberg, and Brooke Davis Anderson**

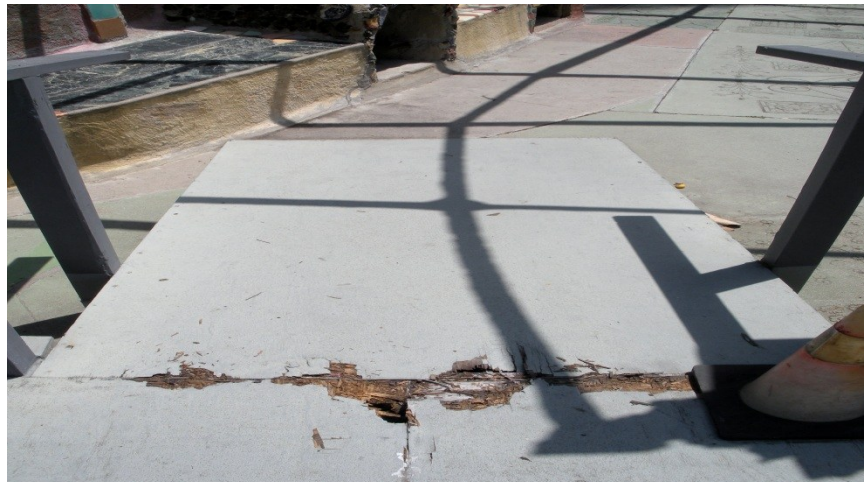
Figure 1: deteriorated wood at platform ramp

The wood of the platform in the location of Rodia's house is heavily deteriorated and the platform is unsafe (Figure 1). The current access to the platform is also not ADA compliant. For safety reasons the platform was cordoned off with yellow caution tape by LACMA staff. The caution tape was removed the following day by Watts Towers Art Center staff. At the request of the site curator, it was re-installed on June 22. CDM Construction has submitted three design proposals for the repair of the platform and ADA compliant access. These proposals are currently under review by the City.

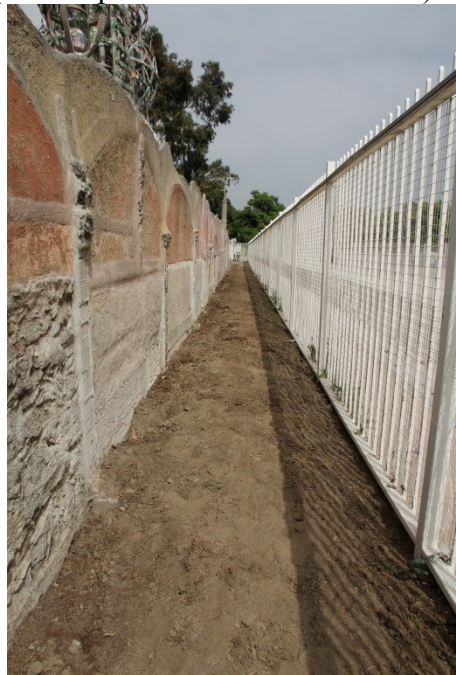
Figure 2: North side after weed removal

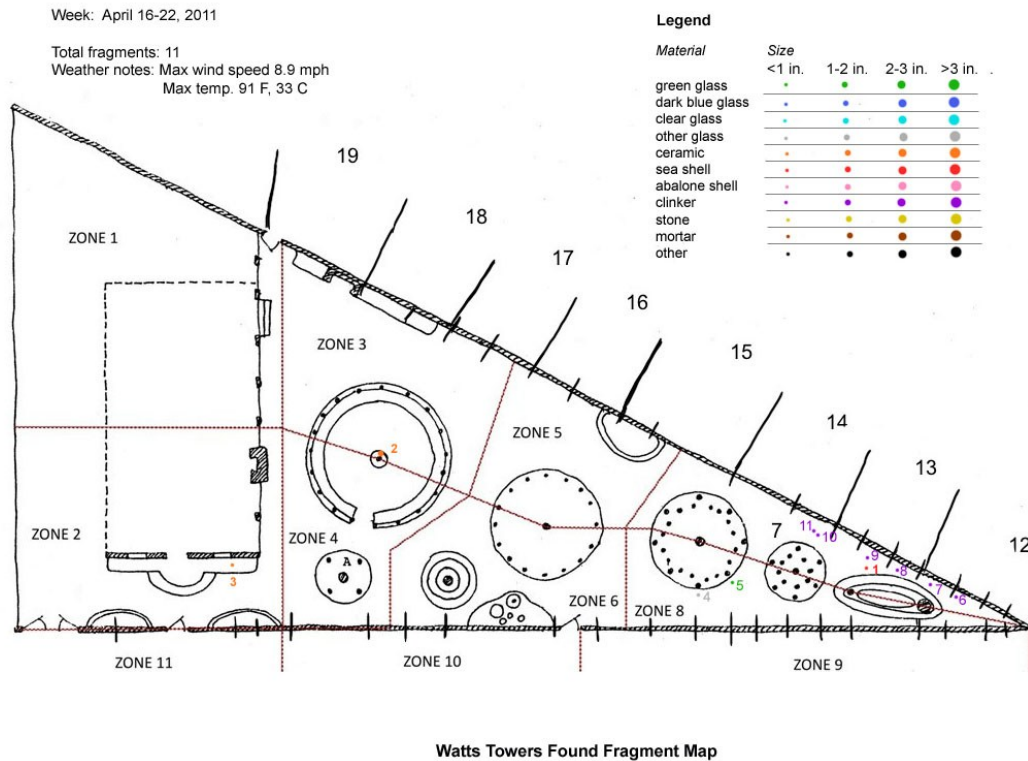
Very few fragments have fallen since the last report. They have been collected, photographed and entered in the database. Figure 3 shows a prototype location map for collected fragments; such maps will allow us to establish patterns of deterioration on site over time.

Figure 3: Prototype fragment map

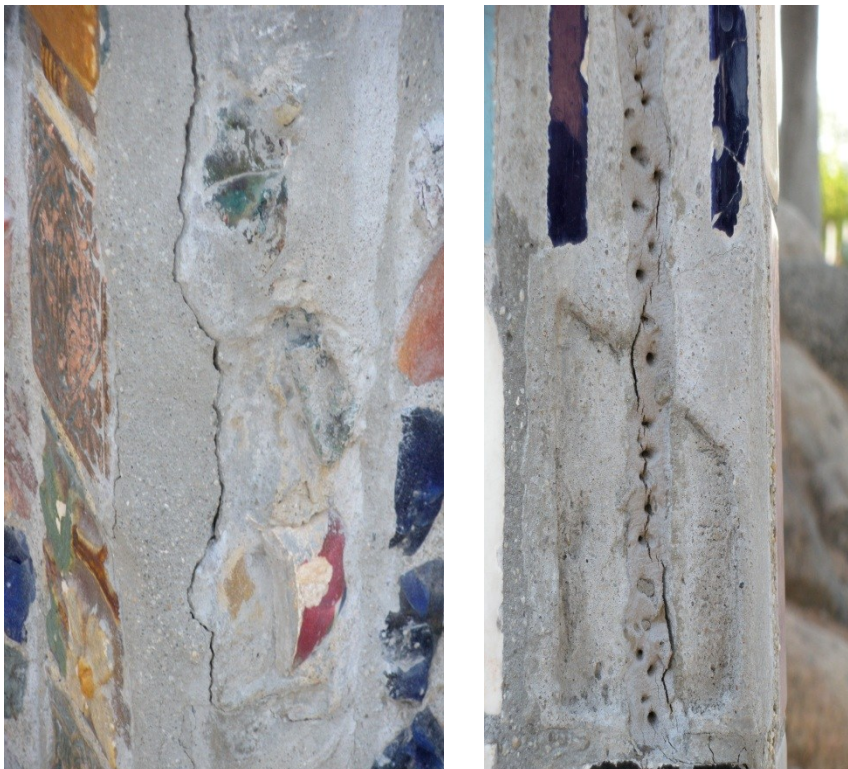
Cracks and crack repairs are a major subject of every report issued on the towers. Not long after extensive crack repairs the development of new cracks has been reported. Our own observations strongly suggest that a majority of the “new” cracks are in fact failed crack repairs (Figures 4 to 10). Assuming that the repairs have been properly executed in terms of materials preparation and application, these failures strongly suggest that many cracks in the towers are not static, but are moving.

Figure 4: failed mortar fill

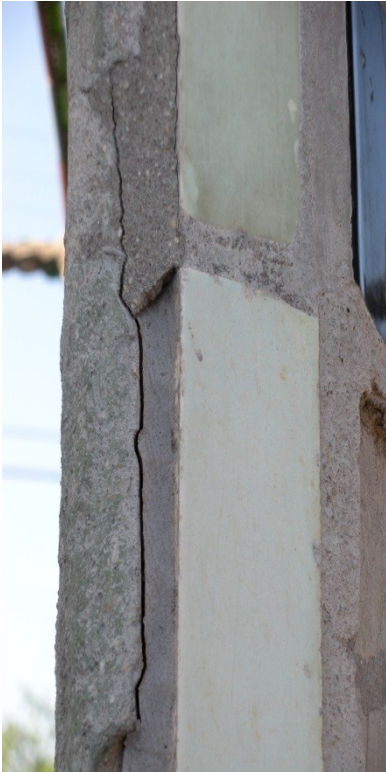
Figure 5: cohesive failure in epoxy repair

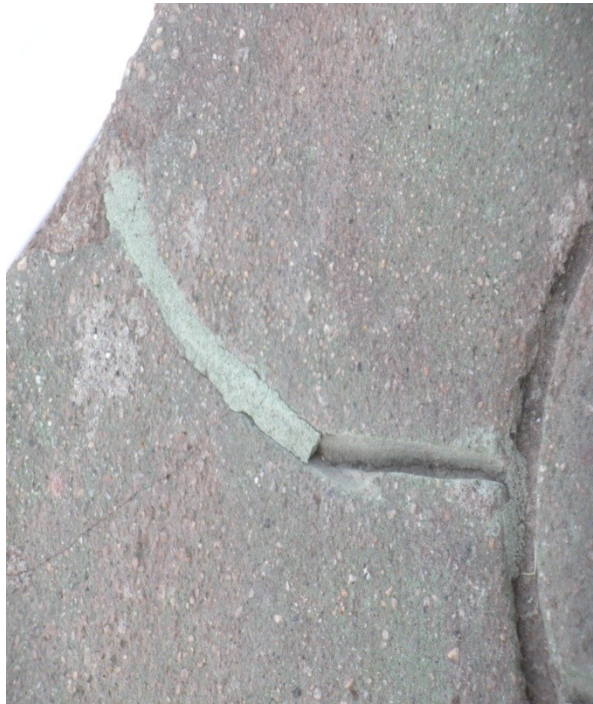
Figure 6: Loss of mortar cover over failed epoxy repair

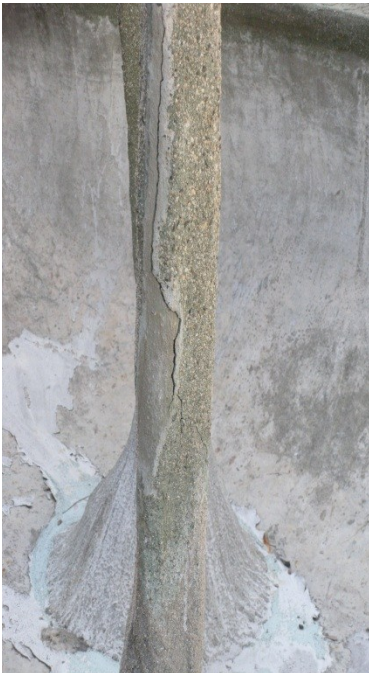
Figure 7: Loss of mortar crack fill

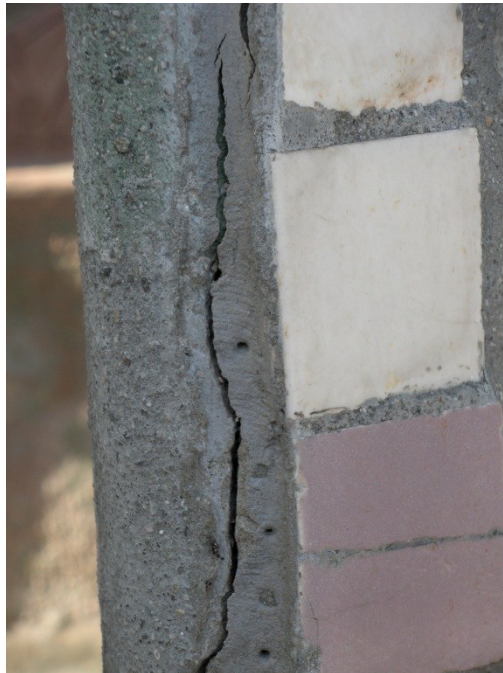
Figure 8: failed mortar repair

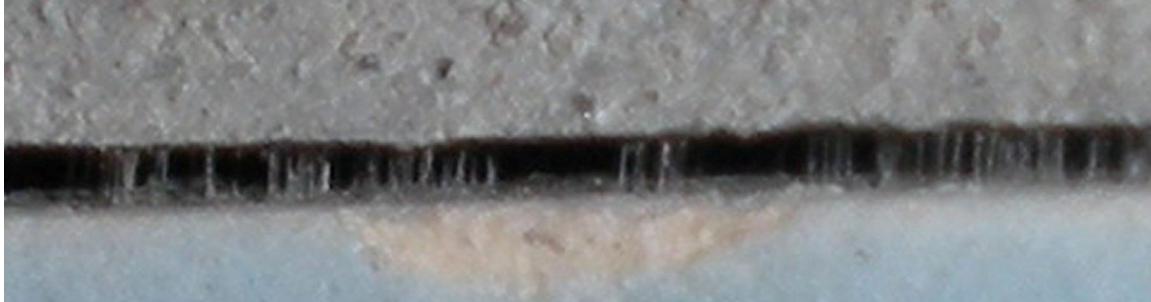
Figure 9: Cohesive failure in epoxy repair

Figure 10: Cohesive failure of epoxy repair

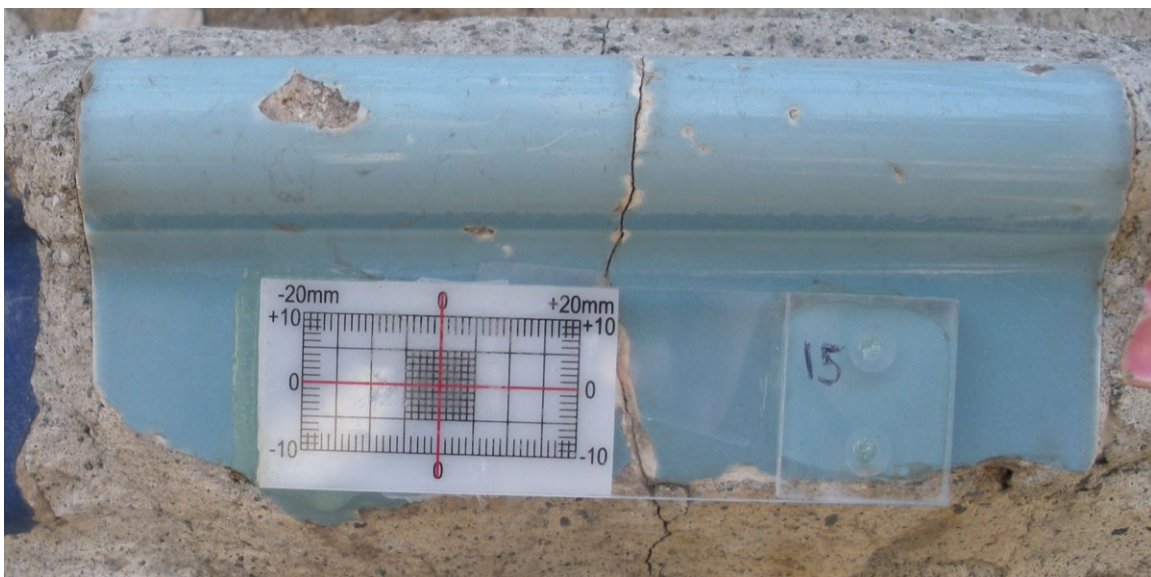
To get started, we installed four Tell-Tale crack monitors (Figures 11 and 12) and 13 plaster bridges (Figures 13 and 14). The locations are marked in Figure 15. The plaster bridges crack when the crack being monitored moves (Figure 14). The Tell-Tales show bidirectional movement of the crack but are not very useful for the monitoring of cracks that open and close. After almost two months, nine of the plaster bridges have cracked and one of the Tell-Tales showed movement. For a more detailed evaluation of the crack movements we will need to install more sophisticated monitoring devices (strain gauges, foil type) and we are currently evaluating the available equipment and the options of doing it ourselves or contracting it out. The locations for future monitoring will partially be determined by the results we obtain from the Tell-Tales and plaster bridges.

Figure 11: Telltale mounted with epoxy adhesive

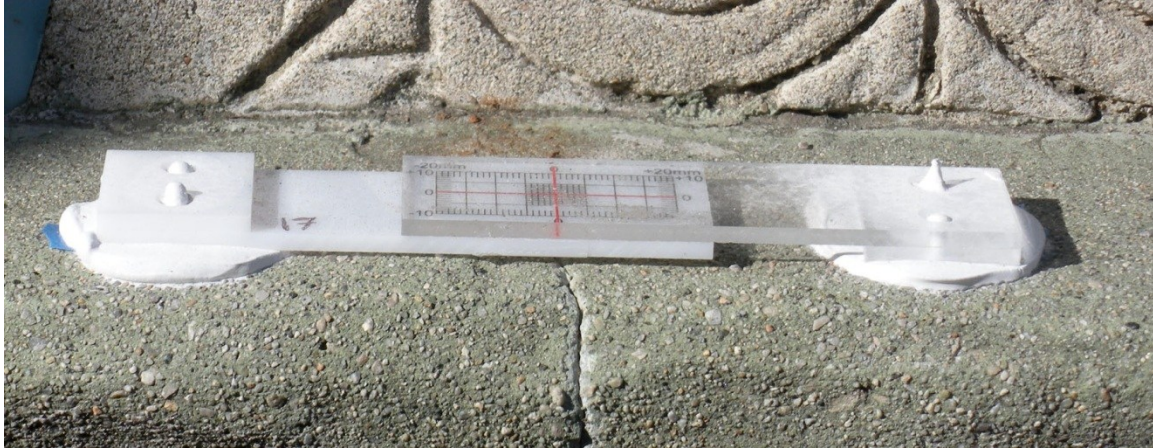
Figure 12: Telltale mounted with plaster

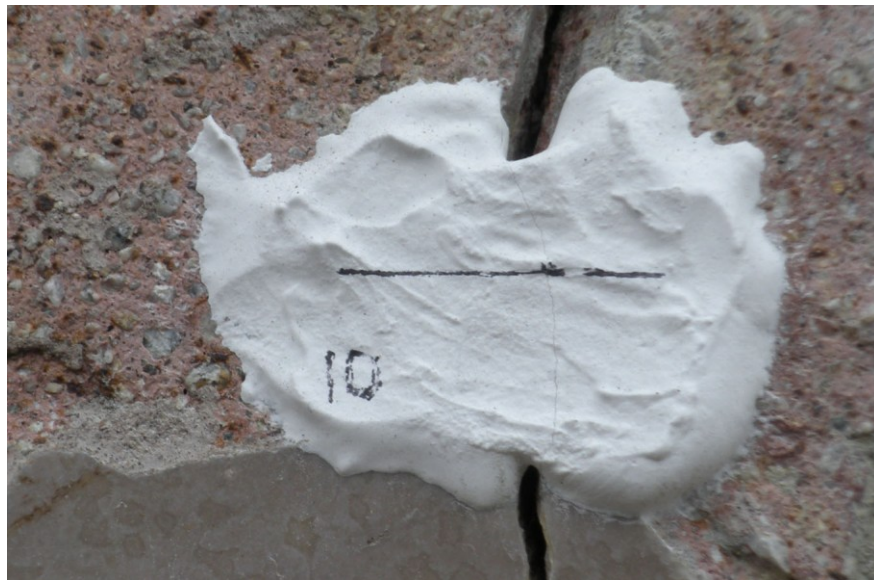
Figure 13: Plaster bridge crack monitor

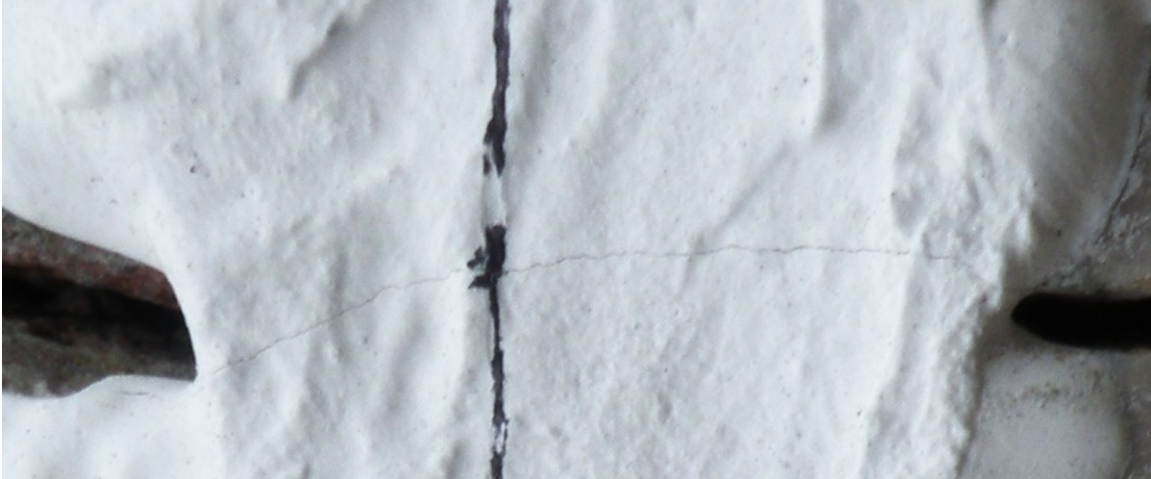
Figure 14: Crack in plaster bridge

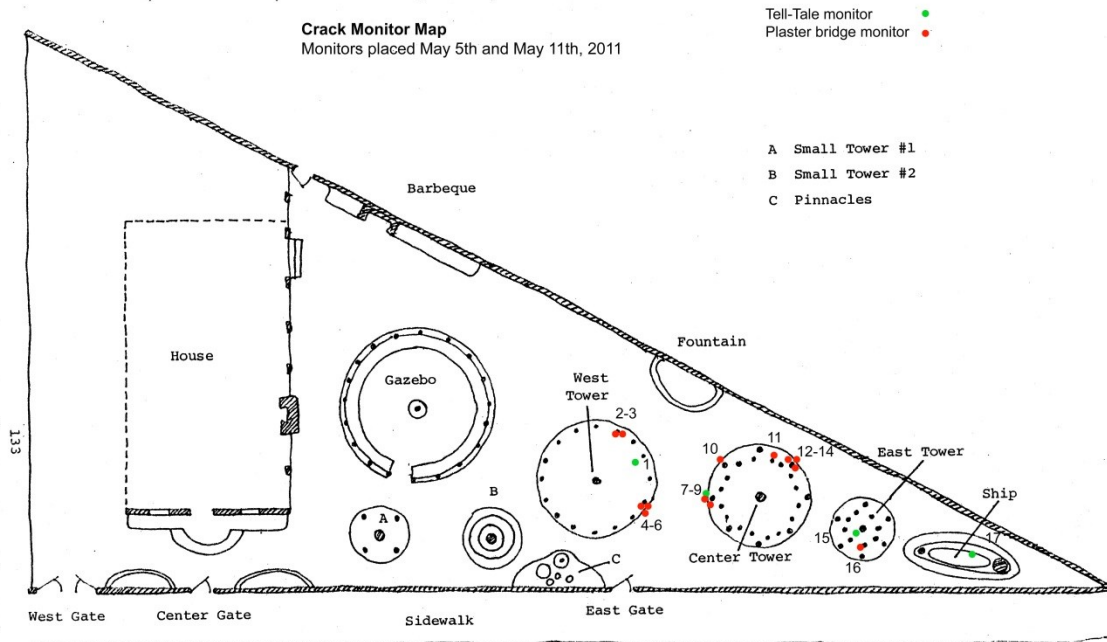
Figure 15: Crack monitor locations

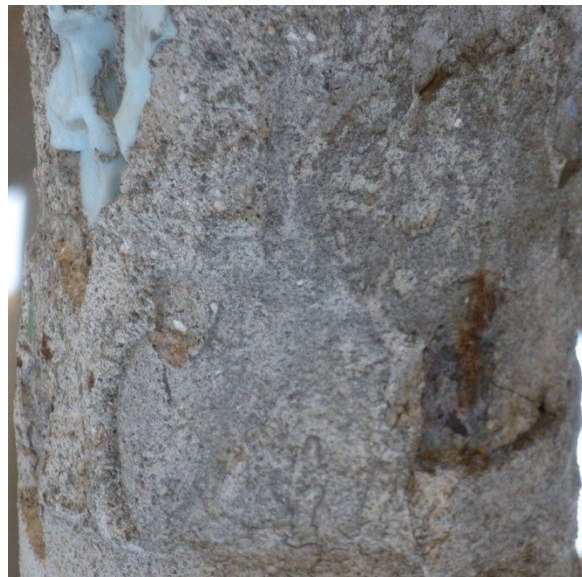
While cracking caused by steel corrosion is normally indicated by the presence of rust staining (Figure 16), it is more difficult to determine if cracks are caused by structural movements or by thermal stresses.

Figure 16: Cement spalling due to rust

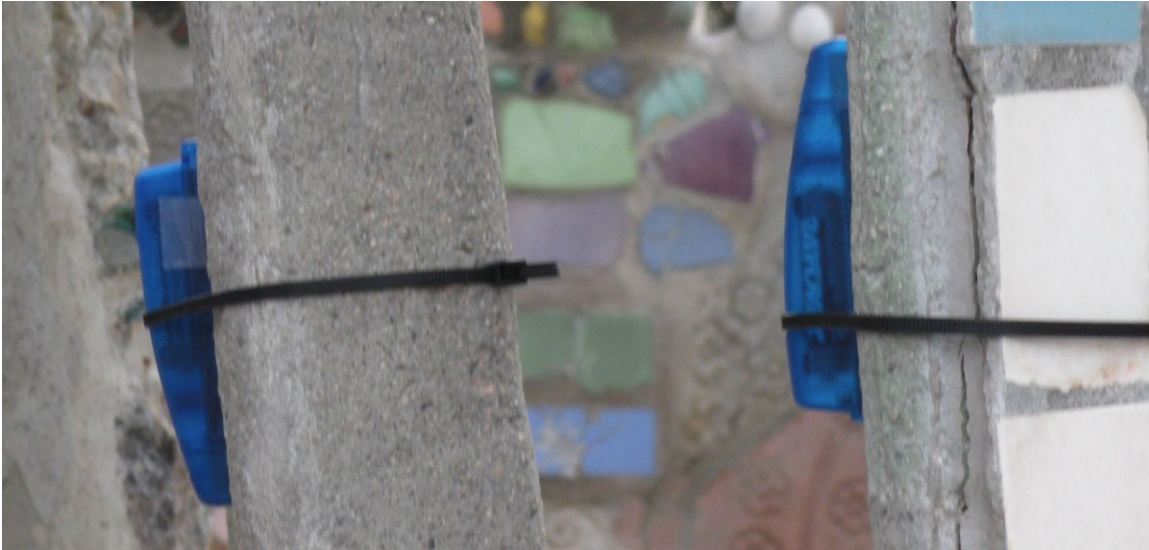
To evaluate the frequency and magnitude of movements caused by traffic, wind, and seismic activity we installed six miniaturized accelerometers for vibration monitoring (Figure 17). While the monitors provided good data it turned out that their batteries need to be replaced every three days, which is not practical for a long term monitoring program. We therefore discontinued their use and are researching other types of accelerometers or the possibility of connecting these monitors to an external power source (either the grid or solar).

Figure 17: Vibration monitors
