LACMA

LACMA, DCA, and Watts Towers

Fourth Quarterly Report (October - December 2011)

INCIDENT REPORT for the Watts Towers of Simon Rodia

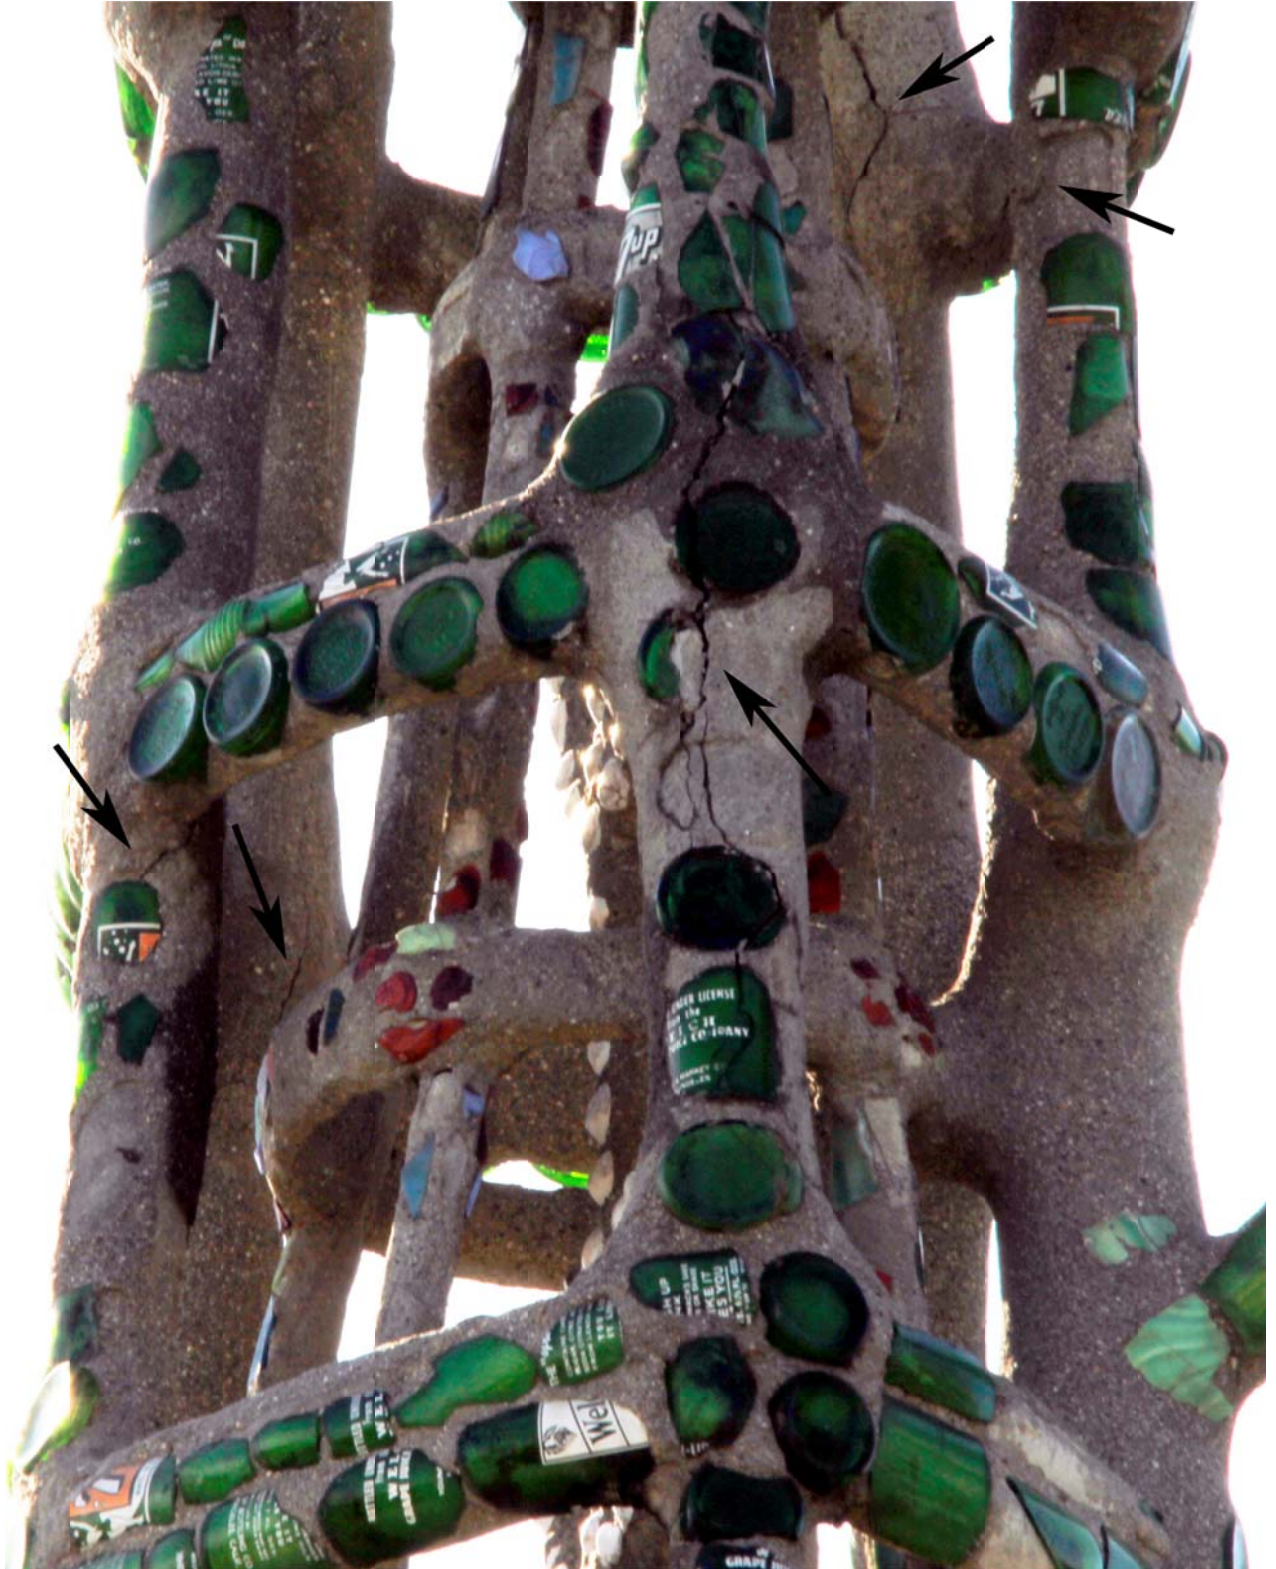
Figure 2: Detail of Top Third of the East Tower; cracks marked with arrows

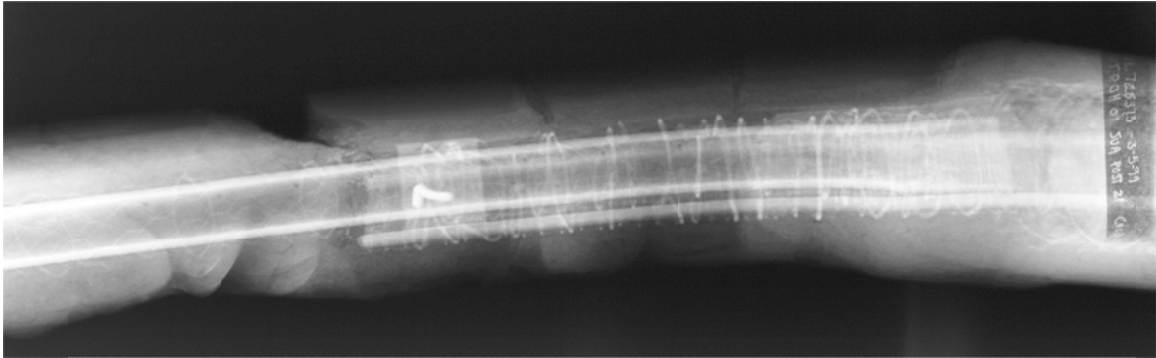
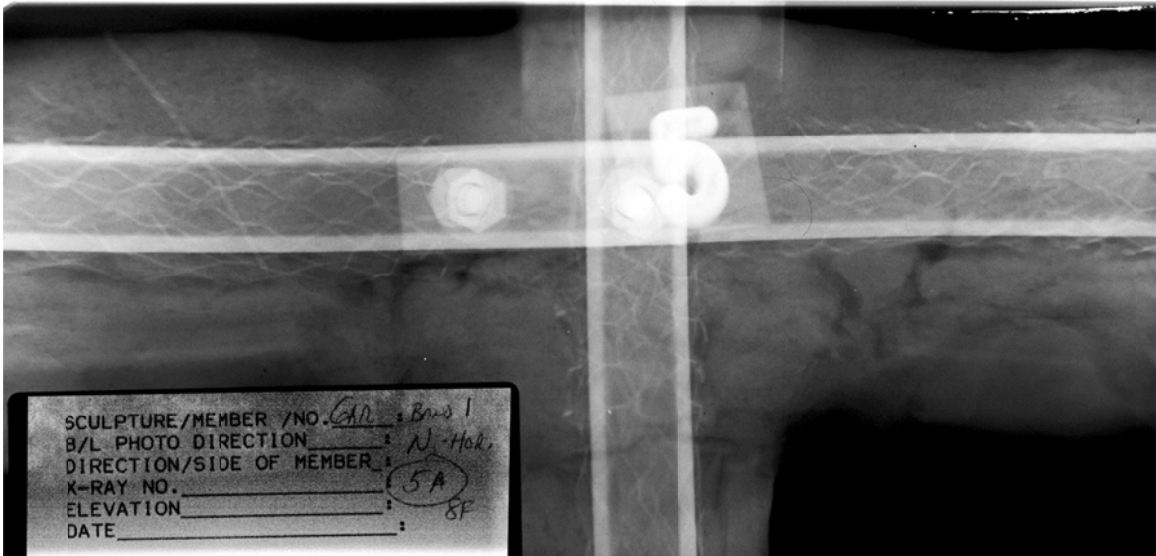
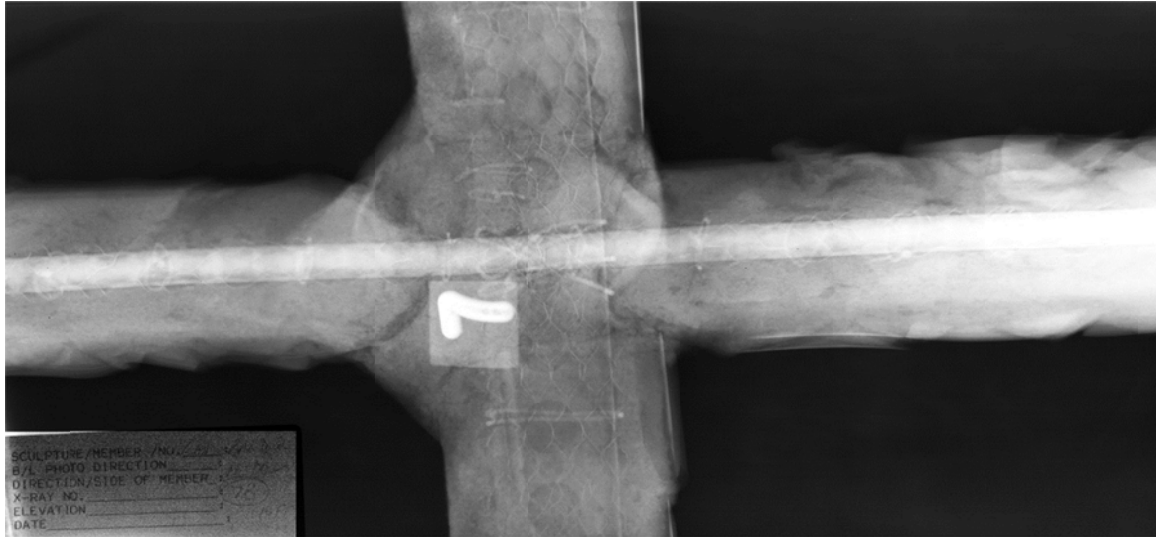
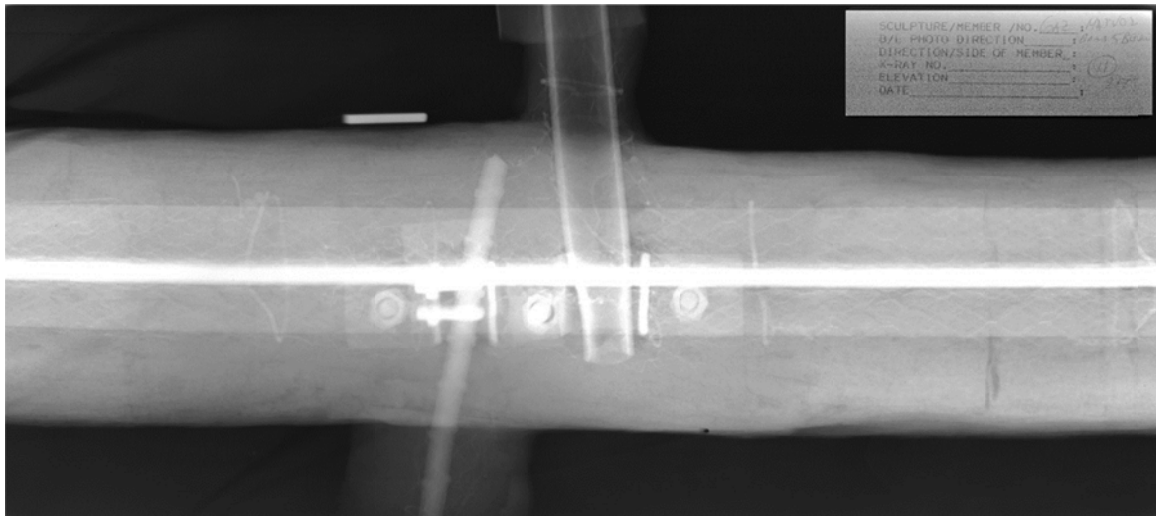
Some 60+ X-radiographs have been taken in the past, providing some interesting insight in the construction of the monument and into some of the cracking problems. Mr. Yosi Pozeilov has started digitizing them. To date 19 radiographs have been digitized. Figures 3 - 6 show some examples. Besides showing details of the construction, one interesting aspect of the X-radiographs is that they do not indicate any serious corrosion related problems.

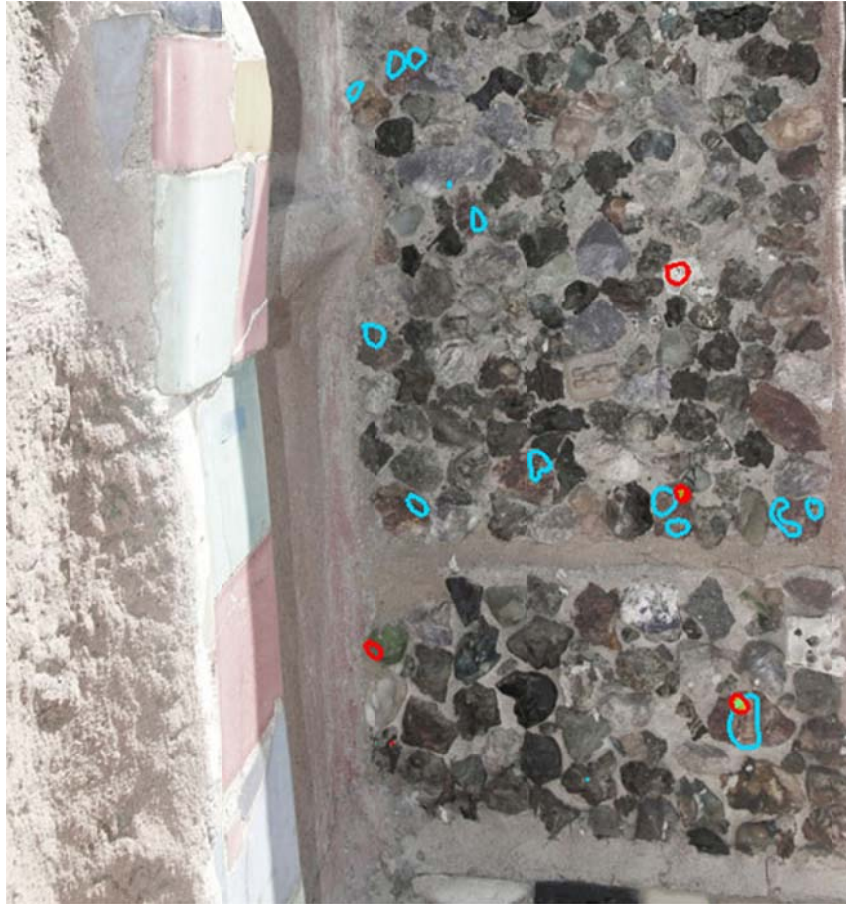
Figure 7: Remedial survey record

The remedial condition survey and stabilization of loose ornaments and mortar made good progress. Figures 7 and 8 show a sample record. Ms. Sylvia Schweri-Dorsch and Ms. Blanka Kielb completed the South and North Walls, the Ship, the lower portions of the East Tower and are currently working on the Central Tower.

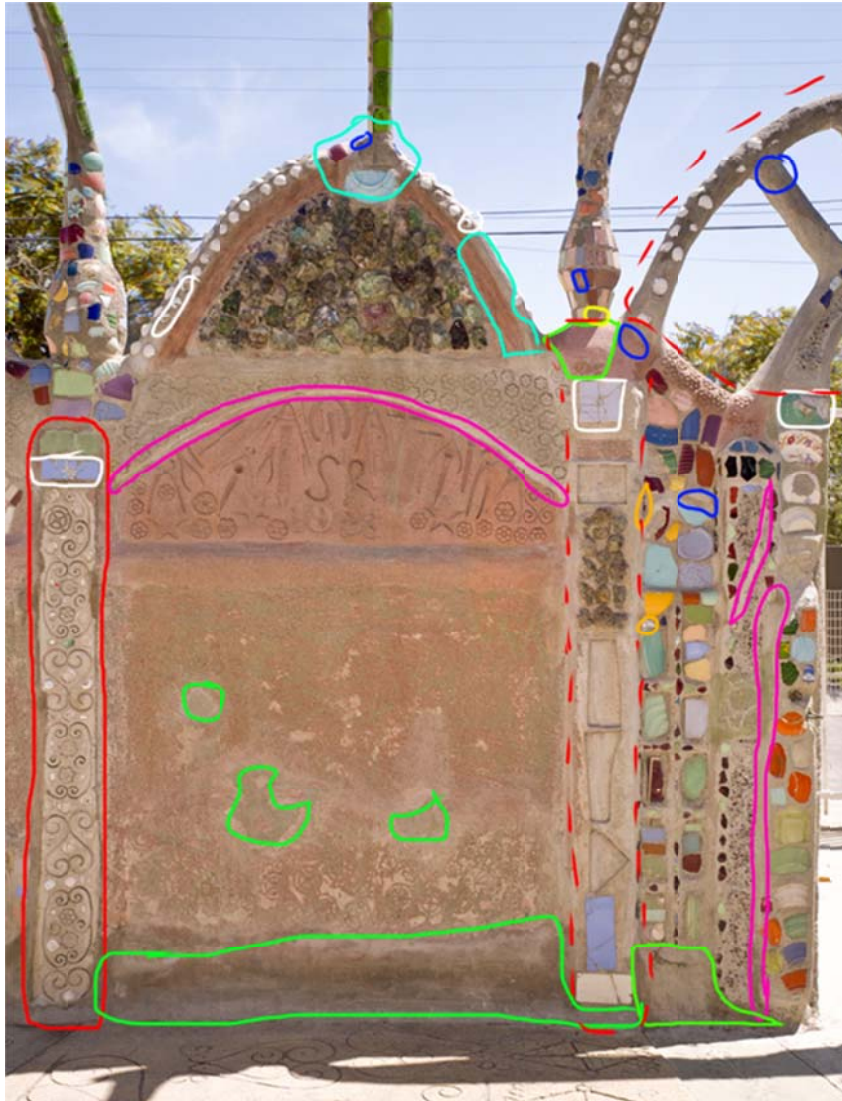
Figure 9: Condition comparison 1987 - 2011

Mr. Israel Campos is comparing the Rand photographs with the current state of preservation of the monument. Any observed changes are then marked on the recent photos taken by Mr. Yosi Pozeilov during the re-photography of the Towers (see Figs. 9 and 10). Israel has to date completed this comparison for the South Wall and is currently working on the North Wall.

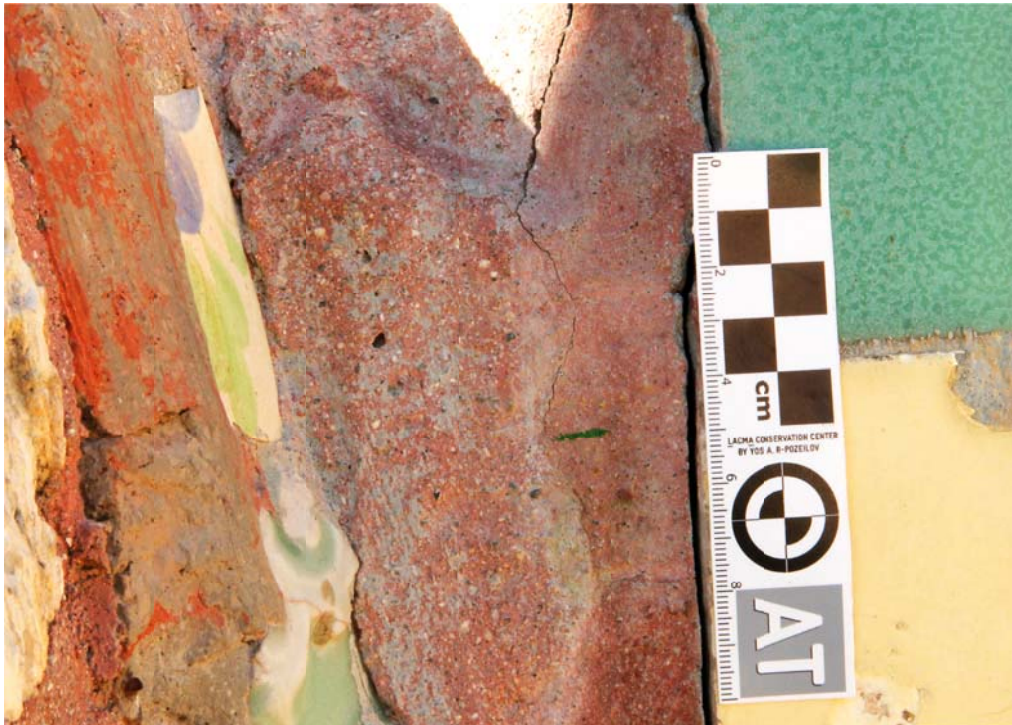
Figure 11: Crack propagation monitoring

Monitoring of selected cracks with plaster bridges and telltales continued. We also started monitoring cracks to determine if they are propagating lengthwise (figure 11).

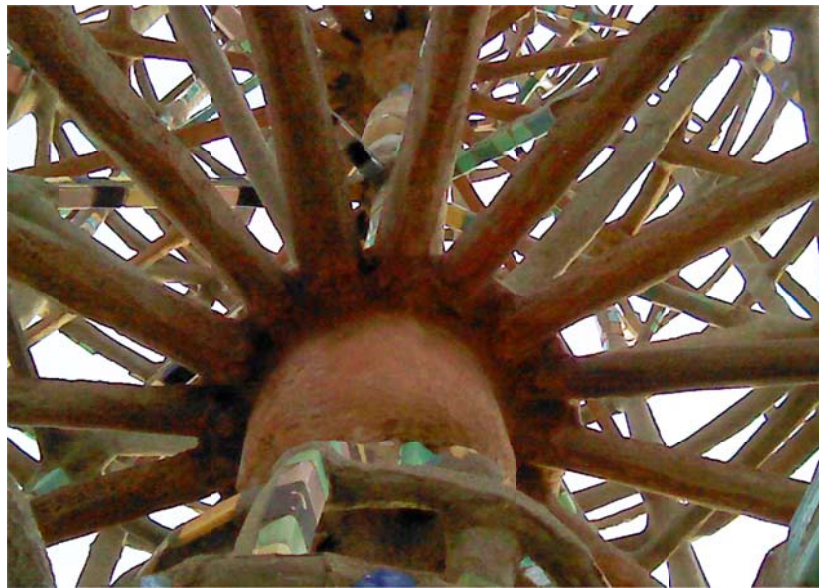
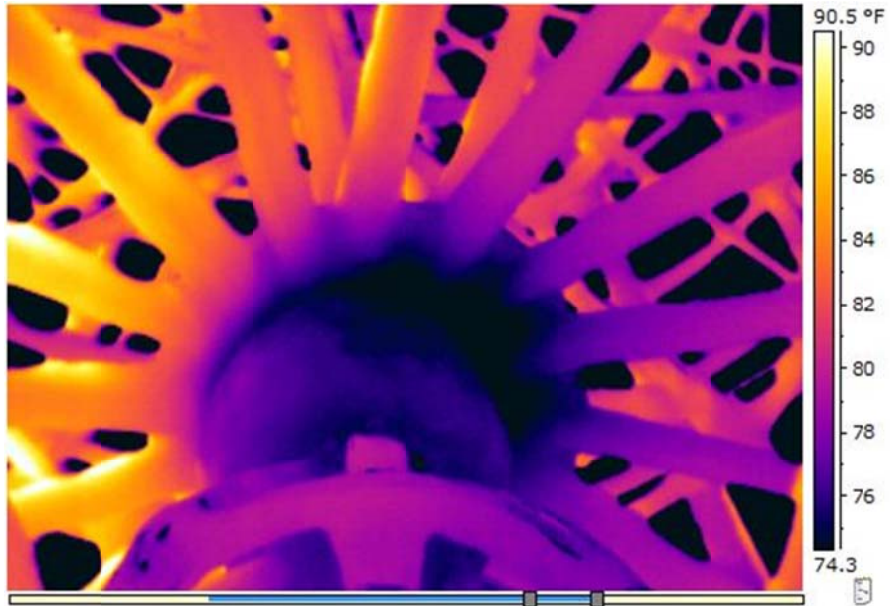
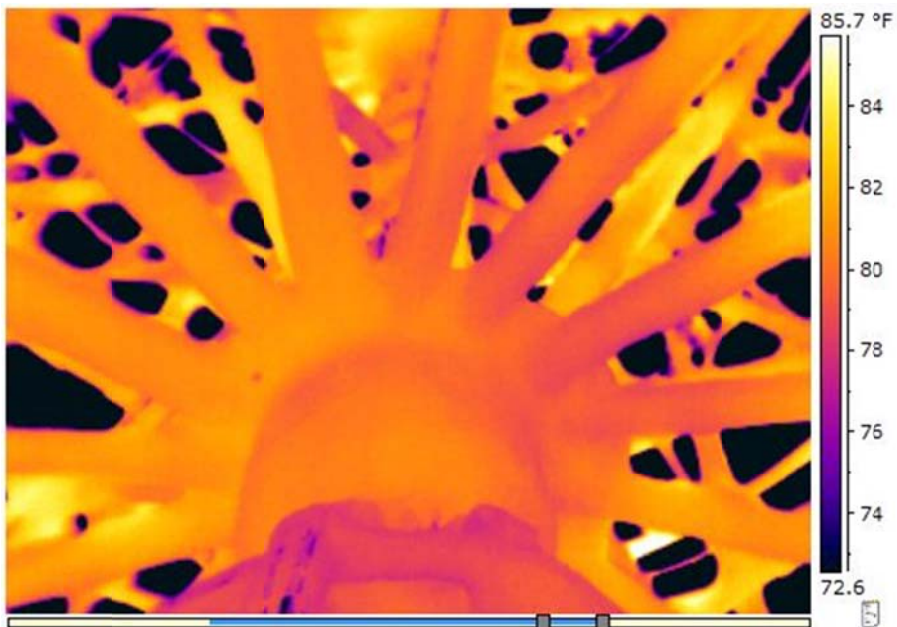
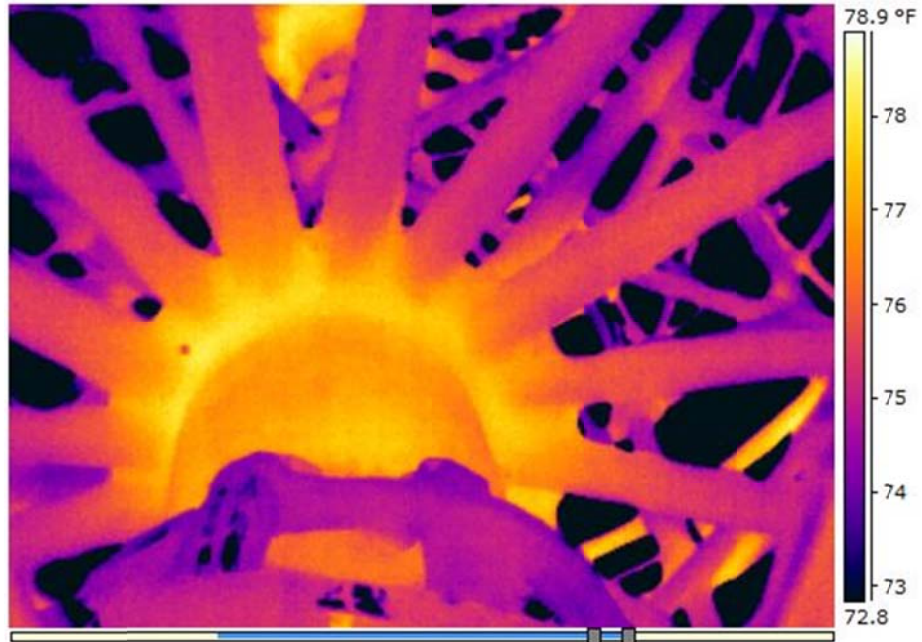
The thermal imaging program yielded quite interesting results, demonstrating significant difference in in the heating and cooling of different elements of the monument (figures 14 - 17).

Figure 15: West Tower, Thermal Image, 11:26 am

Figure 16: West Tower, Thermal Image, 3:39 pm

Figure 17: West Tower, Thermal Image, 5:49 pm

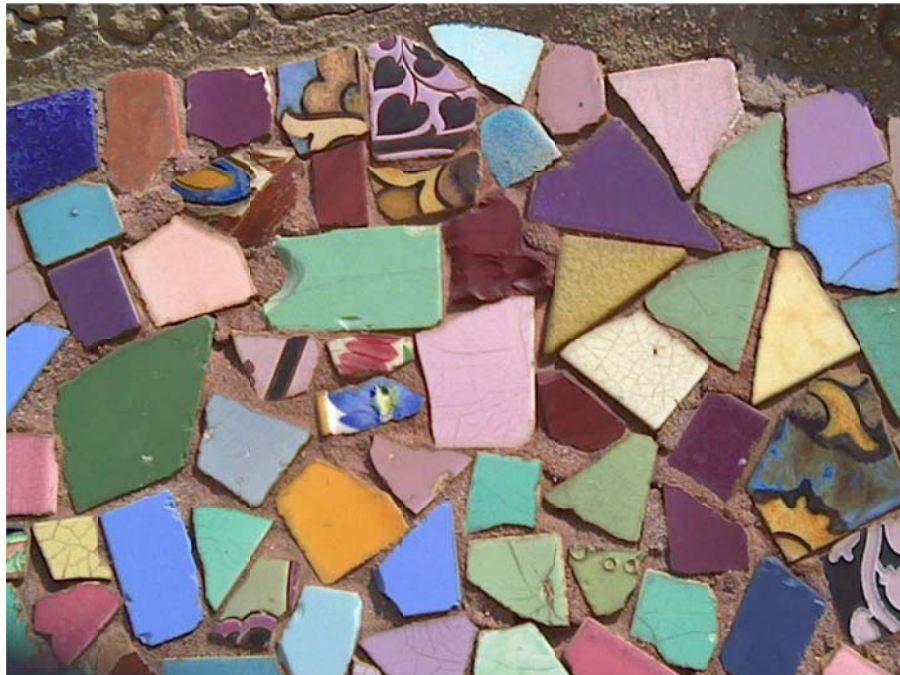
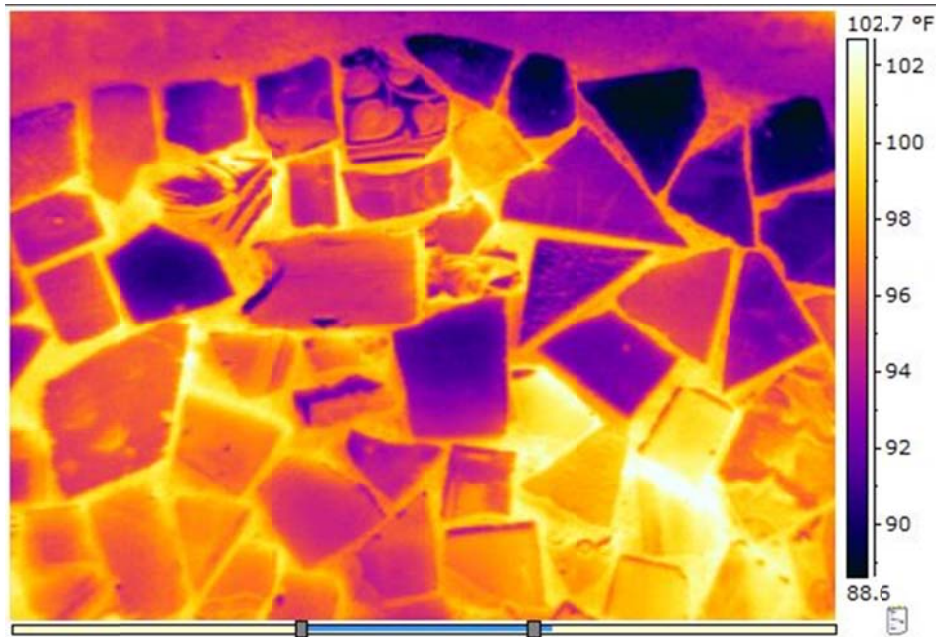
It also serves to document the temperature differences between the cement and different types of ornaments (figures 18 and 19).

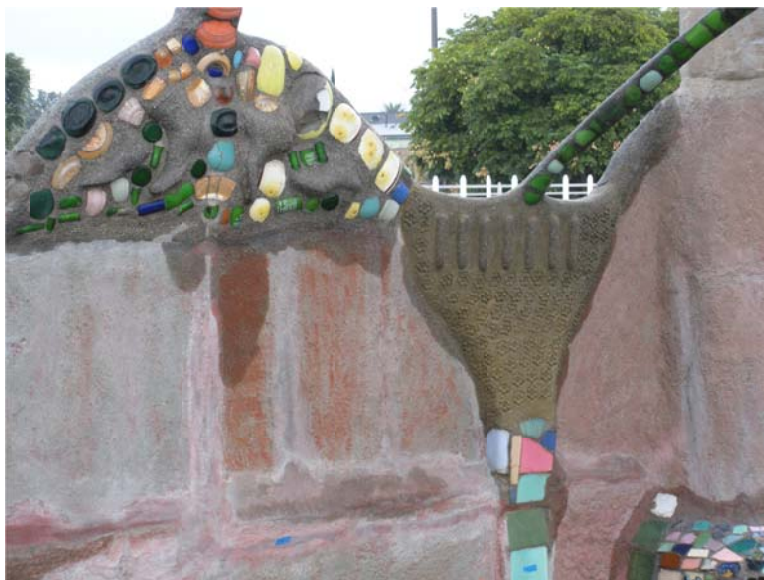
During and after the rains we observed and documented the wetting and drying behavior of a few select areas. As it is to be expected, the wetting occurs in the beginning along water runoff paths (figures 20 and 21) and then spreads to adjacent areas.

Photo 20: wetting along structural elements

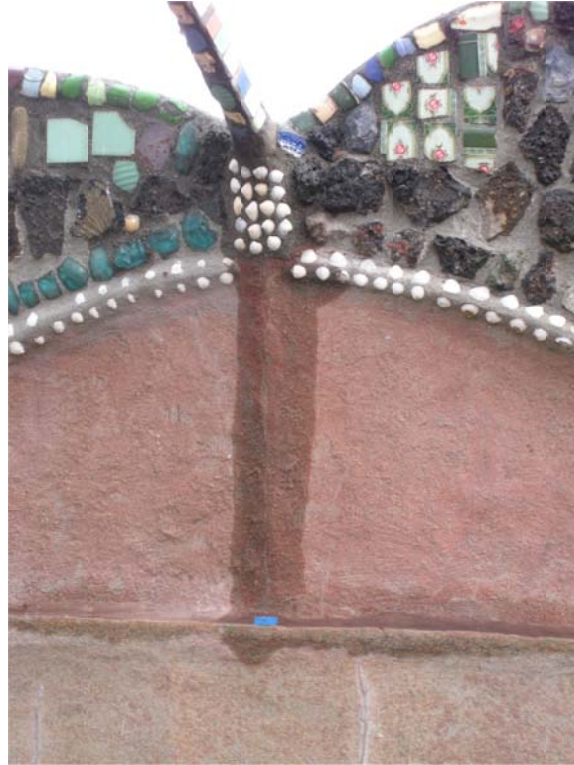
Figure 21: wetting along structural elements

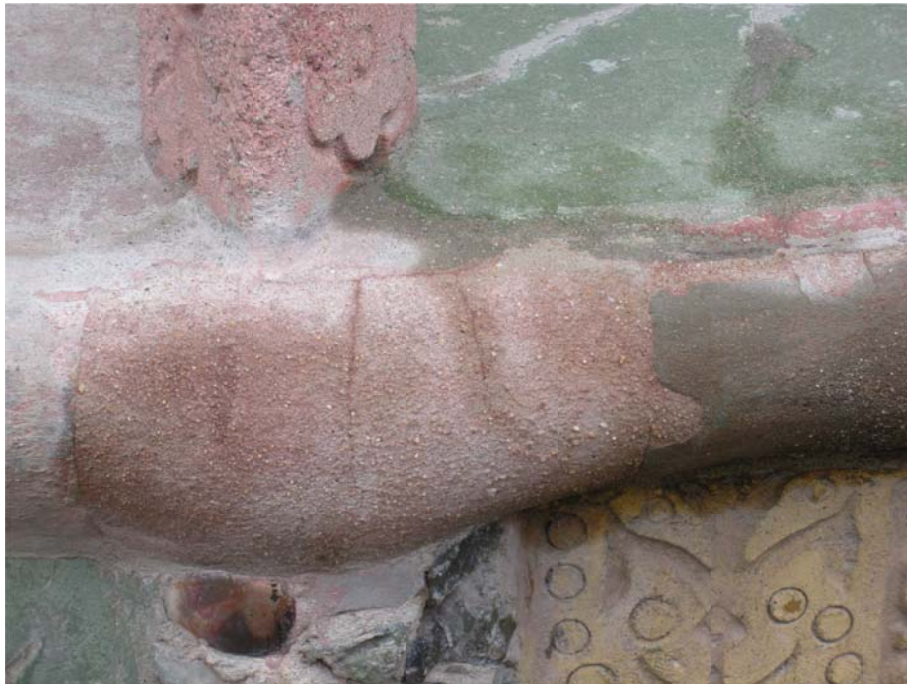
As the wetting continues one can observe distinct differences in the water absorption of the different repair mortars (figures 22 – 25). These differences sometimes become even more pronounced during the drying cycle.

Figure 22: differential wetting of repair mortars and cracks

As a consequence of the differential wetting and drying there are differences in the dissolution of the cementing material of the mortars, leading to even greater differences in their thermal and hygric behavior. In future work we will have to explore the possibility of applying an improved water repellent, suitable for carbonized cementitious materials.

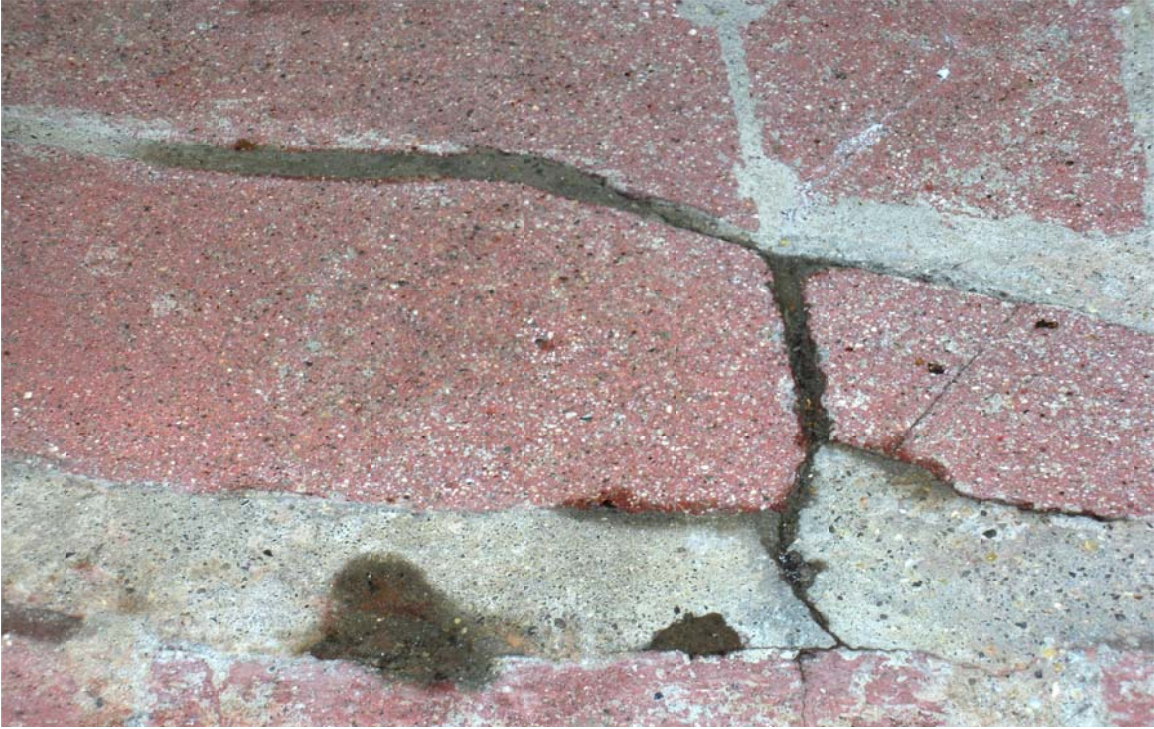
Figure 23: differential wetting of repair mortars

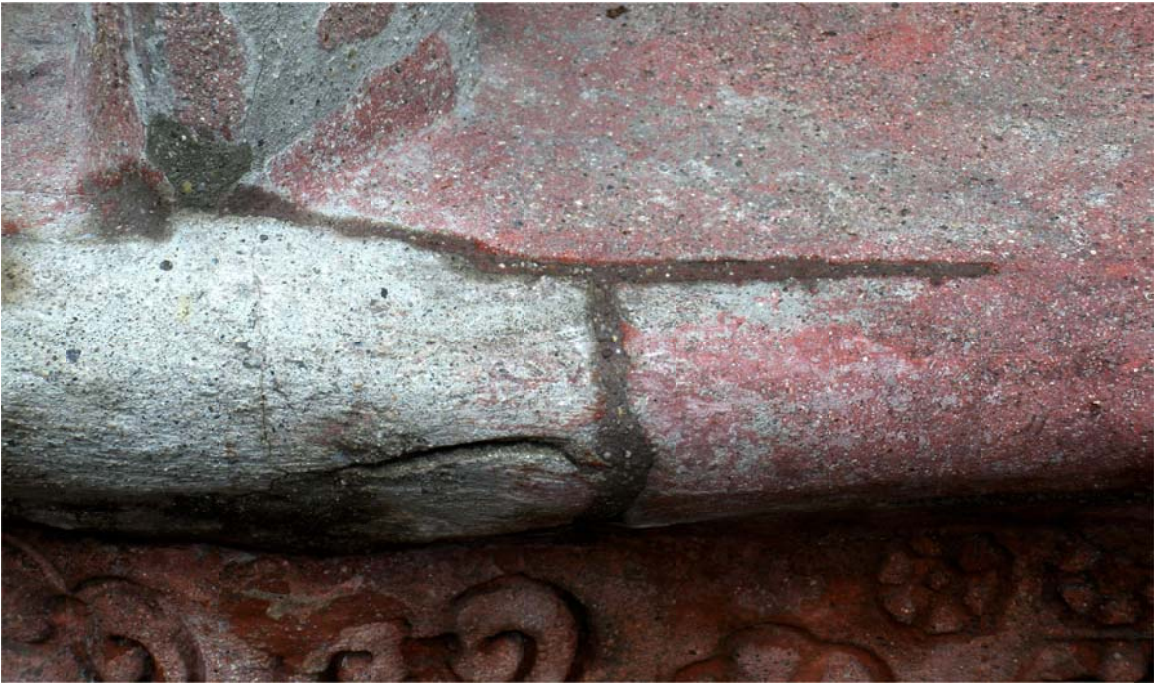
Figure 24: differential wetting of repair mortars

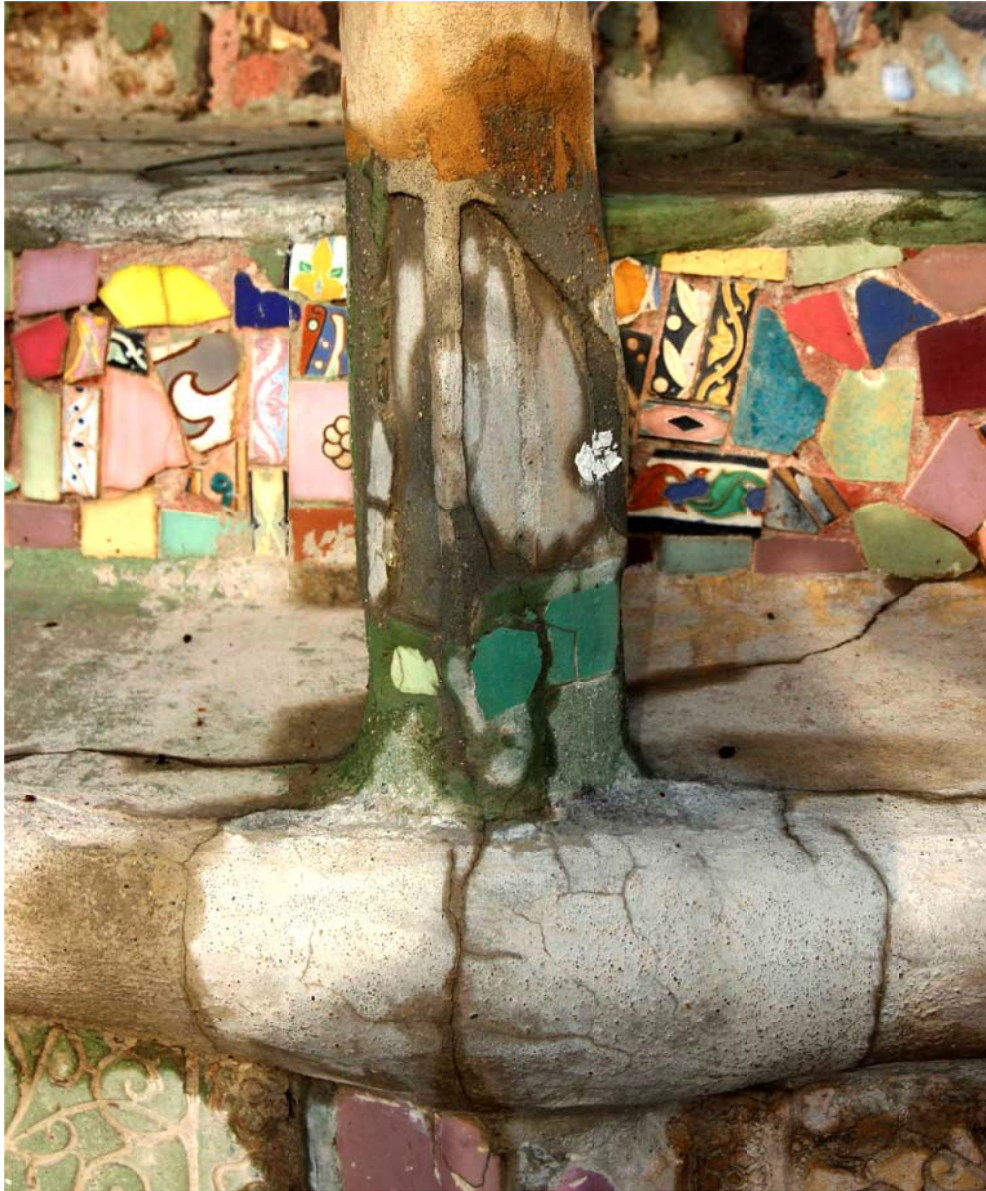
Figure 25: differential drying at WTO

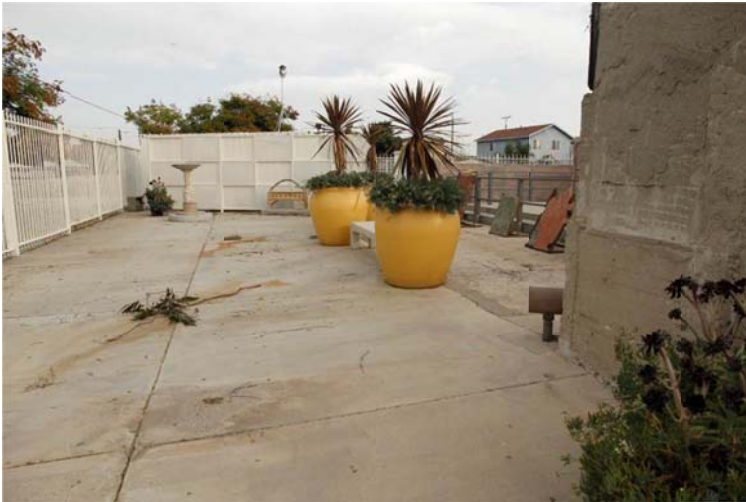
The site was inspected for wind-related damage on the morning of Thursday, December 1st by Conservators Sylvia Schweri-Dorsch and Blanka Kielb and Research Assistant Israel Campos. Small branches, twigs and leaves were strewn throughout the site, with the heaviest accumulation of debris noted east of the House (see **Figure 3**) and along the South Wall (see **Figure 4**). A general site clean-up

Figure 3. View of the site entrance following the Santa Ana wind event.

was performed on the morning of Thursday, December 1st. The site was swept and cleared of branches and twigs.

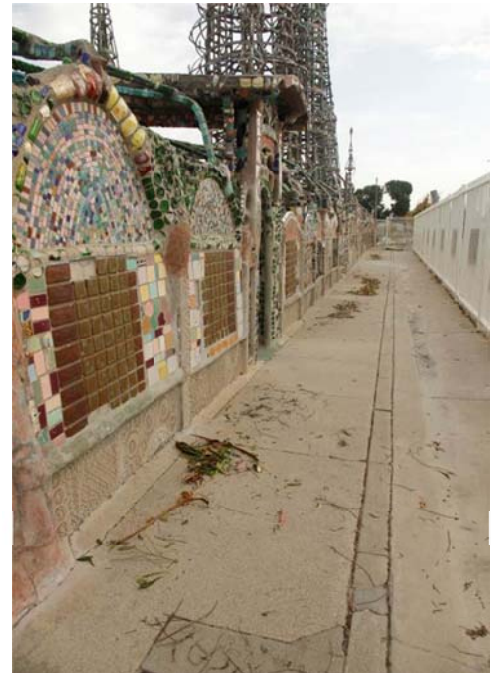
Figure 4. Scattered twigs and leaves along the South Wall.

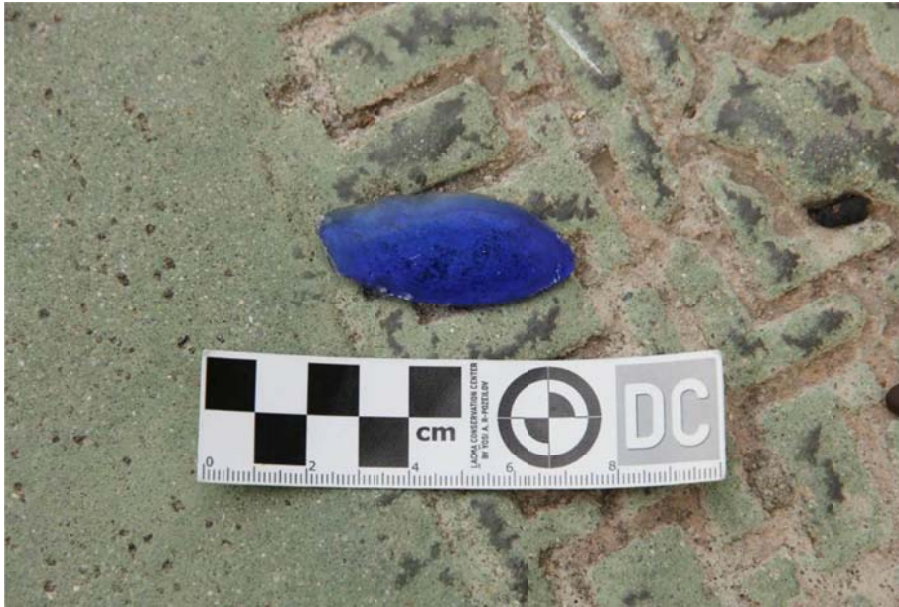
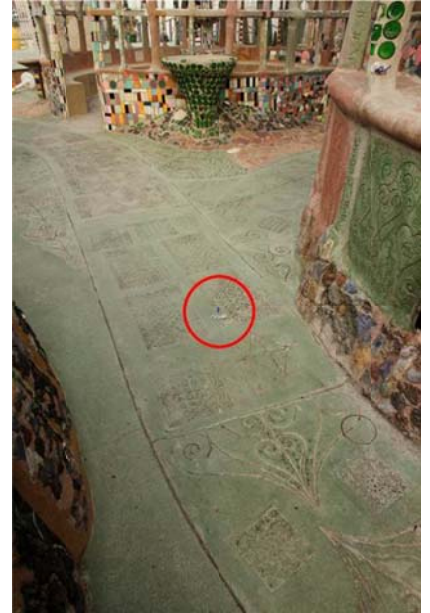
Overall, the damage caused by the Santa Ana winds was minimal. In all, 3 fragments and 1 fragment group (all glass) were found on the morning of Thursday, December 1st. Two of the fragments were found near the West Tower (see **Figures 5-8**); 1 fragment was found next to the Central Tower (see **Figure 9-10**); the grouping was found on the sidewalk adjacent to the South Wall (see **Figure 11-12**). The site was checked for fallen fragments again on Friday morning, but none were found.

Figures 5-6. Blue glass fragment (left), found next to the West Tower, Zone 6 (right).

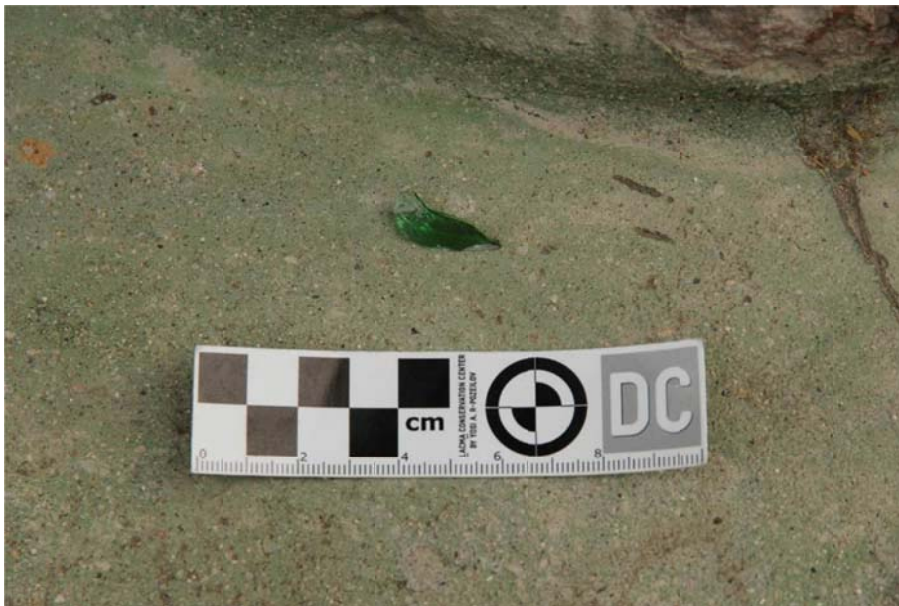
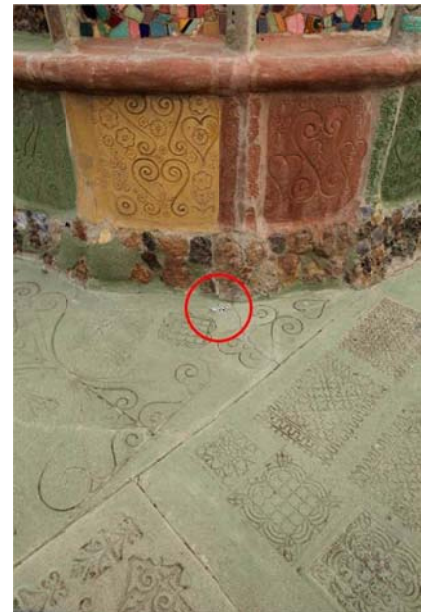
Figures 7-8. Green glass fragment (left), found next to the West Tower, Zone 6 (right).

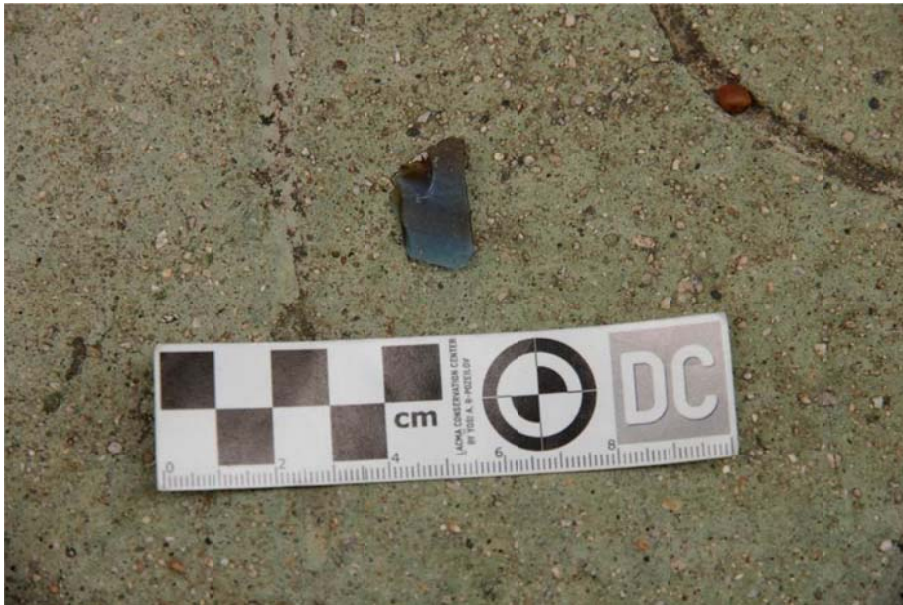
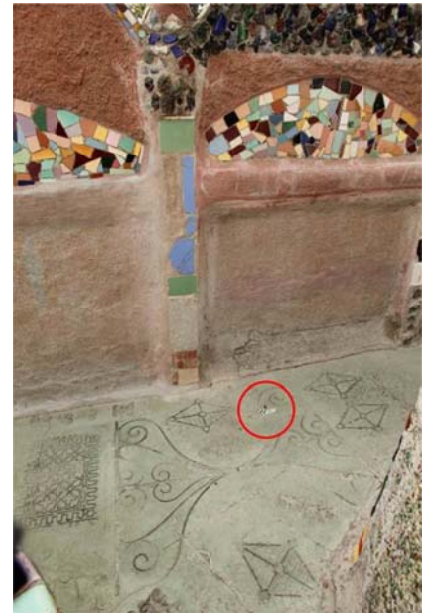
Figures 9-10. Brown glass fragment (left), found between the Central Tower and South Wall, Zone 8 (right).

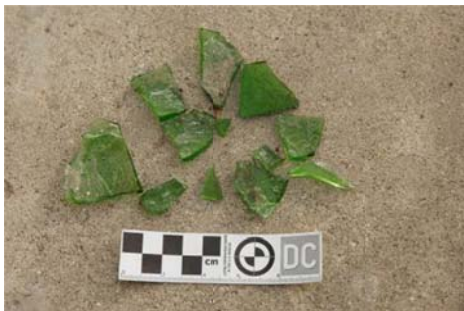
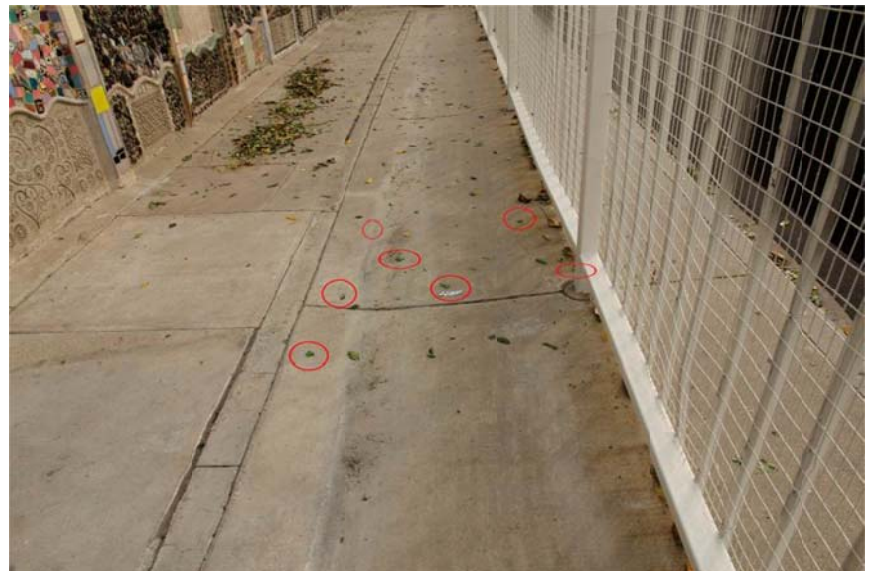
Figures 11-12. Grouping of green glass fragments (above) found on the side walk next to the South Wall (right).
