LACMA, DCA, and Watts Towers

Progress Report October 2012 through December 2012 (Seventh Progress Report)

Prepared for the DCA, City of Los Angeles, by Frank Preusser and Mark Gilberg

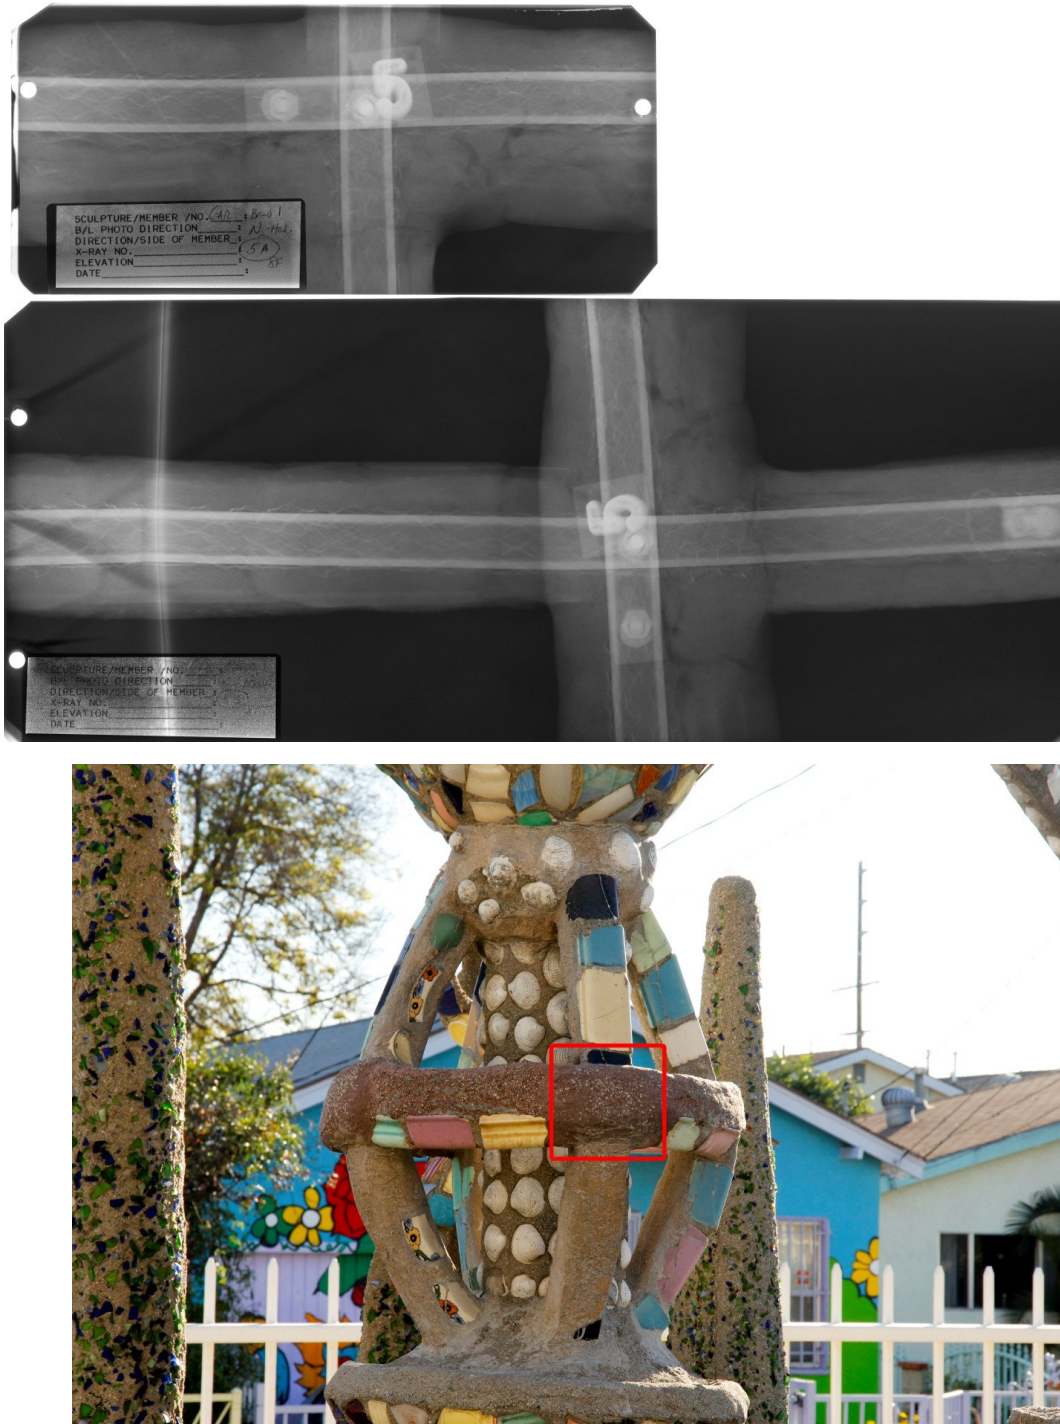
Figure 1: Garden Spire (Pinnacles along the south wall), north view- horizontal (1A) and vertical (1B), Band 1- Jahn Mortar repair at 8 ft

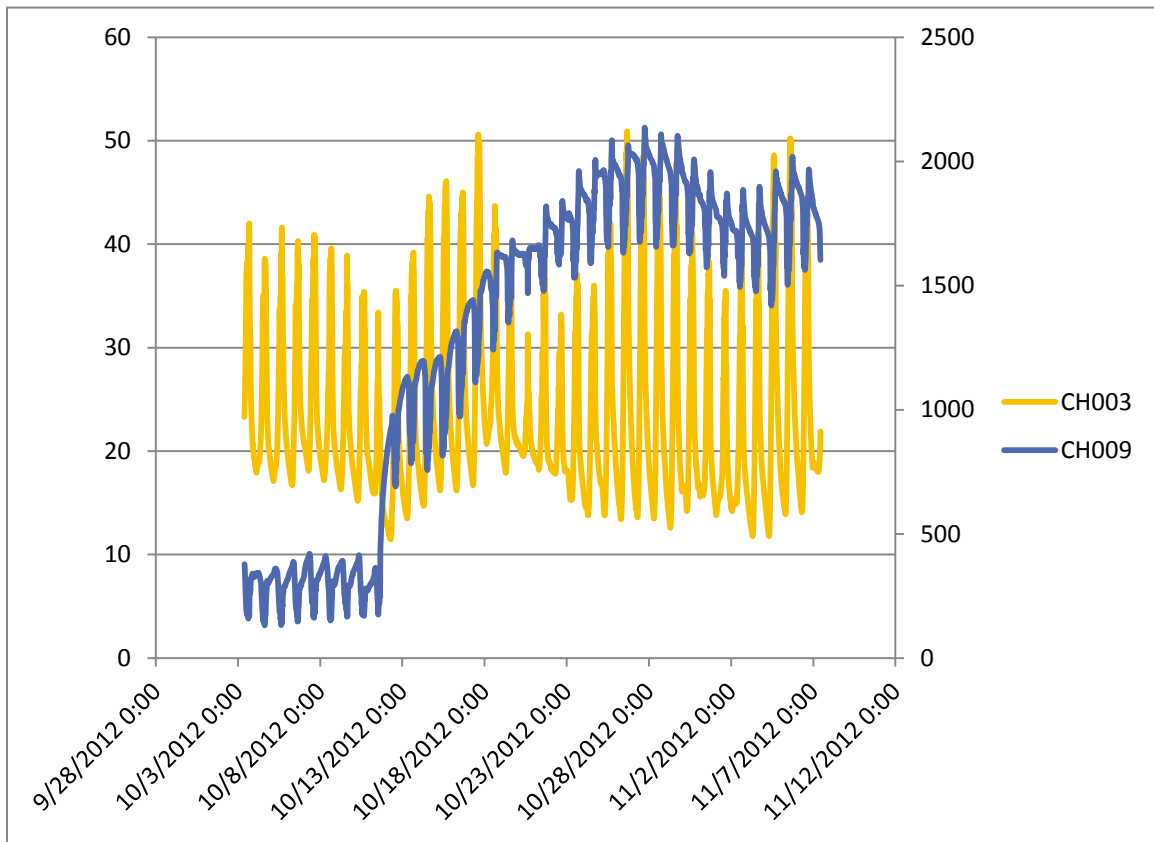
Figure 4: Crack movement during wind event (yellow: temperature, blue: crack width)

The strain gauges and displacement transducers continue to provide useful data (one strain gauge detached due to adhesive failure and was removed). The data are downloaded on a monthly schedule and data reduction is carried out by Dr. Charlotte Eng⁴ and Ms. Mariana Ruiz. The most interesting data were obtained during a heavy Santa Ana wind event (figure 4).

During the Santa Ana events in the second half of October the displacement transducers recorded irreversible widening of the monitored cracks (blue curve in figure 4). The magnitude of this movement was far greater than the daily thermal movement of the cracks. The thermal movement of the cracks is mostly reversible and leads only to a gradual widening of the cracks⁵. Based on these preliminary results it appears that wind and seismic events are the primary causes for the observed severe cracking and that thermal and corrosion cracking may be of secondary importance. This would also explain why it was observed that many more decorative elements and mortar fragments are detaching during severe weather events. This has serious implications concerning the design of future crack repairs and the performance criteria for the repair materials. The repair materials will have to be able to accommodate movements that are much larger than those caused by thermal stresses.

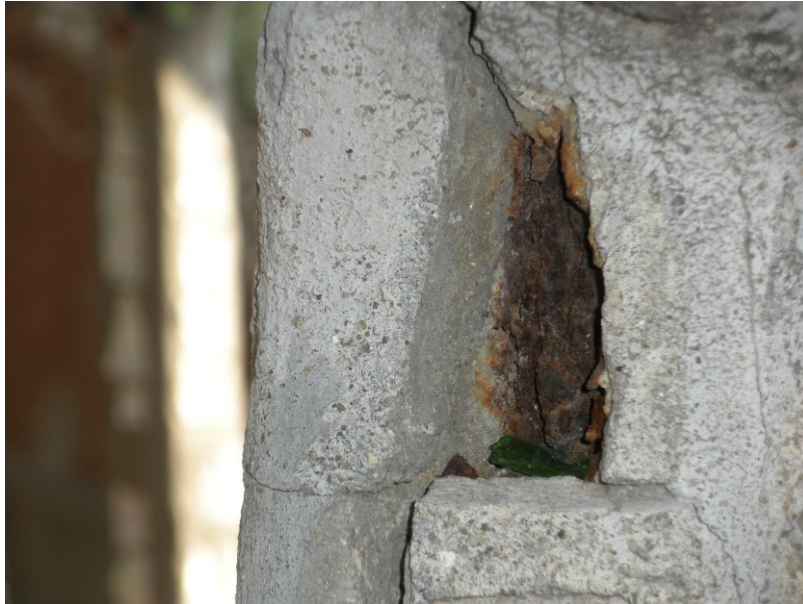
Triggered by the results of some laboratory experiments we decided to also determine how deep into the cement the temperature fluctuations progress and if the supporting steel is also affected. We selected an area which was cut open in the past⁶ and never had been restored (figure 5).

Figure 5: Selected area for thermocouples

The exposed steel was mechanically cleaned from loose corrosion products (rust), and then treated with tannic acid. Four thermocouples were installed, one directly on the steel, two at different depth on the cement plaster, and one on the surface (figure 6). The

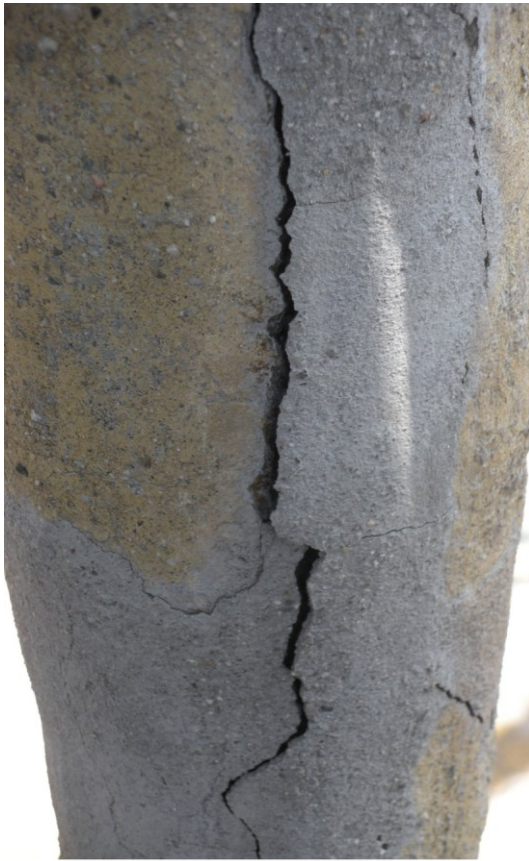
A further complication arose when we discovered that some of the failures and losses of past repairs are caused by lack of adhesion of the mortar on epoxy based repairs (figure 10).

Figure 10a: failed cement mortar cover

Further inspection of the monument and the files indicated that this type of repair may have been used quite extensively. As a consequence the testing program had to be expanded to determine if the selected repair mortars have sufficient adhesion to old epoxy mortar repairs. Blanka also obtained two adhesion promoters that may help solve this problem⁷

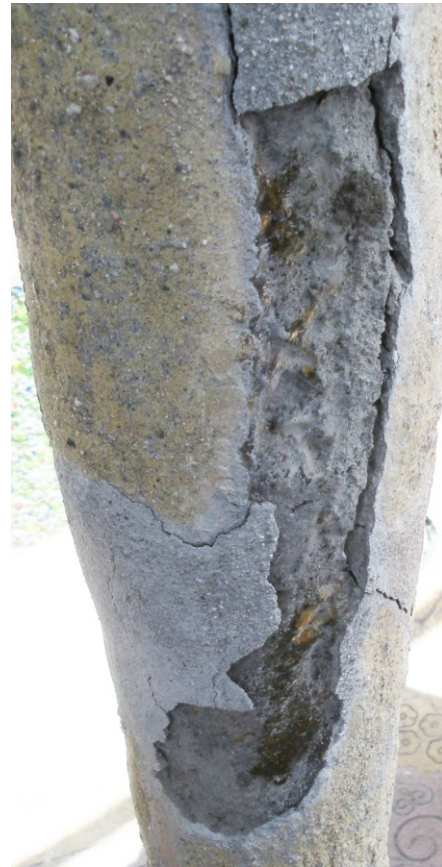
Figure 10b: exposed epoxy mortar after removal of failed cement mortar cover
