LACMA, DCA, and Watts Towers

Progress Report January 2013 through March 2013 (Eighth Progress Report)

Prepared for the DCA, City of Los Angeles, by Frank Preusser and Mark Gilberg

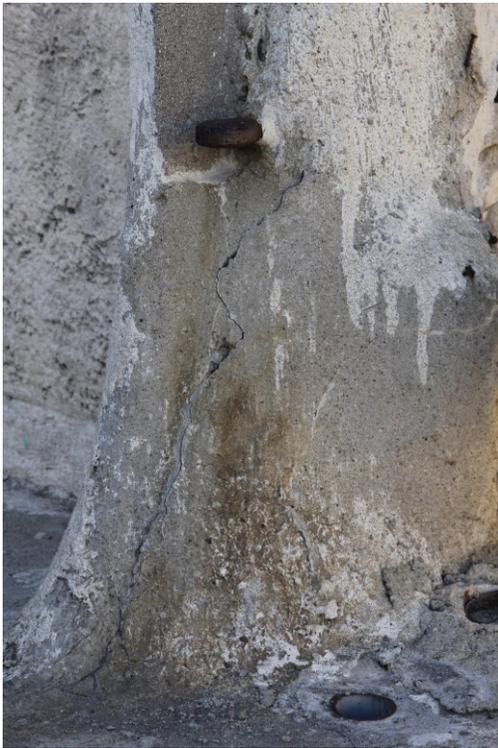
The previous repair was cracking and appeared to be detached (figure 7). The failure of this repair appears to be mostly corrosion related (figure 8). After removal of the old repair and treatment of the metal with a primer (figure 9) the loss was filled with an amended mortar (figure 10).

Figure 7: Cracked and detached repair at garage

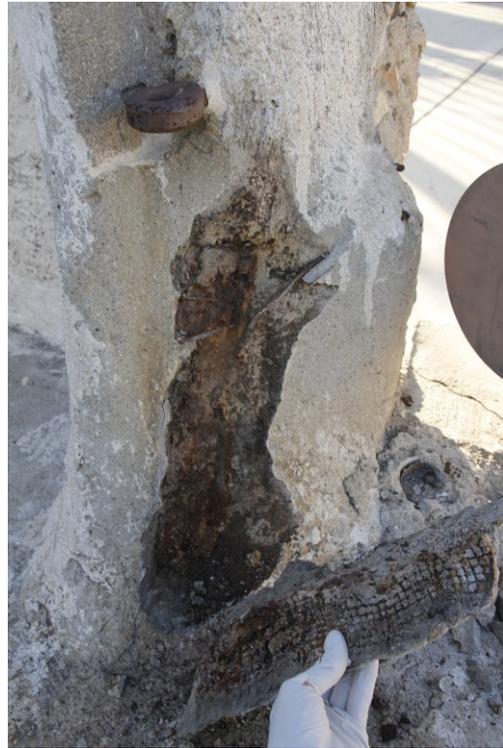
Figure 8: During removal of old repair

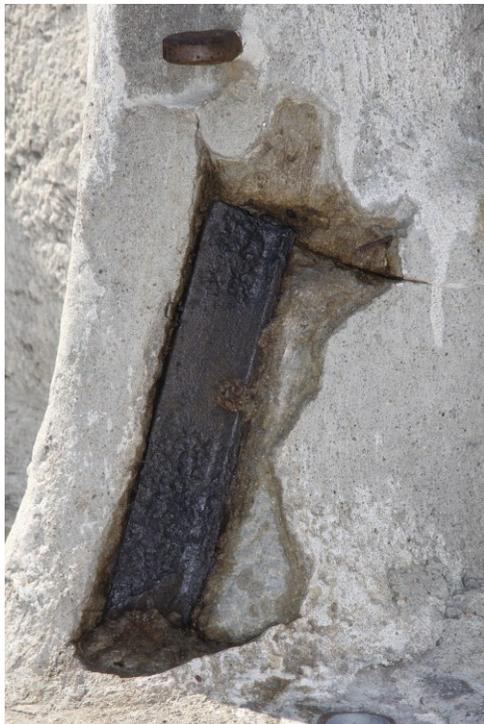
Figure 9: repair removed, metal treated

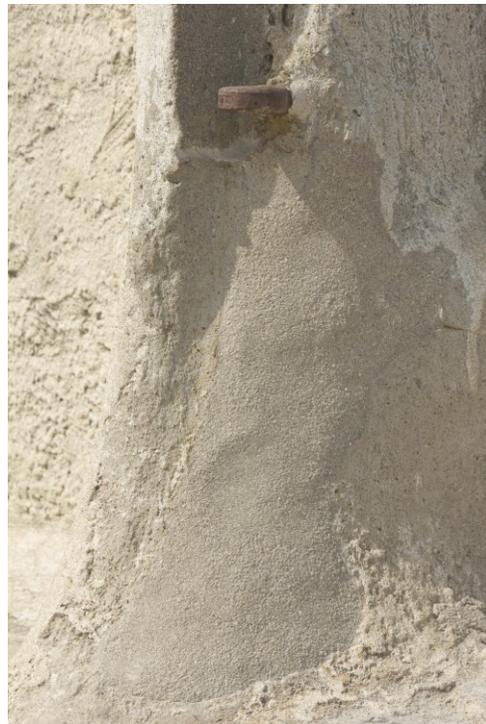
Figure 10: Completed repair

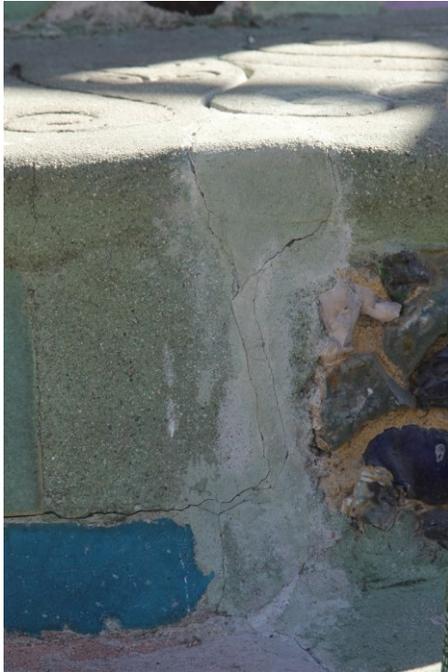
An area was selected that was last repaired in 2001 and then again in November 2004, using Jahn Mortar M90 (figure 11). The old repair was removed and the surface prepared for restoration (figure 12). This will be restored with a pigmented polymer amended cement mortar and serve as another site for the monitoring of the performance of these mortars.

Figure 11: WTO base, 2001 & 2005 repairs

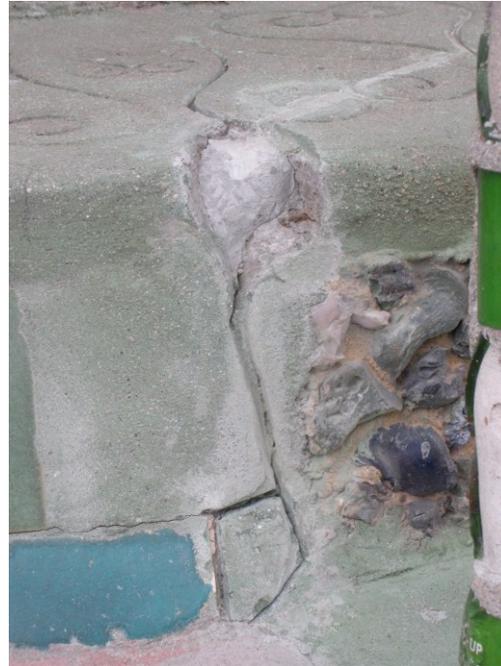
Figure 12: WTO base after removal of repair

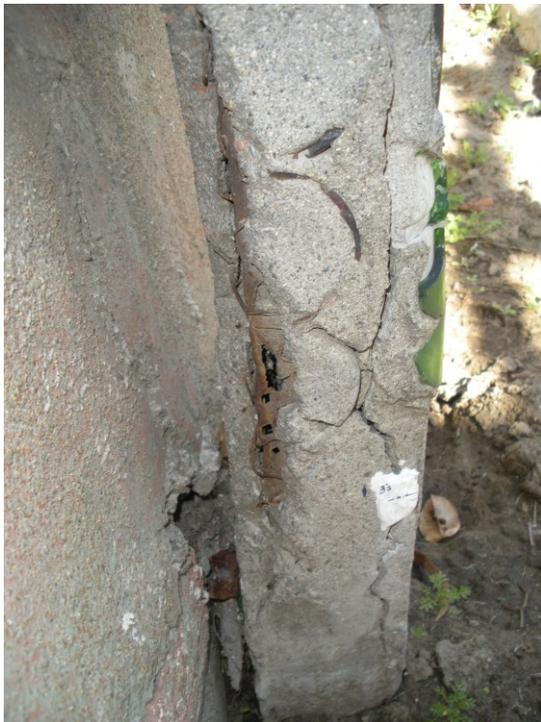
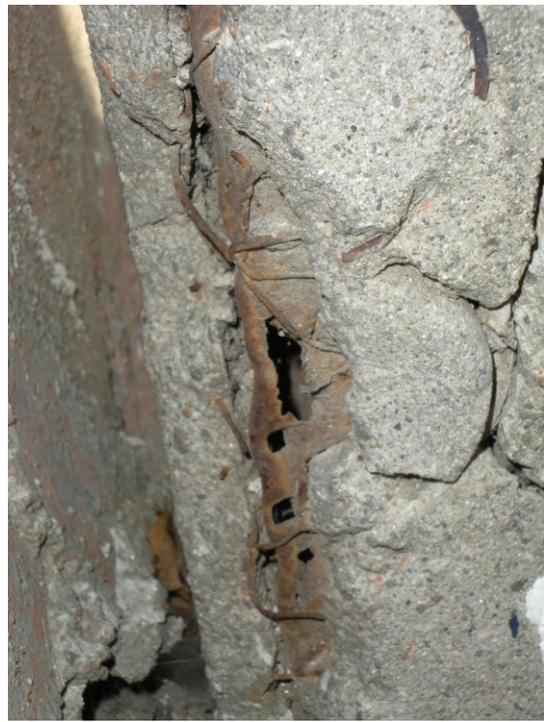
Post 5 however required immediate attention due to losses in cement covering, corrosion of the steel armature, severe cracking, and a general instability (figures 13 and 14). To structurally stabilize the post it was decided to connect it to the house foundation by pinning it with a threaded stainless steel (figures 15 and 16).

Figure 13: Post 5, pre-treatment condition

Figure 14: Detail of figure

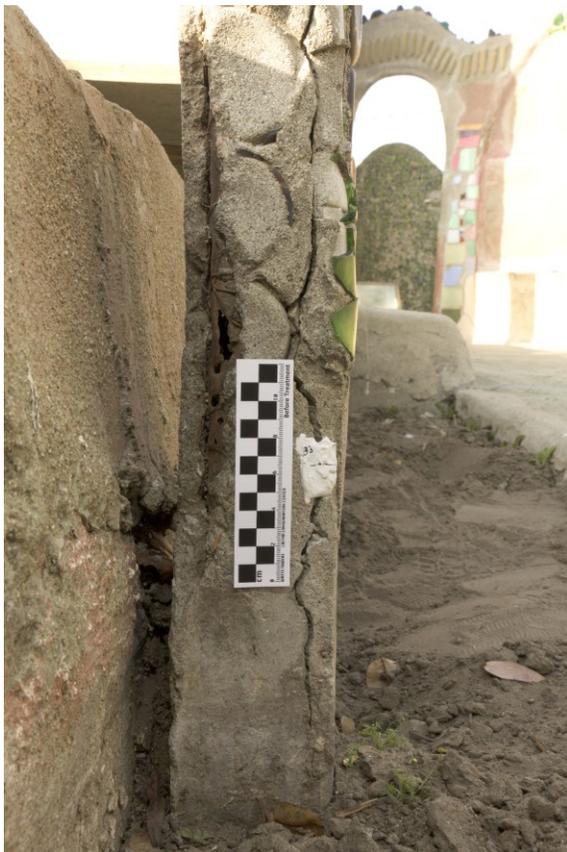
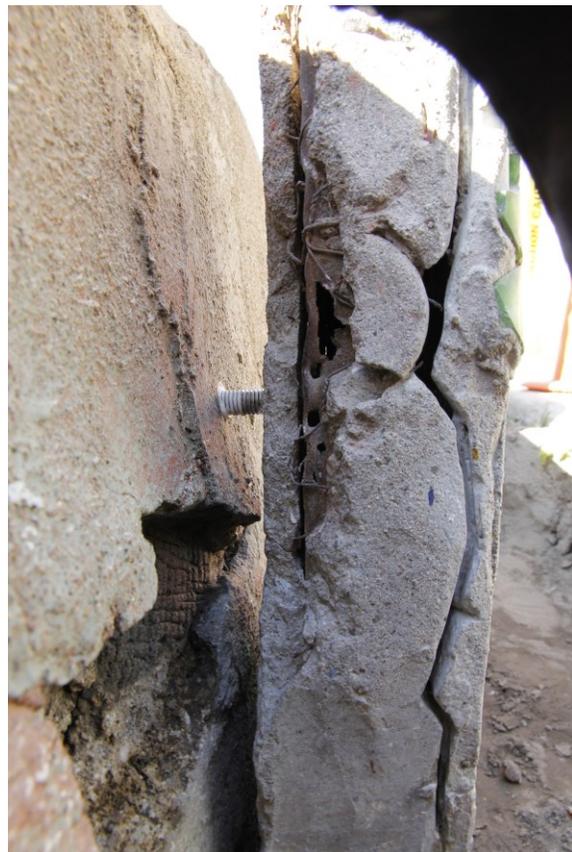
Figure 15: Before pinning

Figure 16: After pinning

The space between the post and the foundation will then be filled with amended cement mortar to provide additional stability and protect the steel rod. In the next steps the voids behind the steel armature will be filled by injection grouting and the cracks will be filled with an amended mortar. The work will be completed by stabilizing the decorations.
