LACMA, DCA, and Watts Towers

Progress Report July 2012 through September 2012 (Sixth Progress Report)

Prepared for the DCA, City of Los Angeles, by Frank Preusser and Mark Gilberg

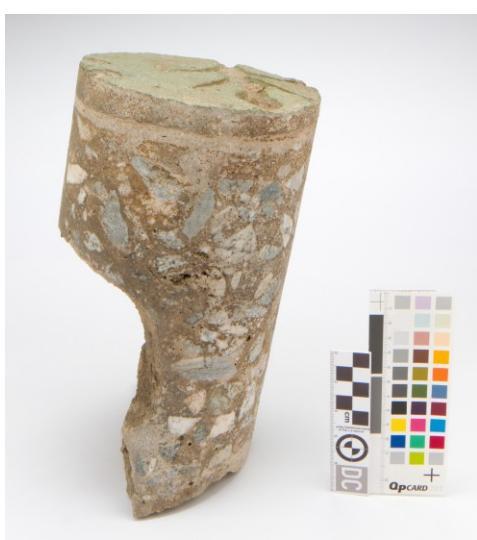
Figure 1a: CTO core

The three 6 inch cores from the bases of the three tall towers have been reset after documentation and analyses (Figures 1a-c).

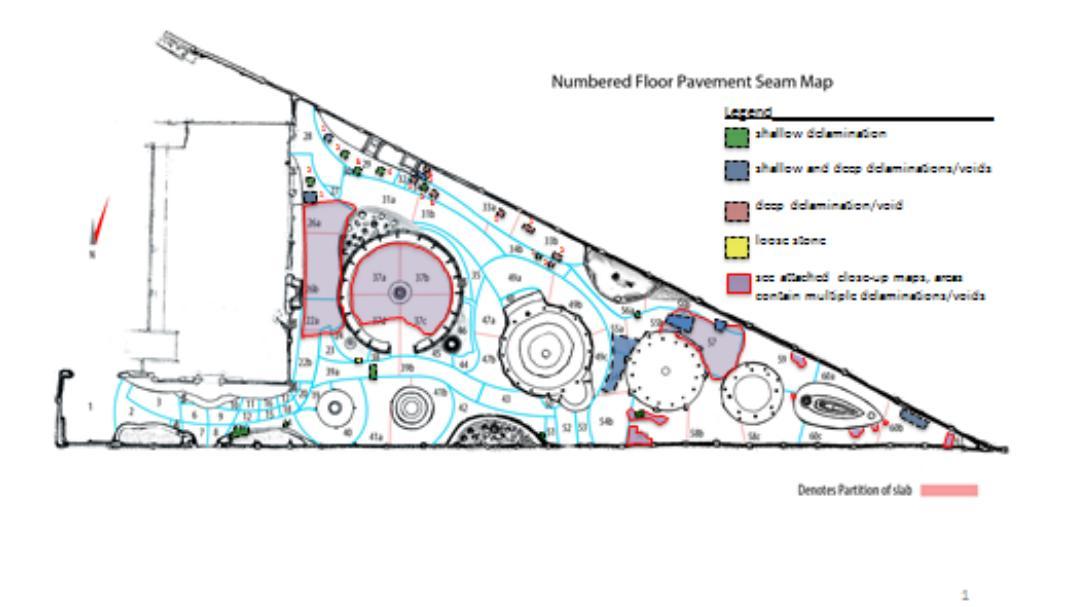
To complete our study of the floor, the UCLA/Verbum Dei interns mapped out areas of delamination within the cement slab (figure 2). This complements the ground penetrating radar study that looked at voids under the slab.

The floor is now completely mapped in terms of its topography, sections, cracks, voids, and delaminations. Based on these studies and comparisons with historic photographs we came to the conclusion that no significant changes occurred during the last 25 years and that there were no movements that would give cause for concern.

Figure 2: Map of floor delaminations.

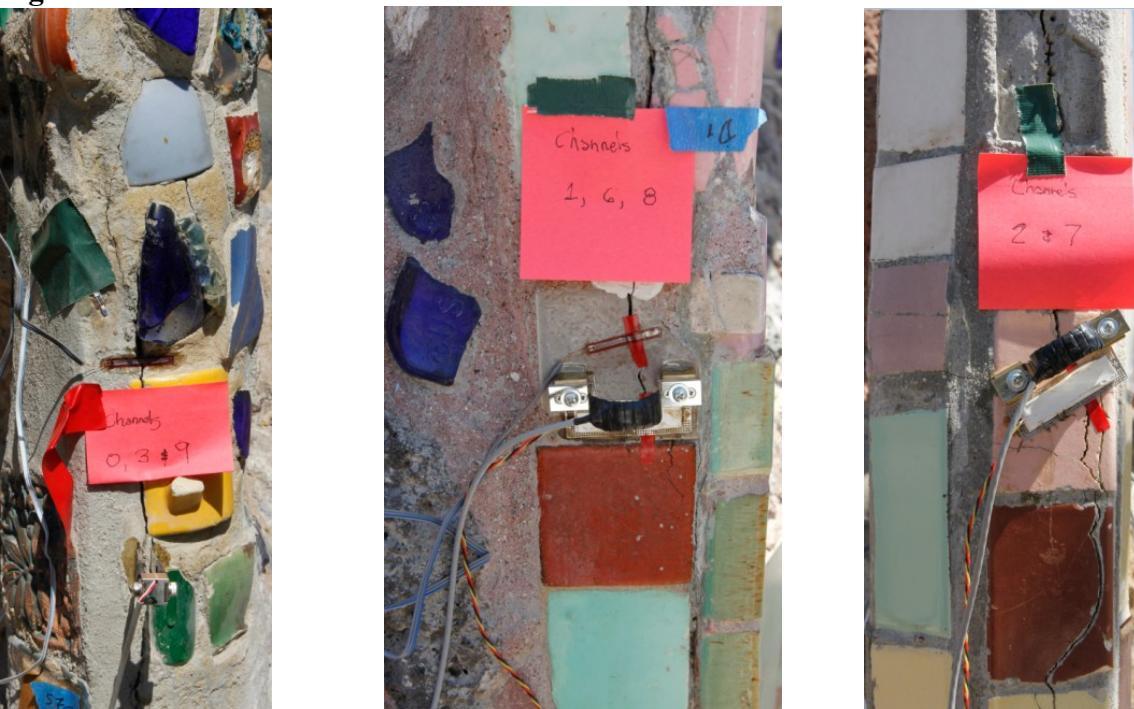
On August 30th and 31st we installed with the help of Harry Jones displacement transducers, strain gauges, and thermocouples (Figure 3). These sensors are connected to a battery operated datalogger.

Figure 3: Locations on Central Tower of monitors

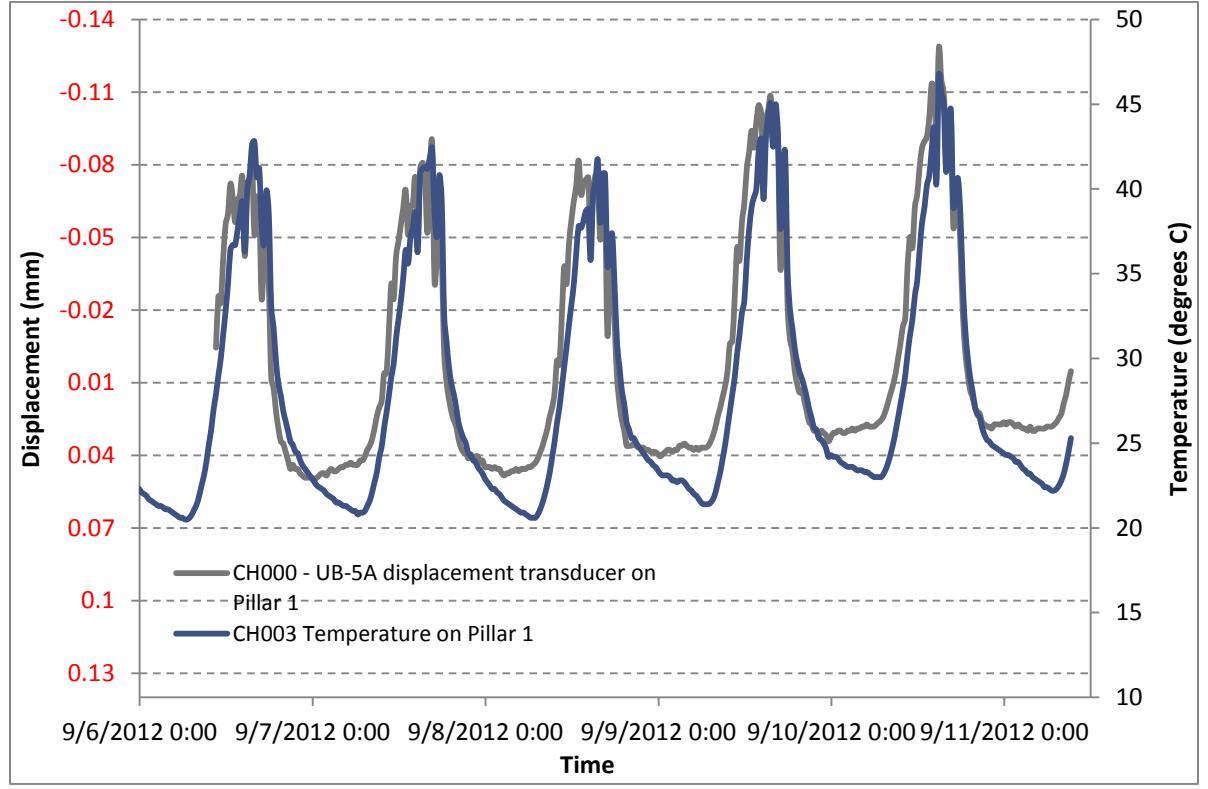
There is a clear correlation between the crack gaps and the surface temperature. As the cement heats up the cracks close, as it cools down the cracks open (Figure 4).
