LACMA, DCA, and Watts Towers

First Quarterly Report (January - March 2011)

Prepared for the DCA, City of Los Angeles, by Frank Preusser, Mark Gilberg, and Brooke Davis Anderson

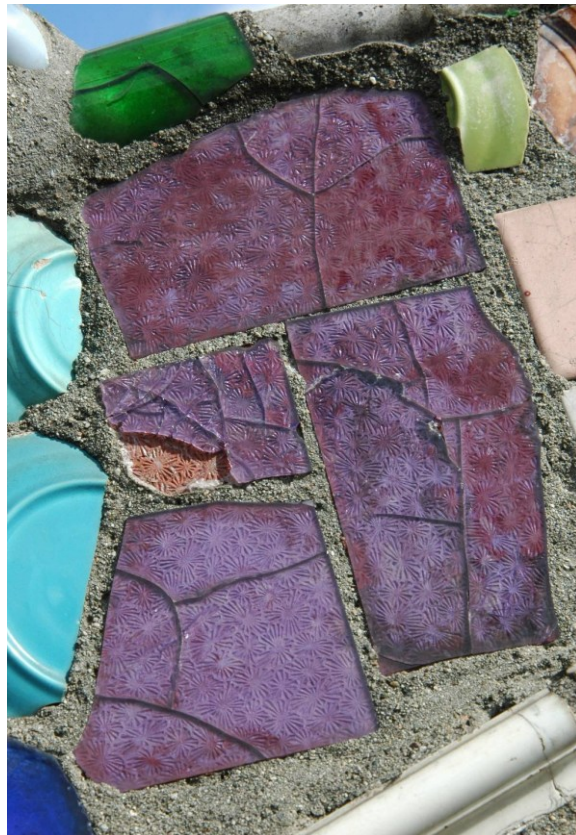
Large, flat, fragmented glass ornaments at the Watts Towers (figures 1 and 2) are losing adhesion to the underlying concrete. An organic adhesive identified as cellulose nitrate has often been applied beneath the plates, either by Rodia himself or in a previous repair.

In addition to the loss of adhesion, the plates are broken into numerous pieces, presumably due to vandalism (e.g. shooting with bb guns) and thermal stresses. Additionally, lichens have been observed growing in spaces between the plates and concrete support, which can speed their detachment. Many fragments of the plates have already been lost, but it has been possible to save a few detached fragments by removing them before they fell off. It is important to prevent these pieces from falling to the ground, since they could shatter irreparably on impact.

Figure 1: Detail of fractured flat glass plates on the interior of the North Wall.

It was decided to secure these ornaments by facing them with a transparent fabric until a permanent solution is recommended. Facing consists of the application of a protective fabric which covers the surface of the unstable glass plates, holding them in place, as well as overlapping onto more stable adjacent ornaments and concrete, which serve as anchor points for the fabric. The fabric is secured to the surfaces using an adhesive which is brushed over the fabric or applied to localized points as a gel.

A 10% solution of Paraloid B72 in Toluene was chosen as the adhesive because it is relatively UV and water stable, at least within time frame projected for this treatment, reversible and not too strong. As facing fabric we chose Stabiltex white¹: low density weave, extremely fine polyester fabric normally used in textiles conservation.

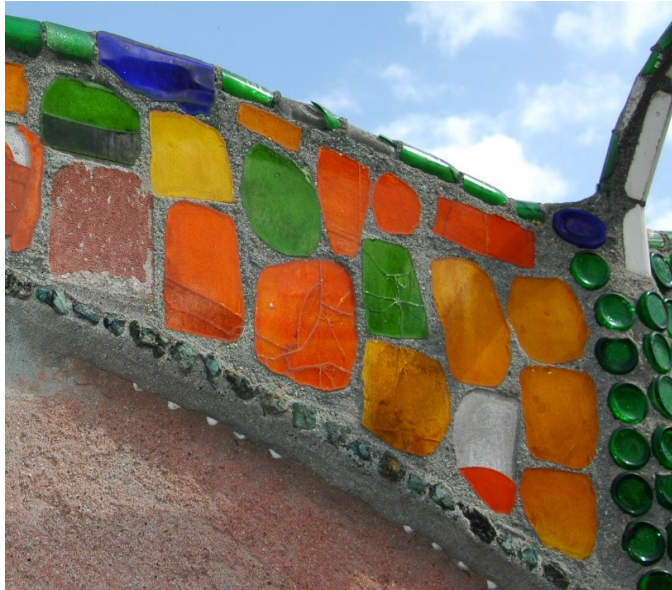
Figure 2: Interior of the North Wall, before facing.

Figures 2 and 3 show one of the treated areas before and after facing.

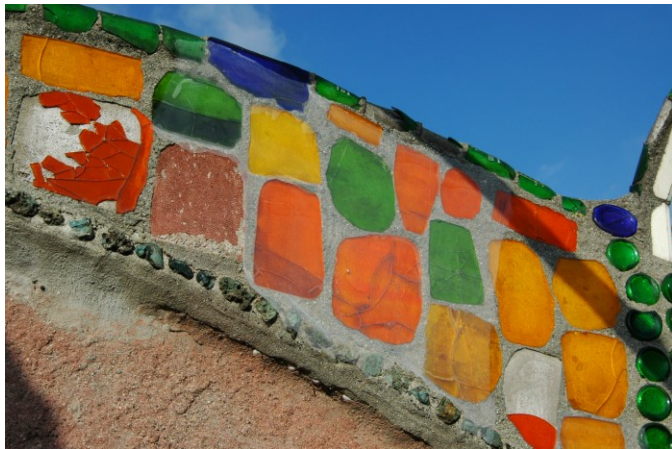
Figure 3: After facing.
