**LACMA, DCA, and Watts Towers**

**Third Quarterly Report (July-September 2011)**

**Prepared for the DCA, City of Los Angeles, by Frank Preusser, Mark Gilberg, and Brooke Davis Anderson**

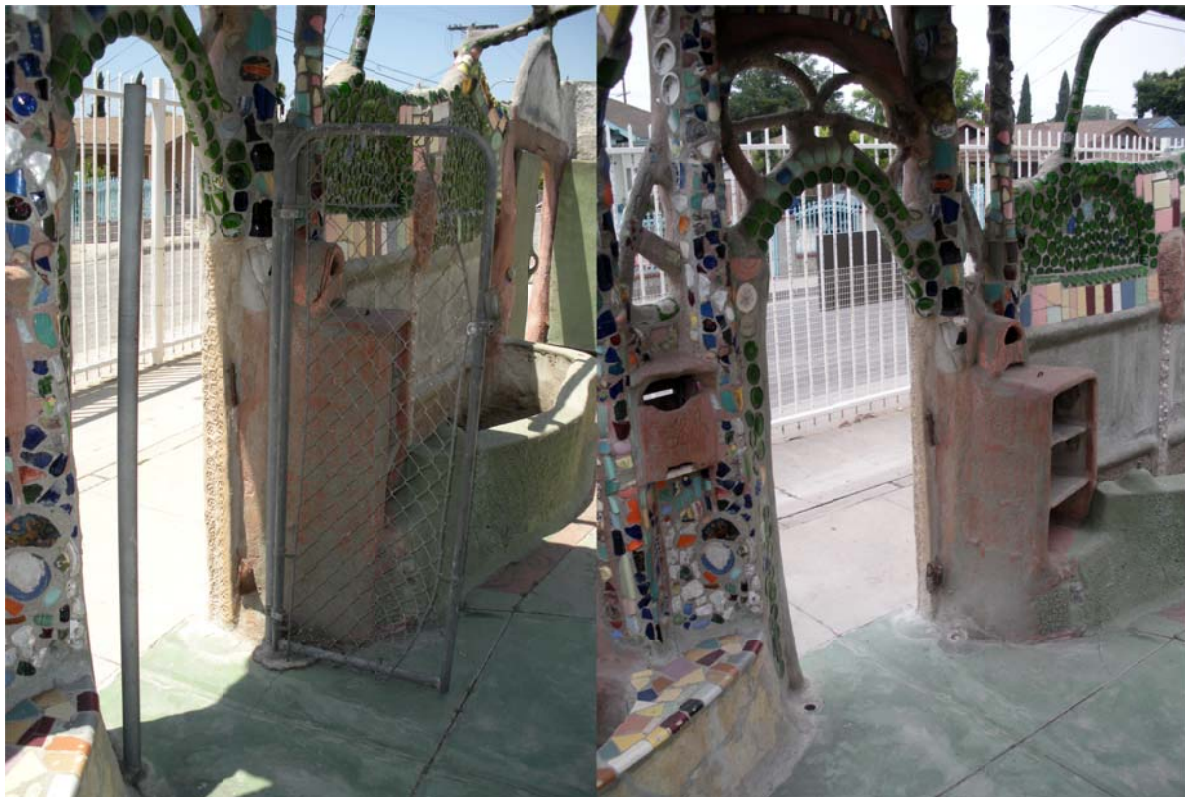
The chain-link fence gate in the South Wall and its posts, and the steel sign post at the SW corner of Rodia's house have been removed by Charles Dickson (figures 1 and 2).

Figure 1: chain link gate

Figure 2: after removal of the gate

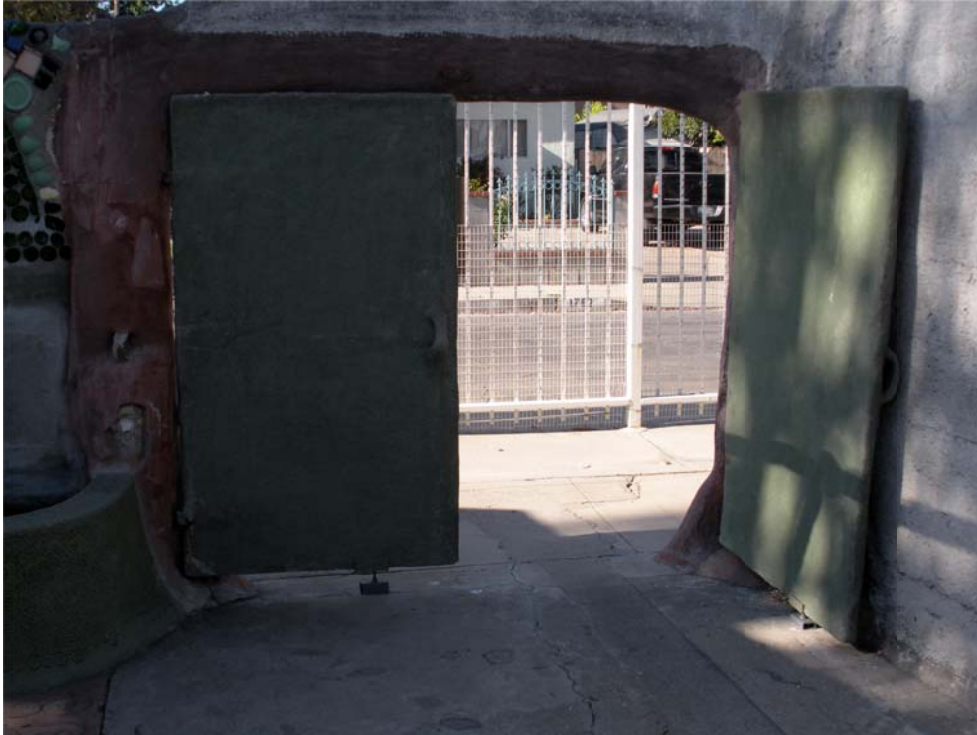
It was observed that the garage doors are moved by visitors and the wind. This puts considerable strain on the hinges. It was therefore decided to fix them in one position and at the same time take some load off the hinges (figures 3 and 4; built by Charles

Figure 3: garage doors locked into position

Dickson). This intervention is fully reversible and the current position of the doors can be changed at any time.

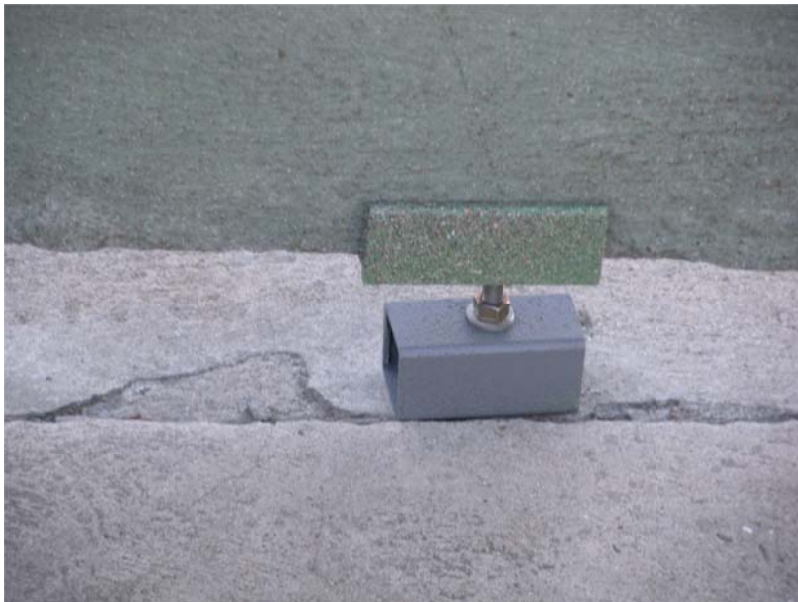
Figure 4: locking and lifting device

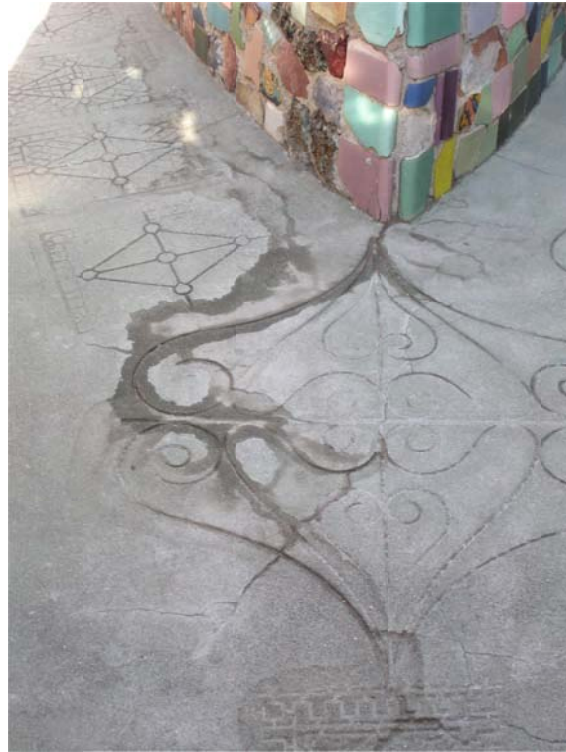
We are also currently exploring strategies to prevent cats from urinating at the bow of the Ship (figure 5). One possibility is the installation of an ultrasonic cat deterrent.

Figure 5: cat urine problem

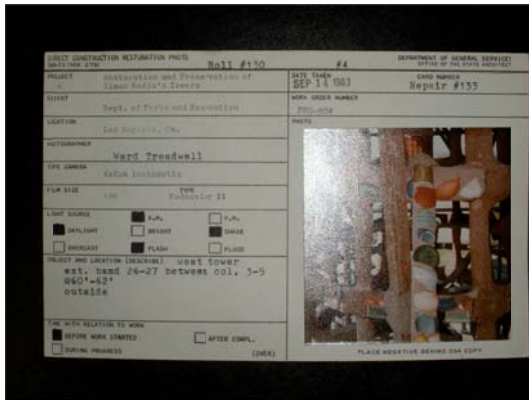
Figure 6: state record from 1983

Ms. Colleen Boye continued re-organizing, re-housing, and creating an inventory of the treatment records from the state. There are approximately 4,000 unique records covering the time period from 1979 to 1985. Approximately 3,000 have been re-housed. Scanning of individual records will be done on an “as needed” basis (figures 6 to 8).

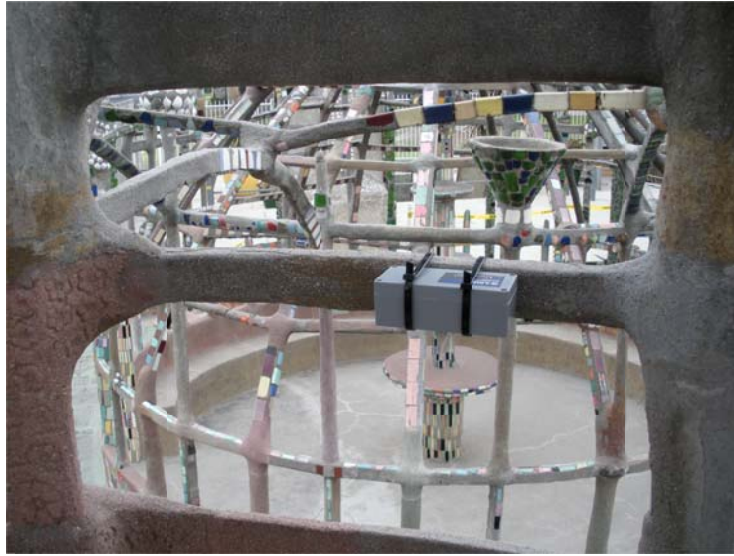
Difficulties arose with the vibration monitors with extended battery life (figure 9). The towers interfere with the radio signal from the monitors and we were not able to record the signal with the base station at the Conservation Office. We obtained a different antenna which seems to solve some of the problems. We will continue exploring this option. Since all the equipment is currently on loan to us we will soon have to decide if we want to purchase it.

Figure 9: vibration monitor

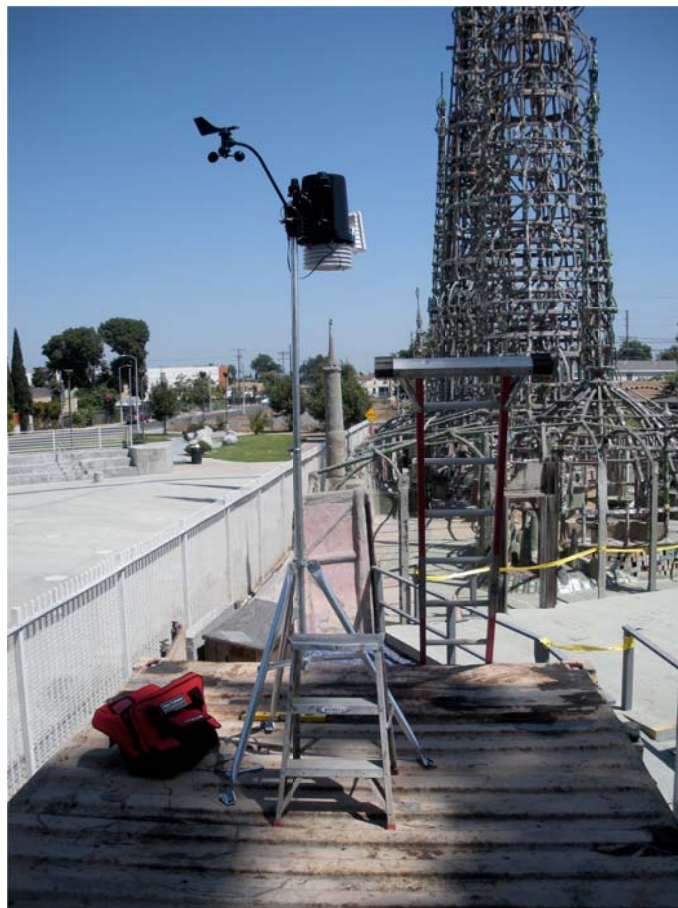
Figure 10: weather station during installation

The Weather Station was received and installed (figure 10). We are currently collecting data at ½ hour intervals. The sampling interval will be reduced to two minutes when Santa Ana conditions or storms are forecast. For this purpose we have signed up for a weather alert service.
