Evaluation and Conservation of Fissures

Report

Watts Towers State Historic Park

Los Angeles, California

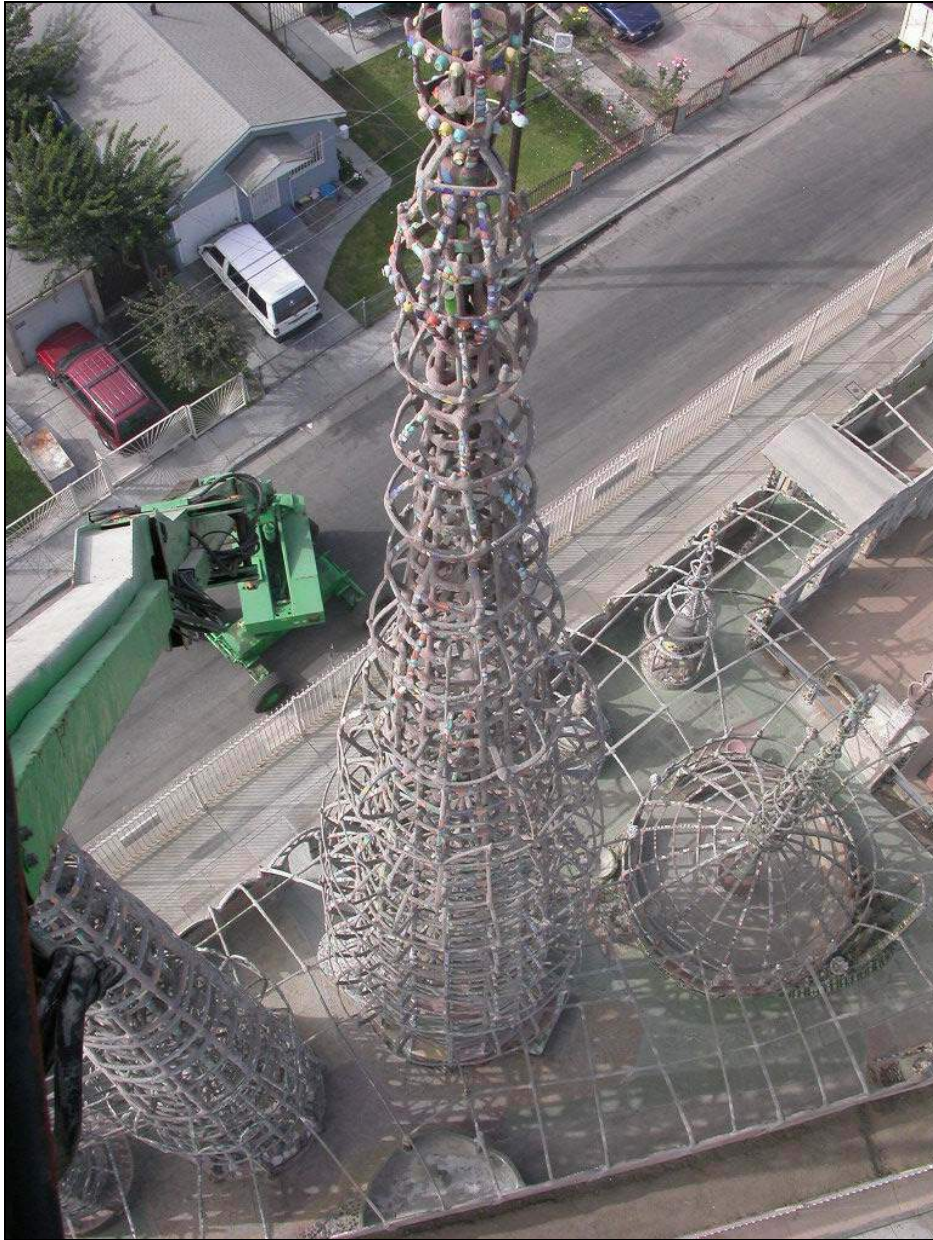
Two small sets of steps at the West Tower lead to a circular base that consists of four stepped levels beginning 4 feet above the floor and ending 8 feet high. The tower measures 15 feet at the base and rises to a height of 99 feet-6 inches. The West Tower has 16 exterior columns at the outer perimeter of the tower. A distinguishing feature of the West Tower is the series of vertical loops outside of the exterior columns. There are a total of 18 loops, climbing from nearly the bottom of the tower to the top every two to three exterior bands. (See Appendix A, Figure 1)

Figure 1: View looking southwest of West Tower from boom lift.

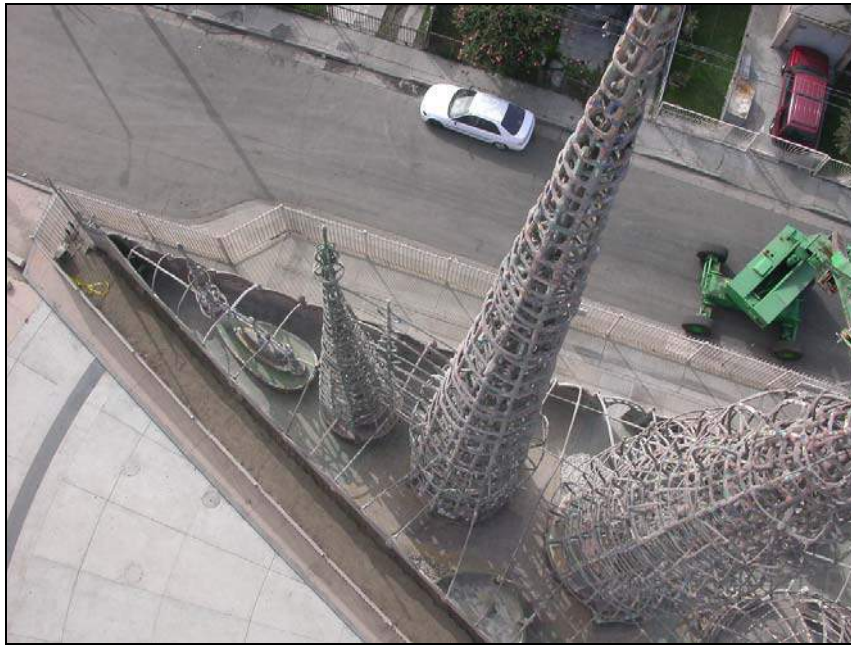
The Center Tower, situated between the West and East Towers, has a dome-shaped base 8 feet high at the center core. The Center Tower is 13 feet-6 inches in diameter at the base and is 96 feet-10 inches high. There are eight exterior columns at the perimeter of the base, and another eight intermediate columns between the center core and the outer columns. There is a ladder-like series of sub bands, most numerous on the north side of the tower, in between the regularly spaced exterior bands completely encircling the tower. A single level of vertical loops near the bottom of the tower, approximately 20 feet from the ground, is the remaining vestige of loops that originally climbed the full height of the tower, similar to the West Tower, but were removed by Rodia before the construction of the West Tower. (See Appendix A, Figures 2 and 3).

The East Tower, 9 feet in diameter at the base and 57 feet high, lies east of the Center Tower and is connected to it by a series of overhead arches. The base of the East Tower is 3 feet high and made up of a series of circular levels of decreasing diameter. The tower has six exterior columns and eight interior columns. (See Appendix A, Figures 2 and 3).

Figure 2: View looking southeast of Center Tower and East Tower from boom lift.

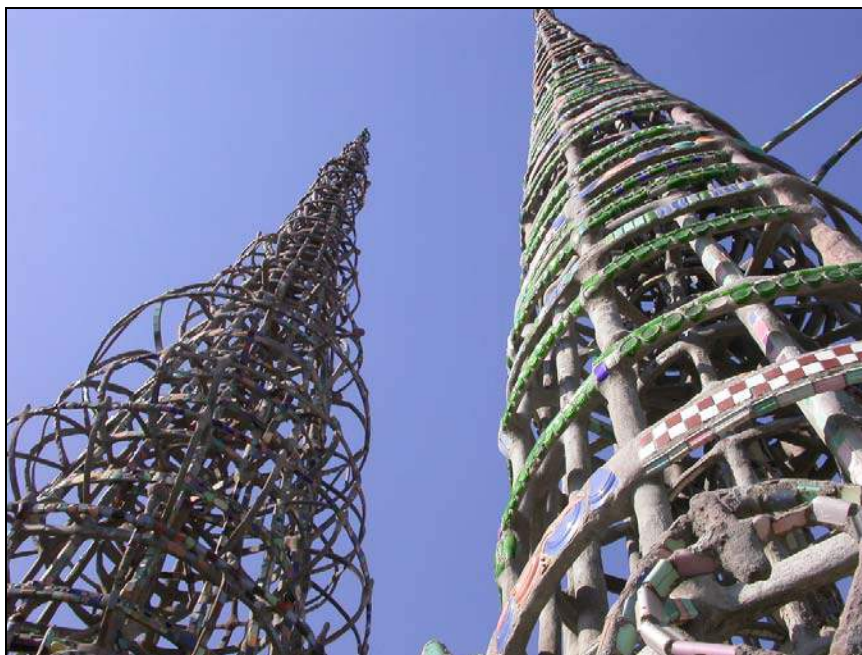
Figure 3: View of West and Center Towers looking northwest from ground.

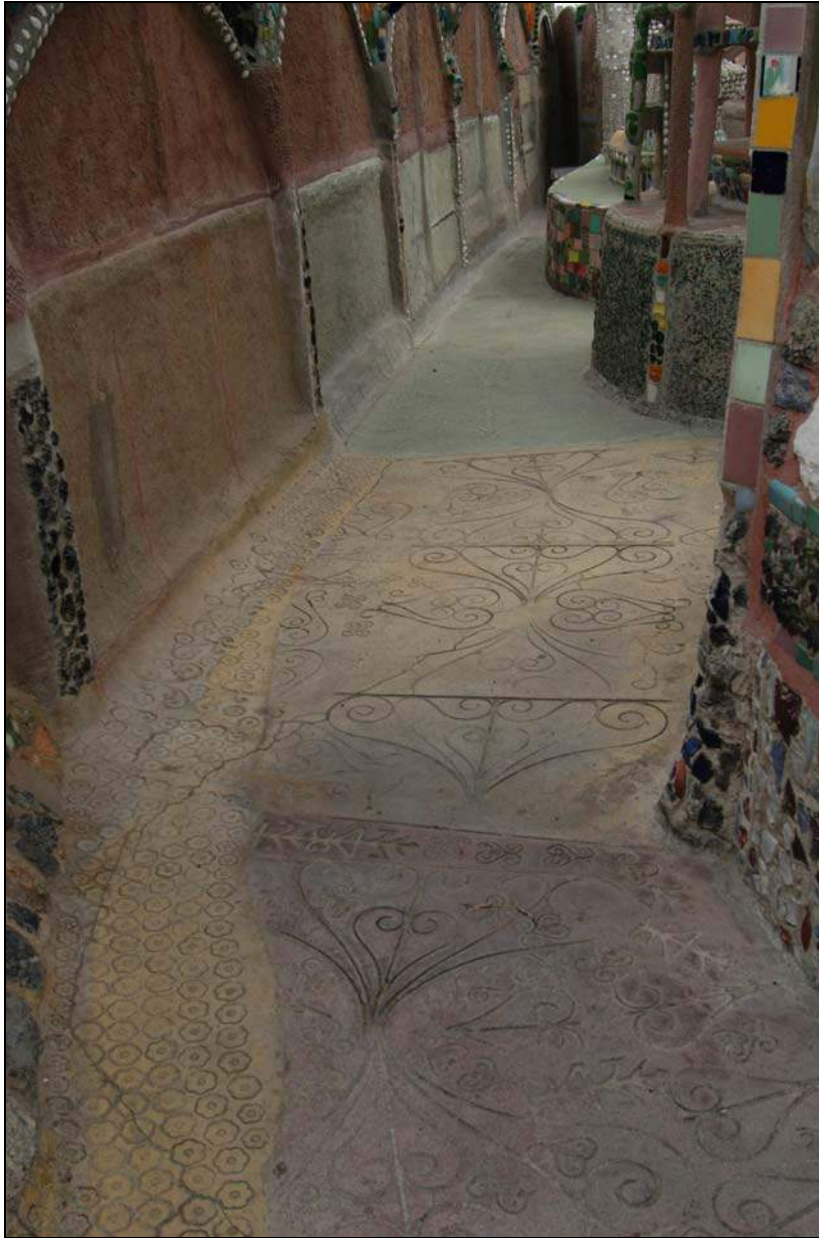
Within the concrete walls that define the site of the towers, Rodia constructed an ornamental floor consisting of colored concrete with stamped patterns. (See Appendix A, Figure 18). The floor, mostly green concrete with some fields of red and yellow, was poured or set as a slab of varying thickness at various stages throughout the construction of the towers. The slab is scored, although not in a regular pattern, as is typical in concrete flatwork, and has relatively large spans between score lines. The top surface of the slab was stamped with heating registers, rug beaters, and other household items to give it a distinctive visual appearance. The joints or score lines between the colored slabs appear to be a function of the artistic design rather than placed specifically for crack control.

Figure 18: Ornamental floor on the north side of the towers showing red-, yellow-, and green-colored concrete slab with stamped patterns.

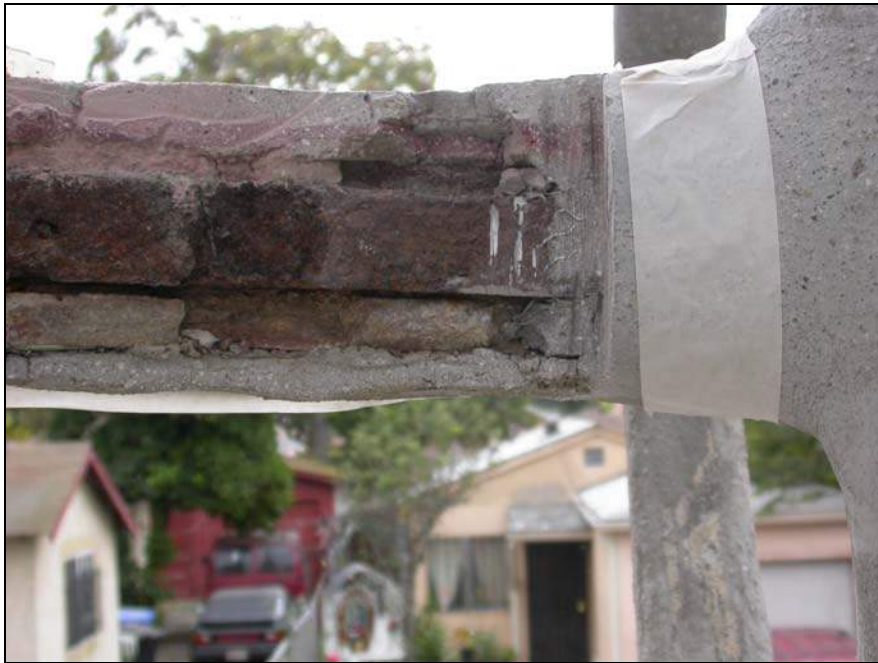
Figure 18: Original steel armature at exterior band on West Tower, as viewed from the interior face.

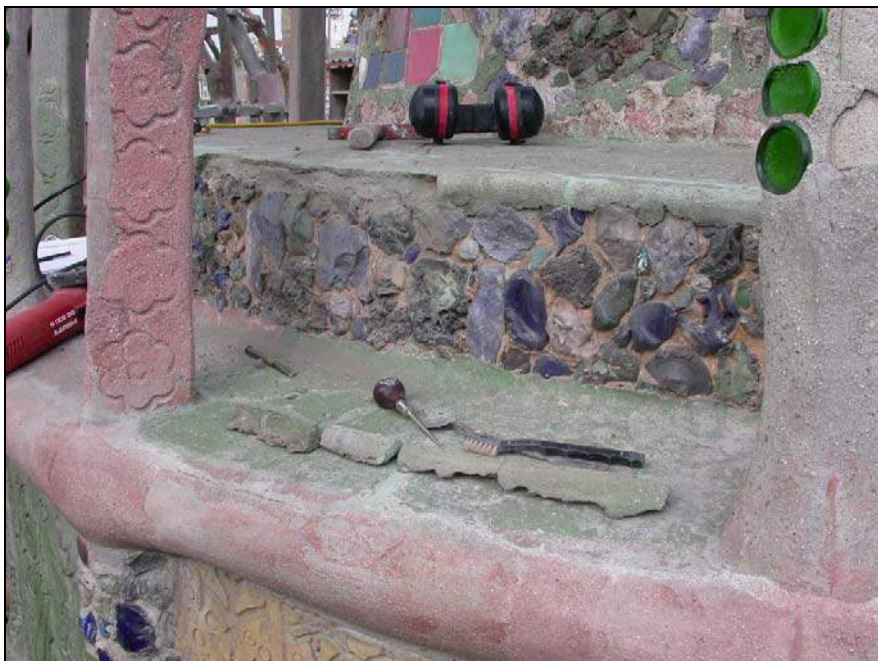
Figure 19: Removed sections of concrete at edge of base level on south side of West Tower.

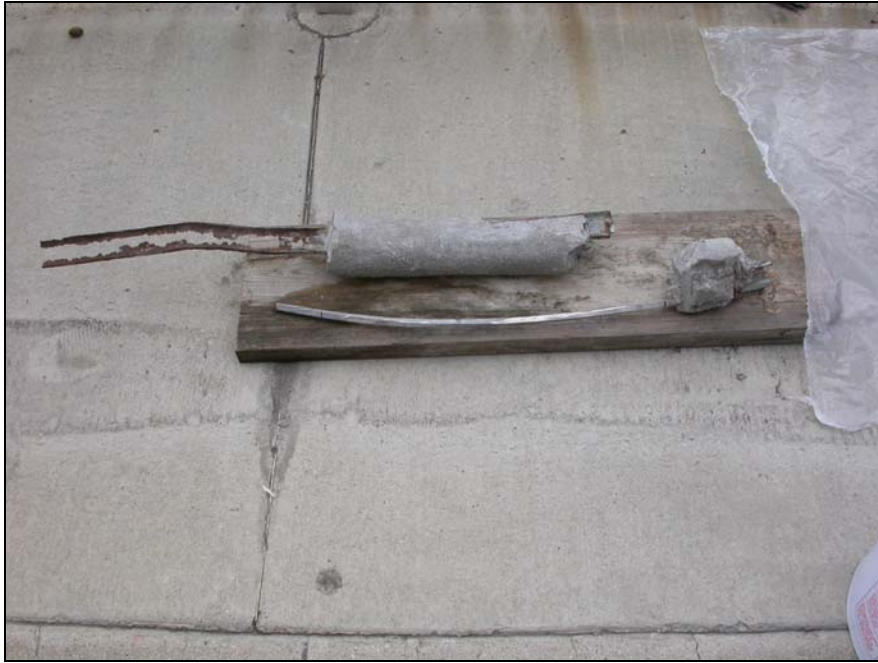
Figure 22: Samples of mortar and reinforcing previously removed from towers used for testing application of water repellent and penetrating rust inhibitor before treatment.

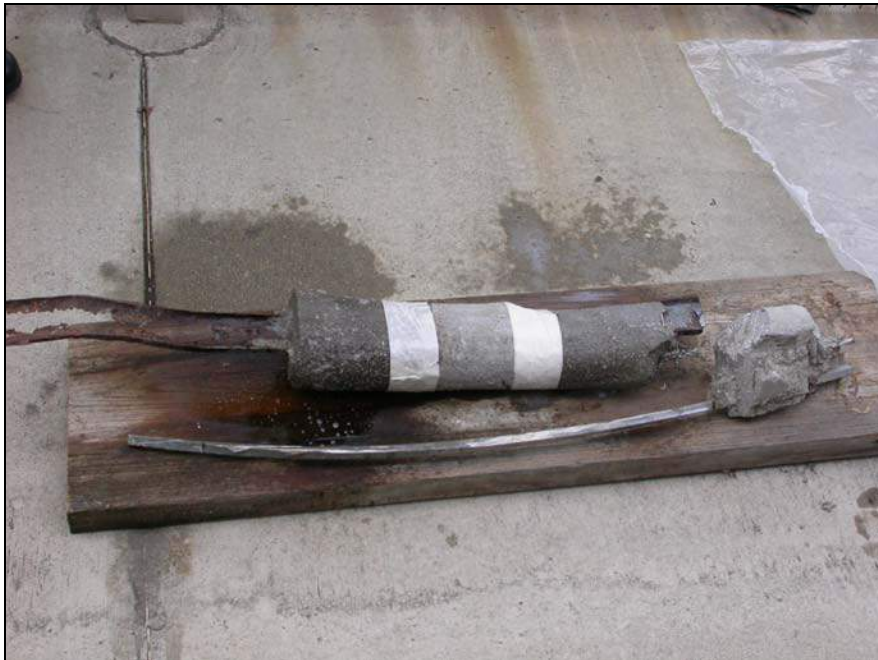
Figure 23: Sample following treatment, with rust inhibitor at the left of the large sample, no treatment at the center, and water repellent applied to the right.

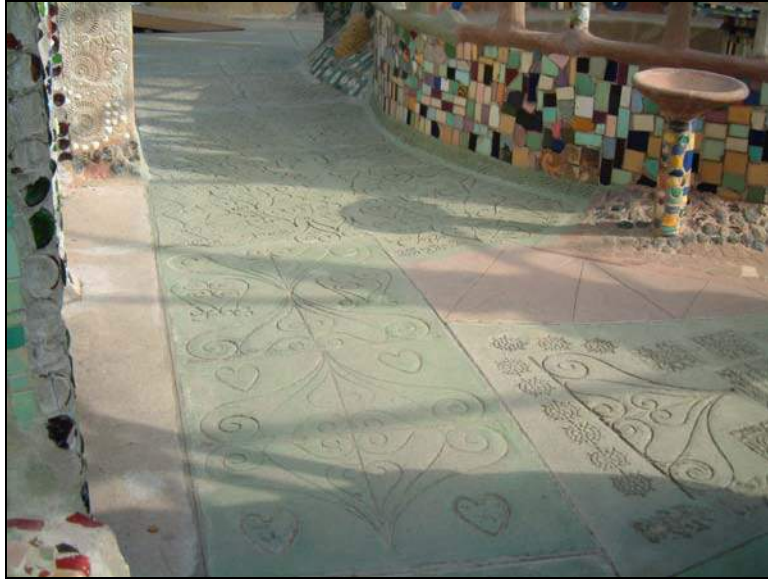
Photo 1. South side of slab near gazebo. The stamp patterns, joint locations and coloring of sections are typical of the entire slab area.

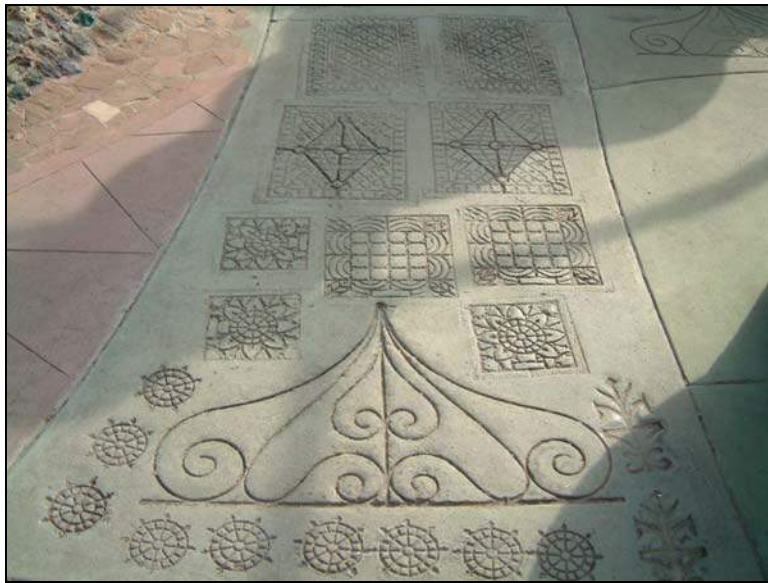
Photo 2. Stamped patterns in walkway.

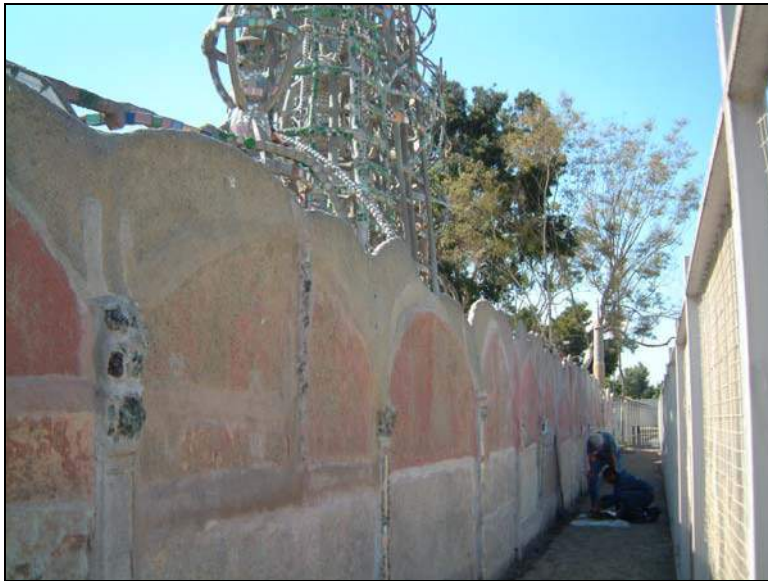
Photo 10. Soil sampling location on north side of property just outside wall.
