Documentation Synthesis and Materials Research

Draft Report

Watts Towers State Historic Park

Los Angeles, California

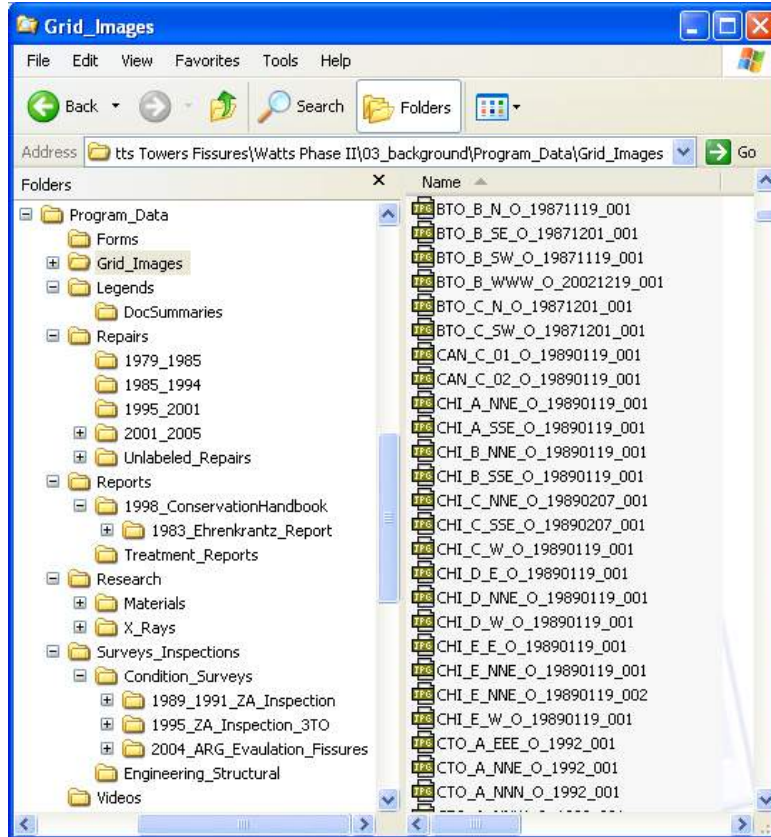
Figure 1 – File organization of existing documentation.

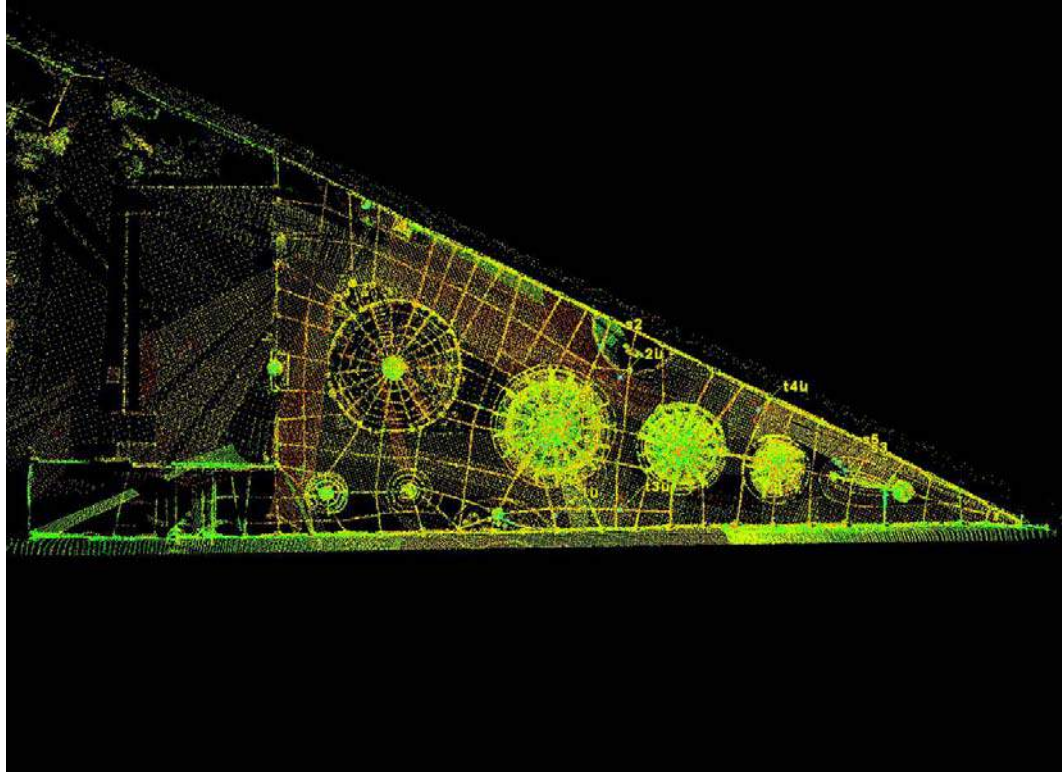
Figure 13 – Site plan generated from point cloud, accurate to 1 centimeter.

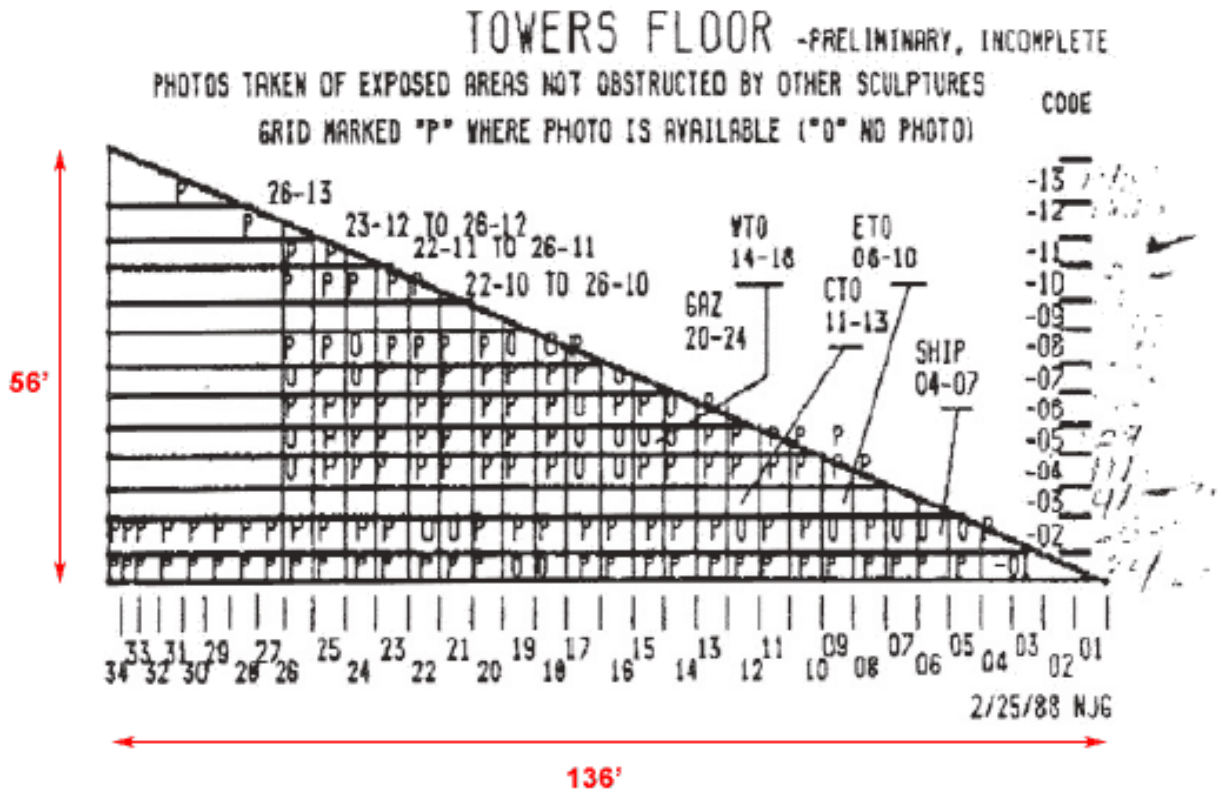
Due to the variation in materials, thicknesses of metal and mortars, and embedded materials, it was difficult to ascertain moisture retention patterns using an infrared thermal camera. Sample images are described in Appendix A, Figures 14 through 16.

Figure 14 – Previous site layout plans indicated a slightly different aspect ratio and dimension.

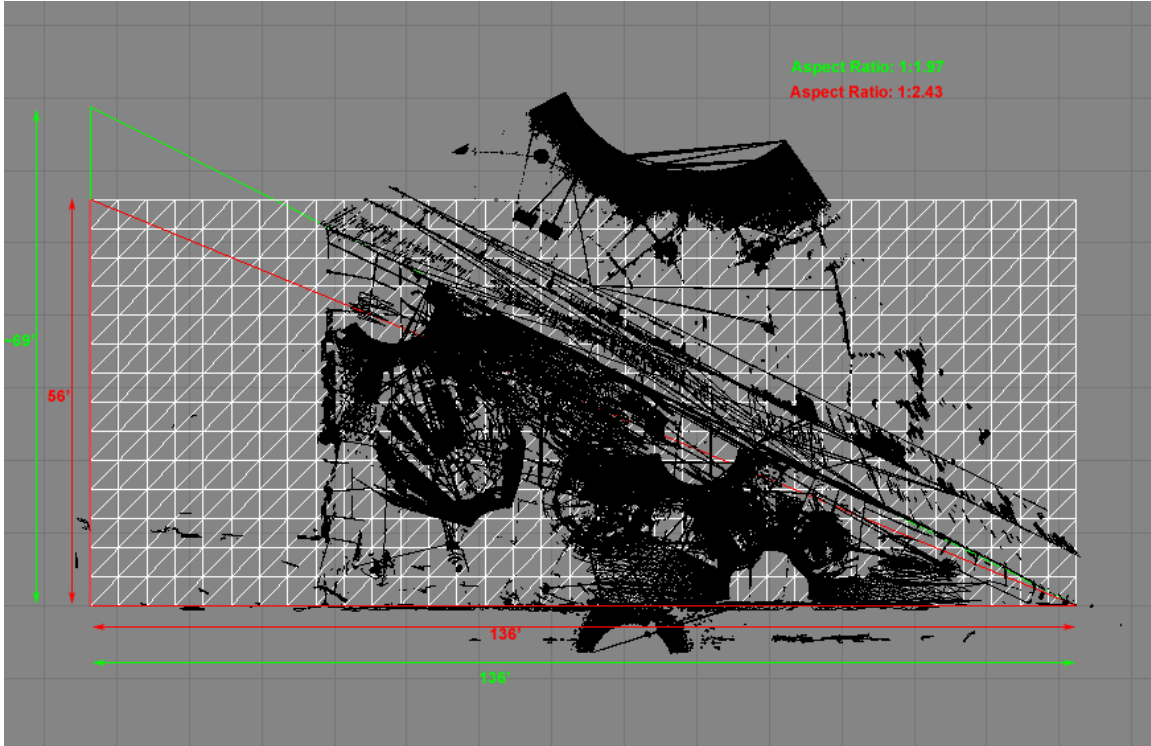
Figure 15 – Previous site layout dimensions highlighted in red; point cloud outline in black and associated dimensions highlighted in green.

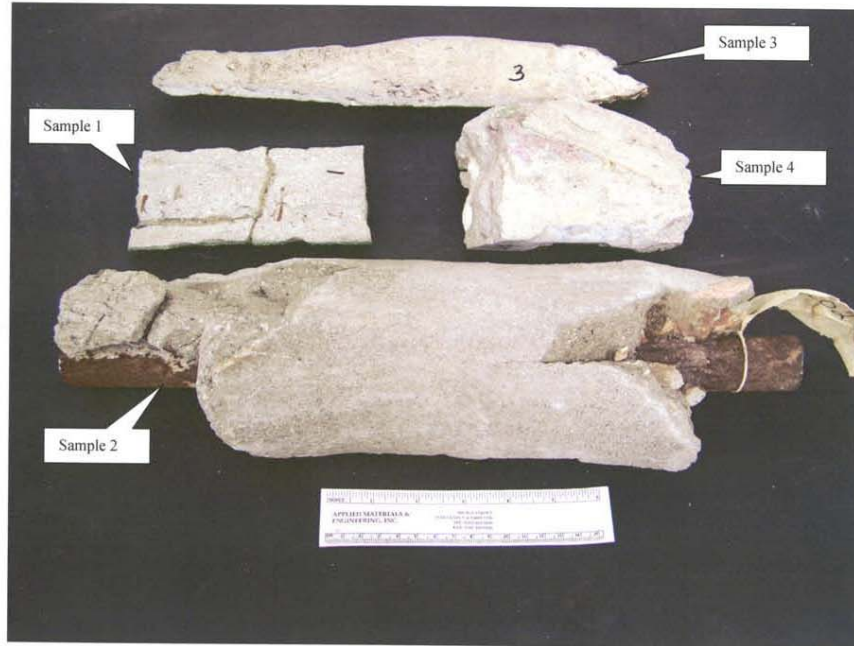
Photo 1. Mortar samples, as received

Four (4) mortar samples were delivered to our laboratory. Table I gives the sample identifications and approximate dimensions. The mortar samples are shown in Photo 1.

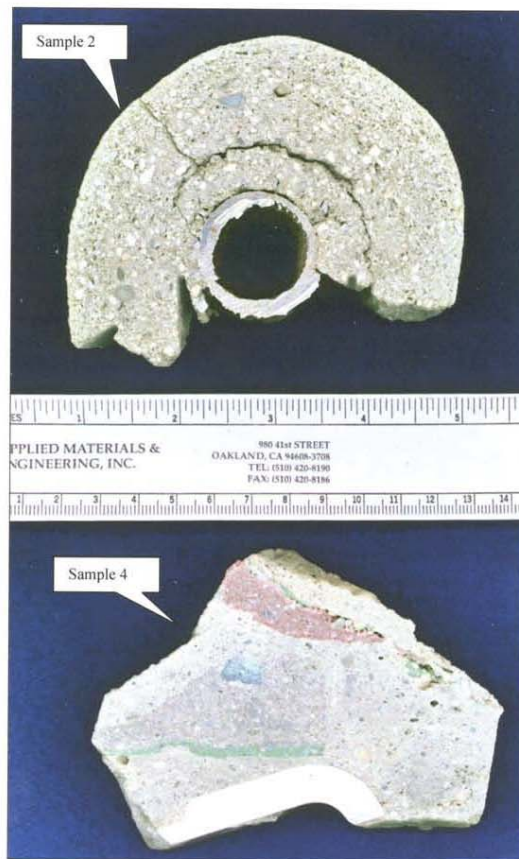
Photo 1. Cross-sections of mortar samples examined.

Two (2) mortar samples were selected for examination from four (4) mortar samples previously tested for carbonation and chloride contents, as described in our report dated February 2, 2006. Table I gives the sample identifications and approximate dimensions of the samples used in the petrographic examination. The mortar samples are shown in Photo 1.

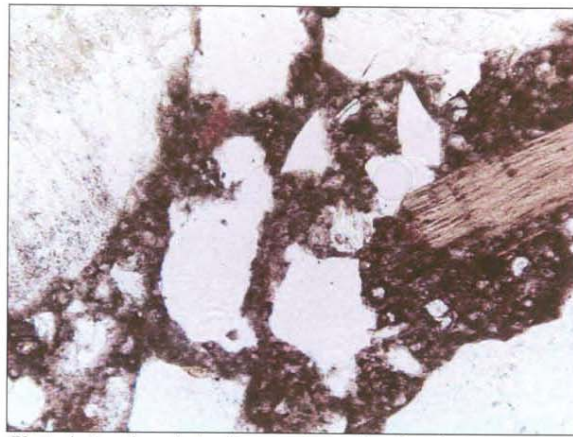
Photos 2 through 5 show some of the typical features of the mortar microstructure of Sample 2.

Photo 4. Another photomicrograph showing the microstructure of Sample 2.

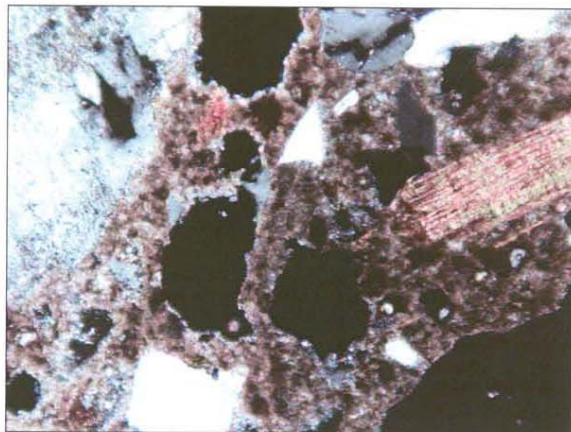
Photo 5. Same area as Photo 4 except viewed in cross-polarized light

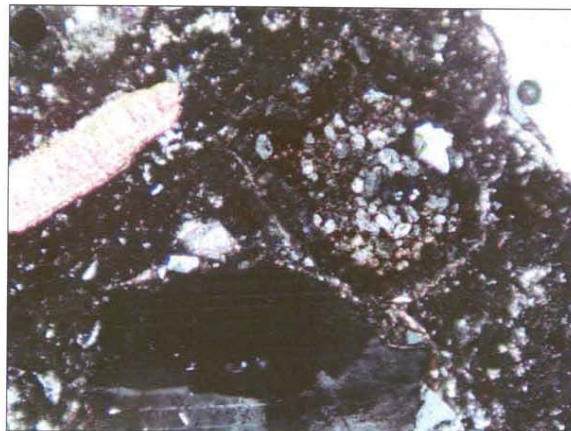
Photo 7. Same area as Photo 6 except viewed in cross-polarized light
