THE WATTS TOWERS
CONSERVATION REPORT

THE GAZEBO

June 1994

CONSERVATION OF THE GAZEBO
WATTS TOWERS CONSERVATION PROGRAM

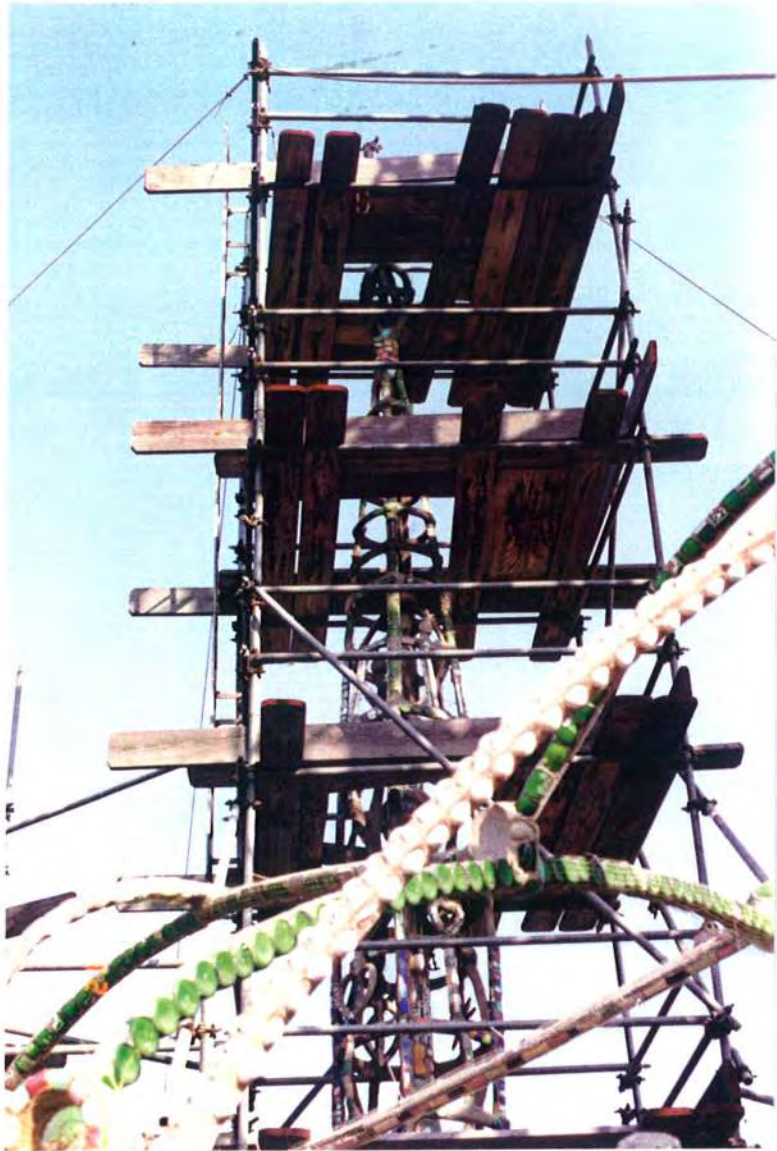
Figure 9.
Scaffolding around
Gazebo spire for
conservation program
access.
Oct 1992.

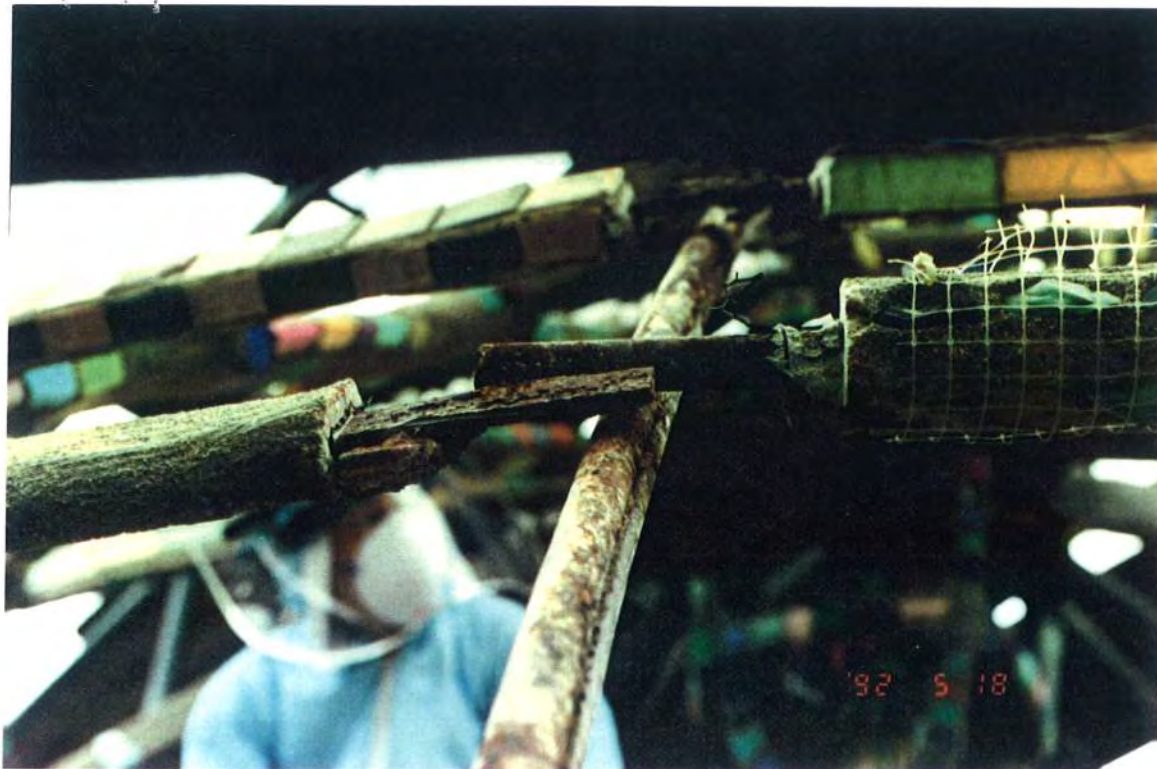
Figure 13.
Junction of horizontal bands
with major vertical support.
May 1992.

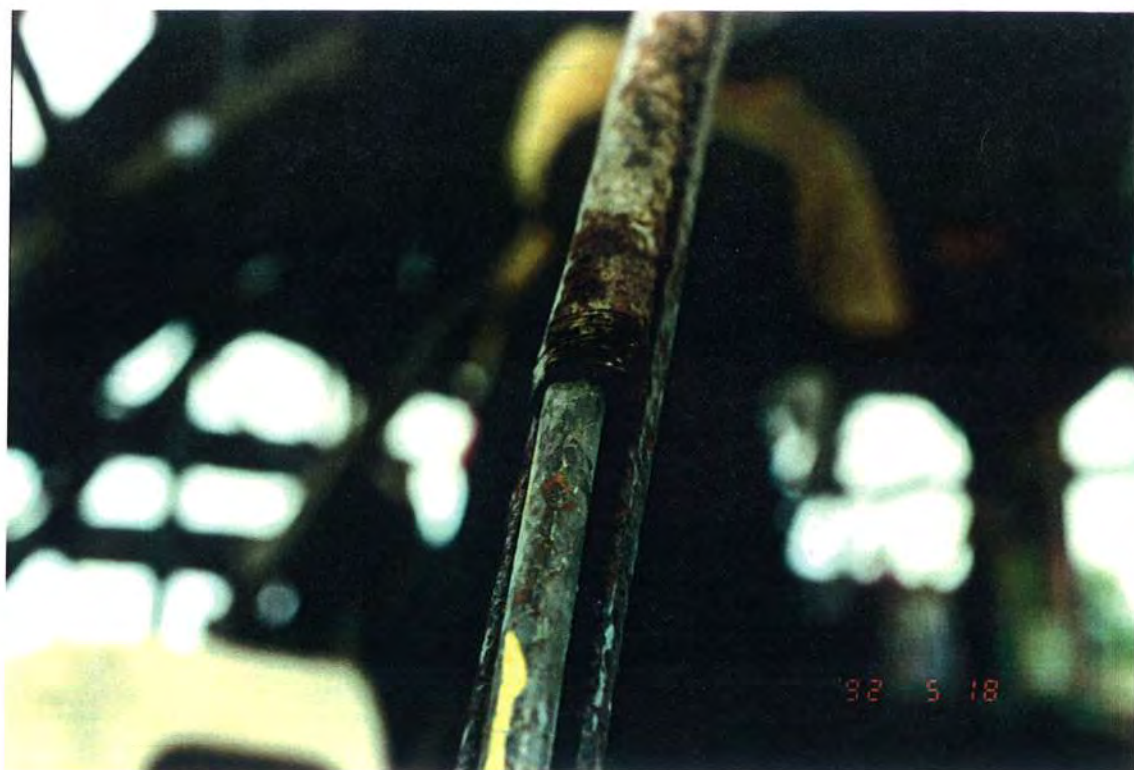
Figure 14.
Major vertical support rein-
forcement by Rodia. Pipe
nested in channel on top
with rebar inserted in pipe
on bottom of photo.
May 1992.

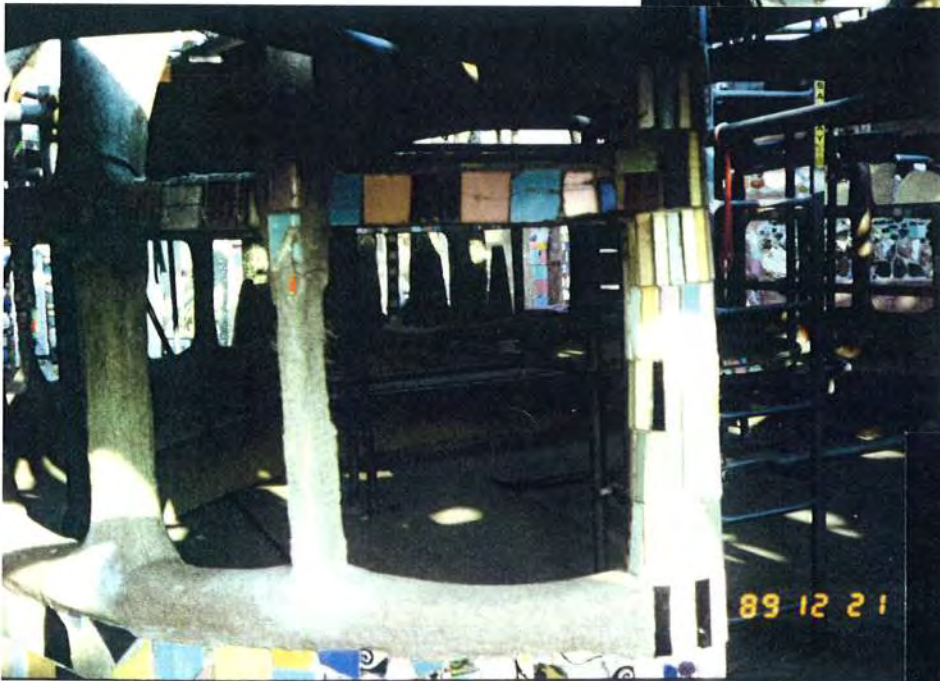
Figure 15.
Shells after cleaning and
consolidation.
Jan 1990.

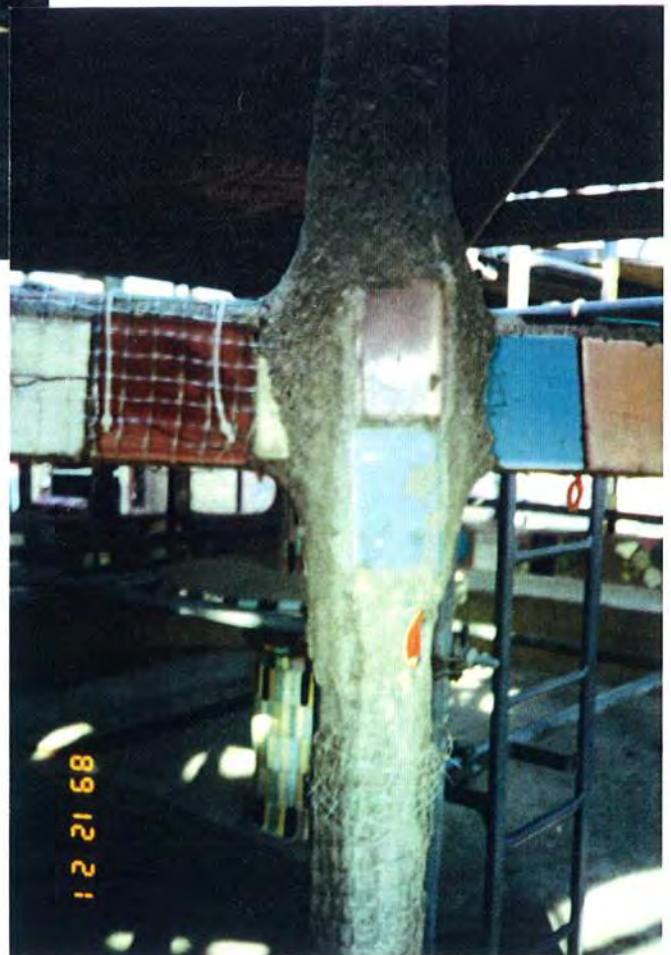
Figure 16.
Area west of Gazebo entrance
after crack-filling and bonding
ornaments to members.
December 1989.

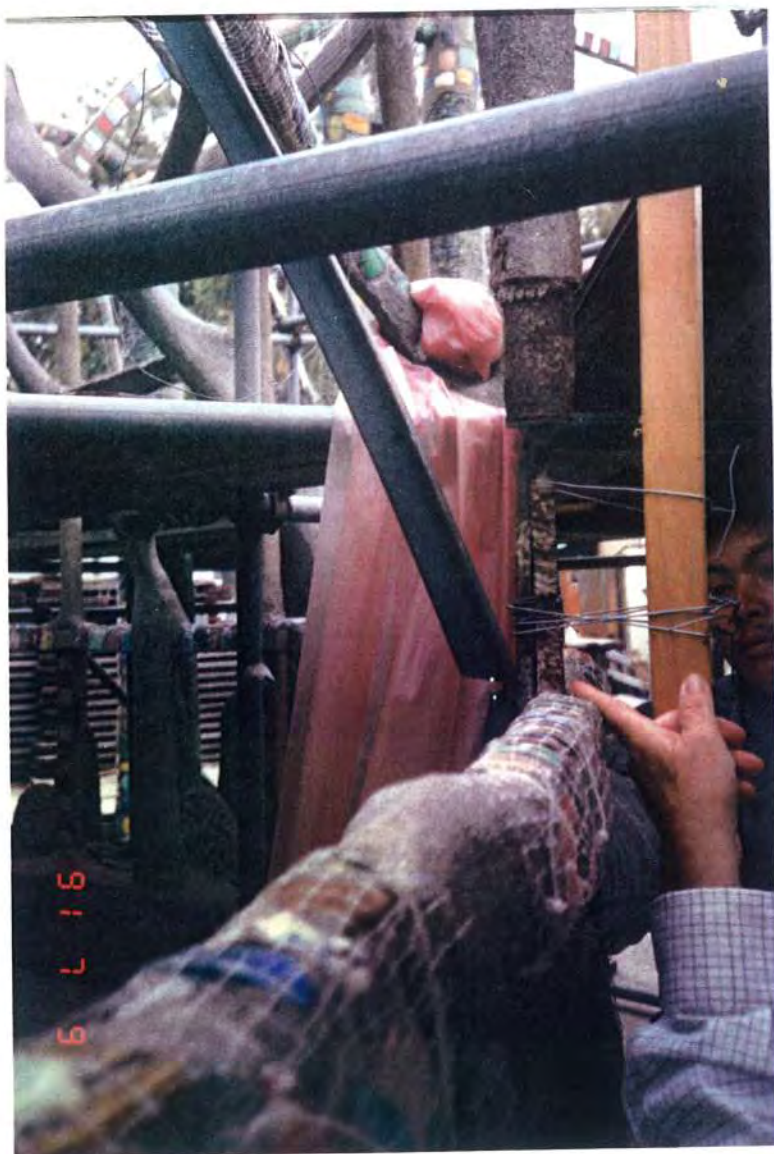
Figure 20.
Top-rusted channel, center-rusted
rebar, bottom-new 'T' section for
MajV02 reinforcement before
installation.
May 1991.

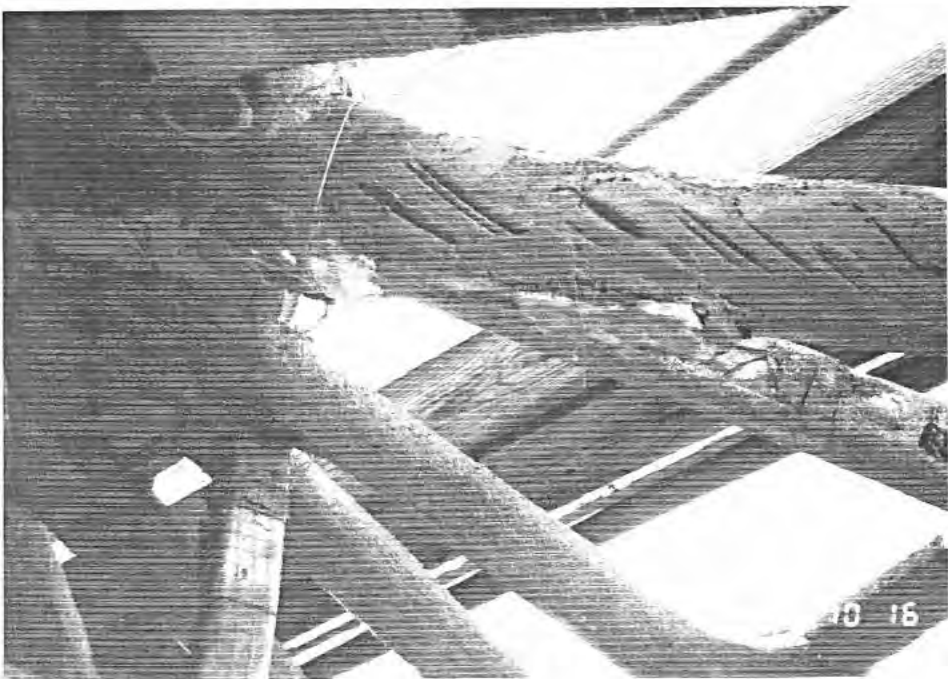
Figure 23.
Support MajV04 after removal
from Gazebo for conservation
work & to replace the rein-
forcement with a new 'T'
section. Nov 1991.

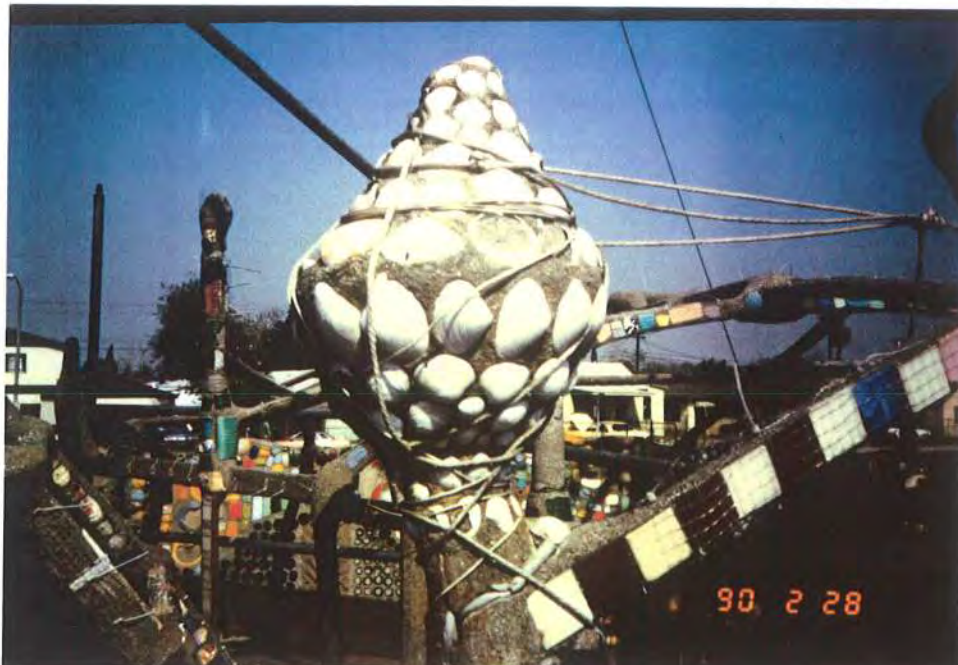
Figure 26.
Finial on top of outer S.E.
vertical after shell treatment
and stabilization.
Feb 1990.

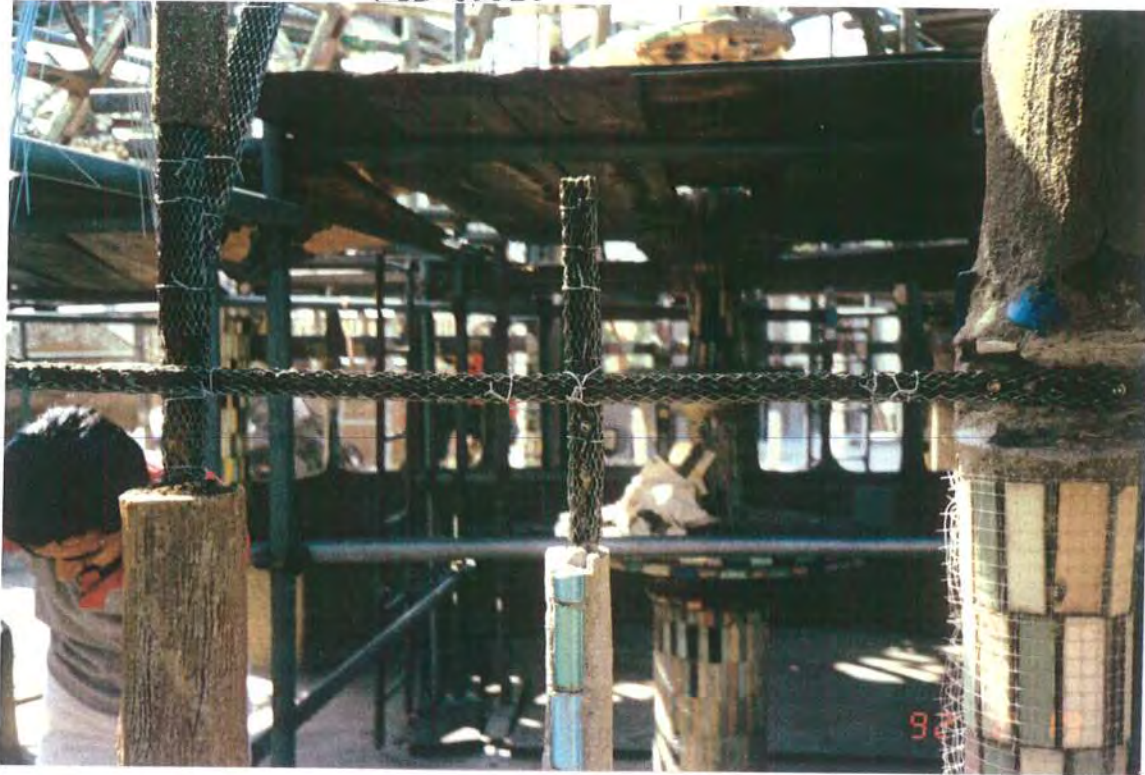
Figure 33. Steel reinforcements wrapped with steel mesh ready to accept mortar and rebonding operation for original covering of mortar and ornaments. Feb 1992.

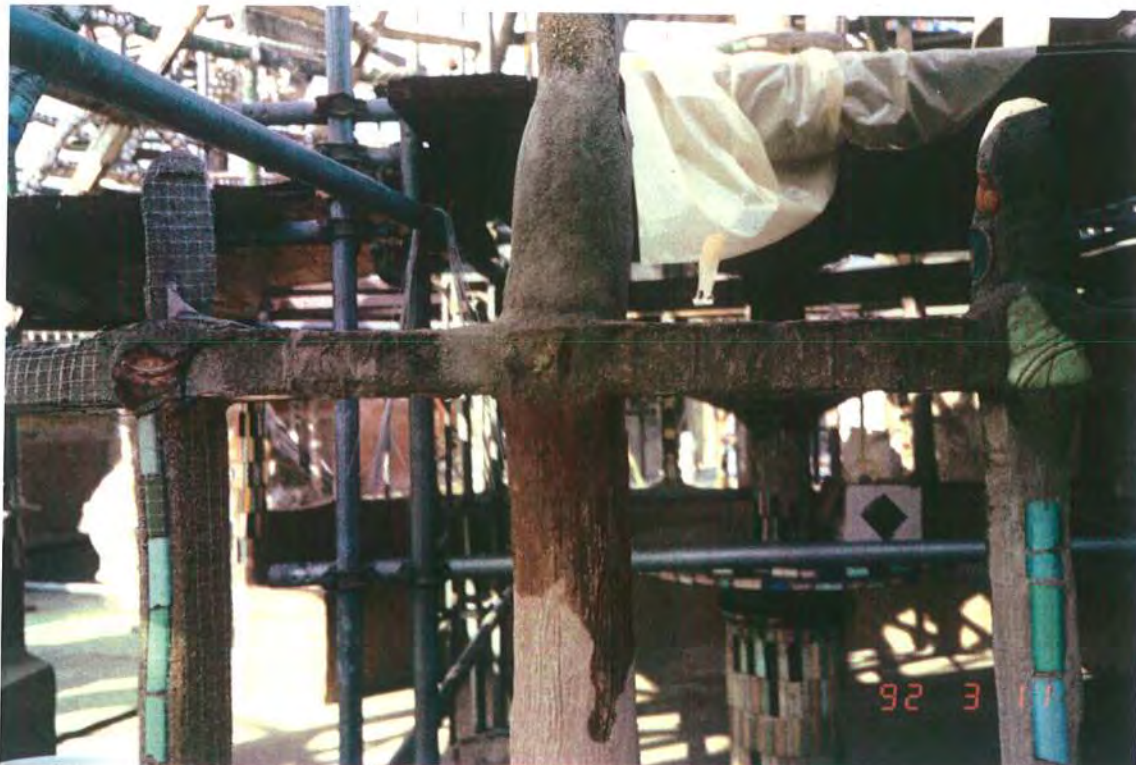
Figure 35. Cracks in third arched support before conservation work. May 1992.

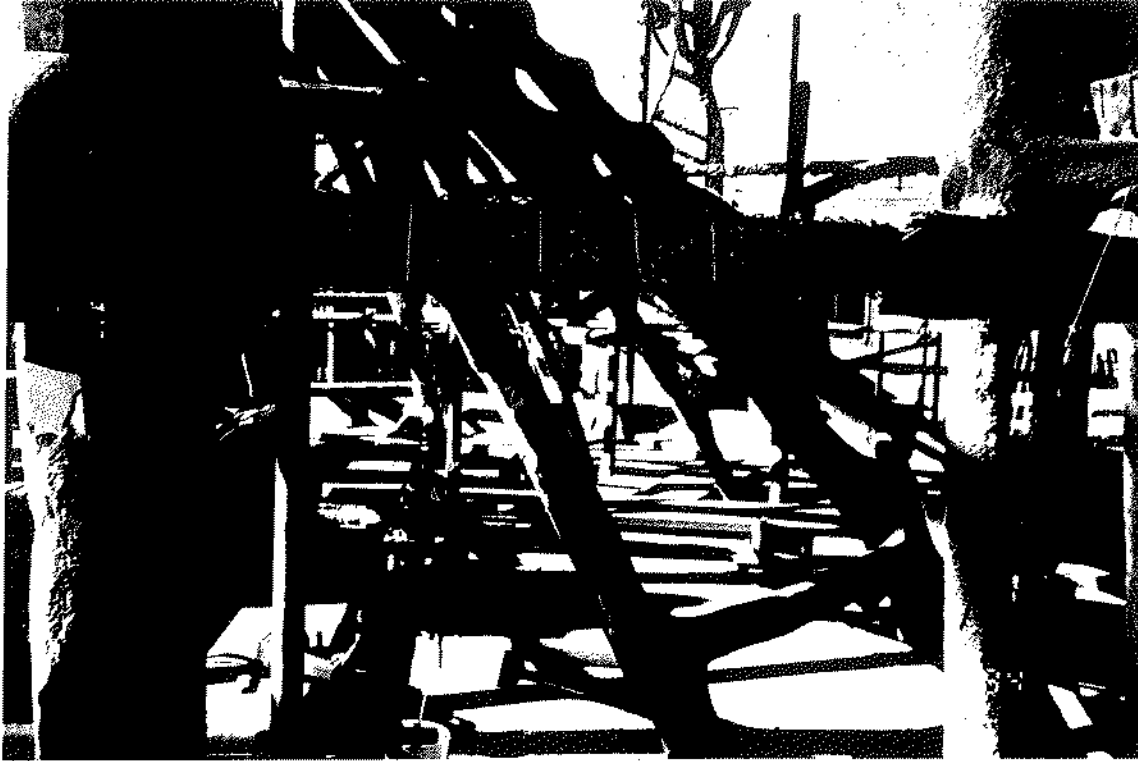
Figure 89. Steel mesh wrapped around replacement reinforcement on ring 2 after removal of mortar with embedded ornaments. (B level). January 1994.
