LACMA

LACMA, DCA, and Watts Towers

Fourth Quarterly Report (October - December 2011)

INCIDENT REPORT for the Watts Towers of Simon Rodia

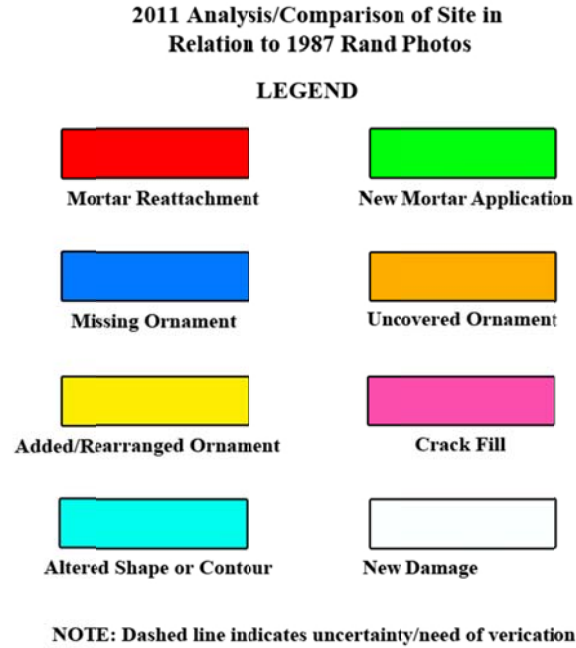
Figure 10: Legend for Rand comparison

Mr. Israel Campos is comparing the Rand photographs with the current state of preservation of the monument. Any observed changes are then marked on the recent photos taken by Mr. Yosi Pozeilov during the re-photography of the Towers (see Figs. 9 and 10). Israel has to date completed this comparison for the South Wall and is currently working on the North Wall.

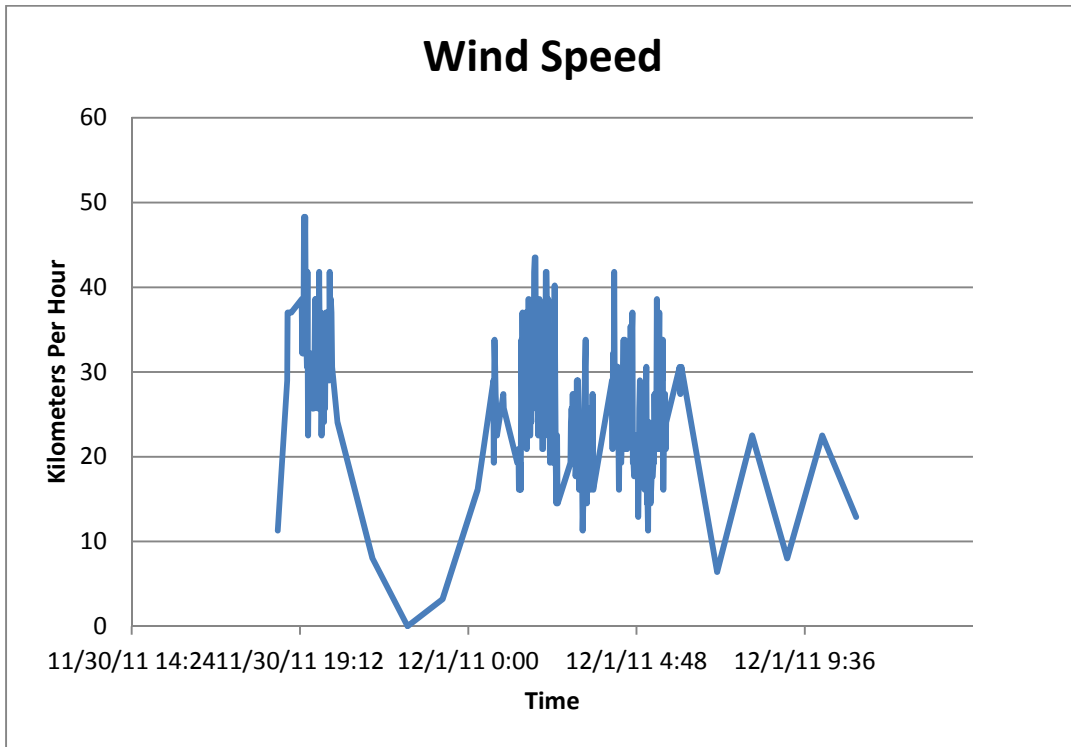
Figure 12: Wind Graph

While we are still searching for the most suitable vibration monitors for the Towers we decided to use the available battery operated accelerometers to monitor the high wind event on November 30 and December 1. We installed 10 accelerometers in different locations at a height of approx. 15 feet. Figure 12 shows the wind speed (in km/h) and figure 13 shows the data from accelerometer 8. There is very good correlation between the wind speed and the vibration data. The results from the different accelerometers show significant variation. This could be due to location specific issues, or to difficulties in the installation of the monitors. This will be further explored during future vibration measurements.

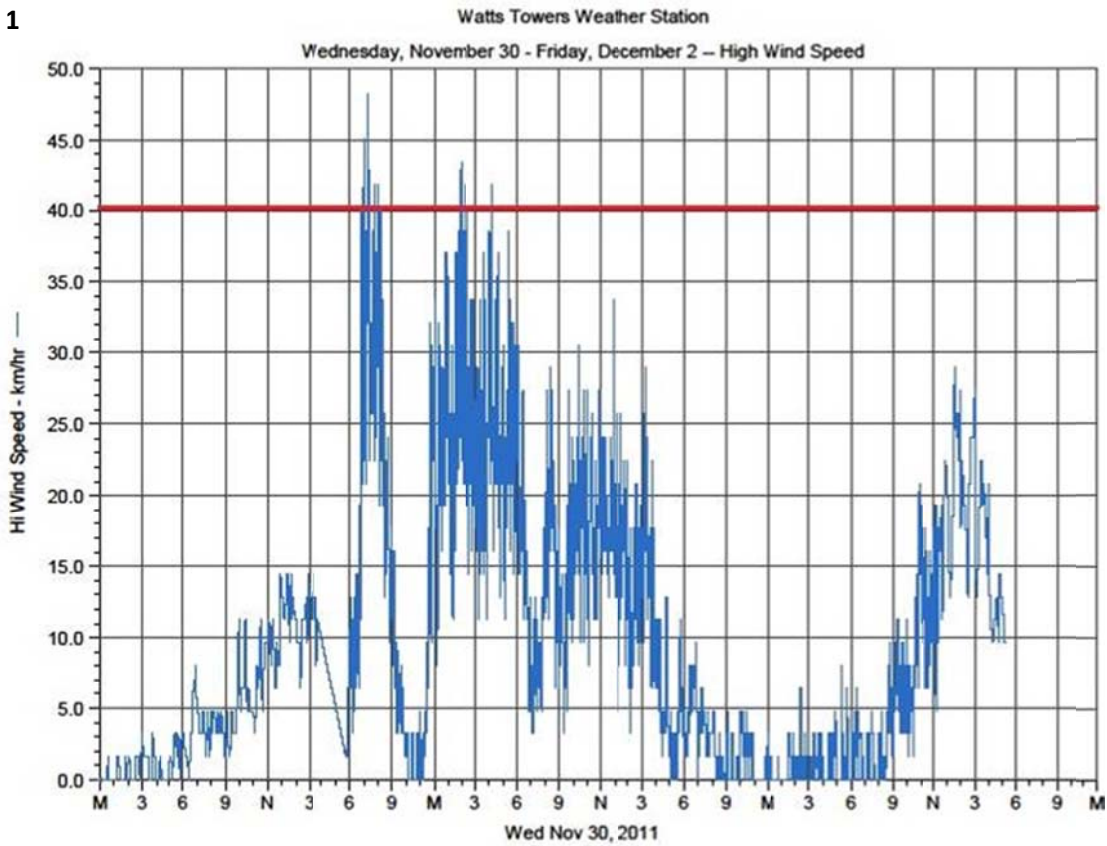
Figure 1

Wind speed data collected from 11/30 to 12/02 is summarized by the line graph in **Figure 1**. Average wind speed, high wind speed, wind direction and temperature data are summarized by line graphs in **Figure 2**.
