LACMA, DCA, and Watts Towers

Progress Report October 2012 through December 2012 (Seventh Progress Report)

Prepared for the DCA, City of Los Angeles, by Frank Preusser and Mark Gilberg

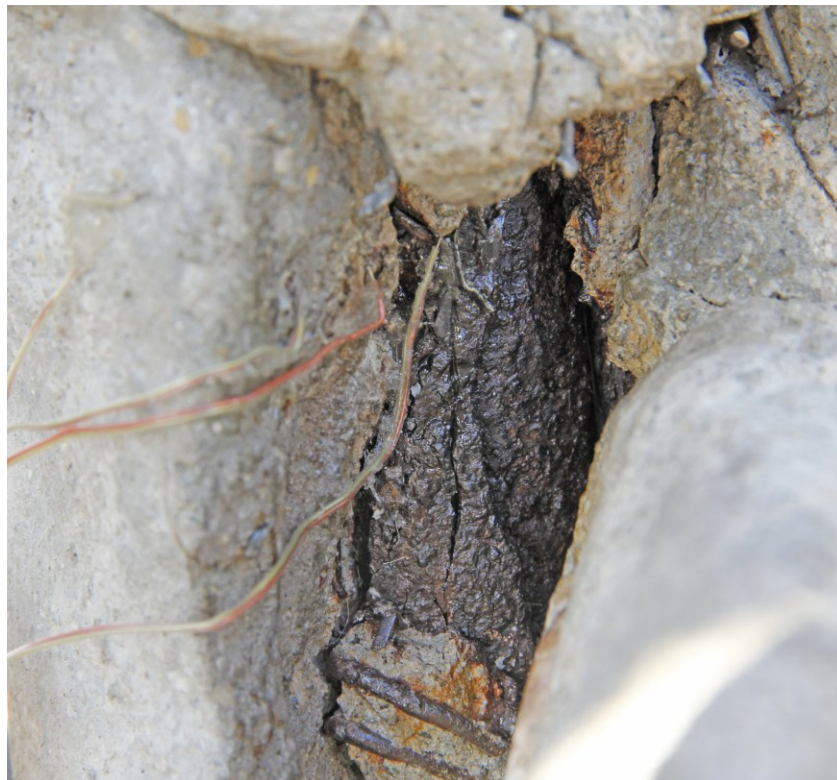
Figure 6: Thermocouples installed

The exposed steel was mechanically cleaned from loose corrosion products (rust), and then treated with tannic acid. Four thermocouples were installed, one directly on the steel, two at different depth on the cement plaster, and one on the surface (figure 6). The

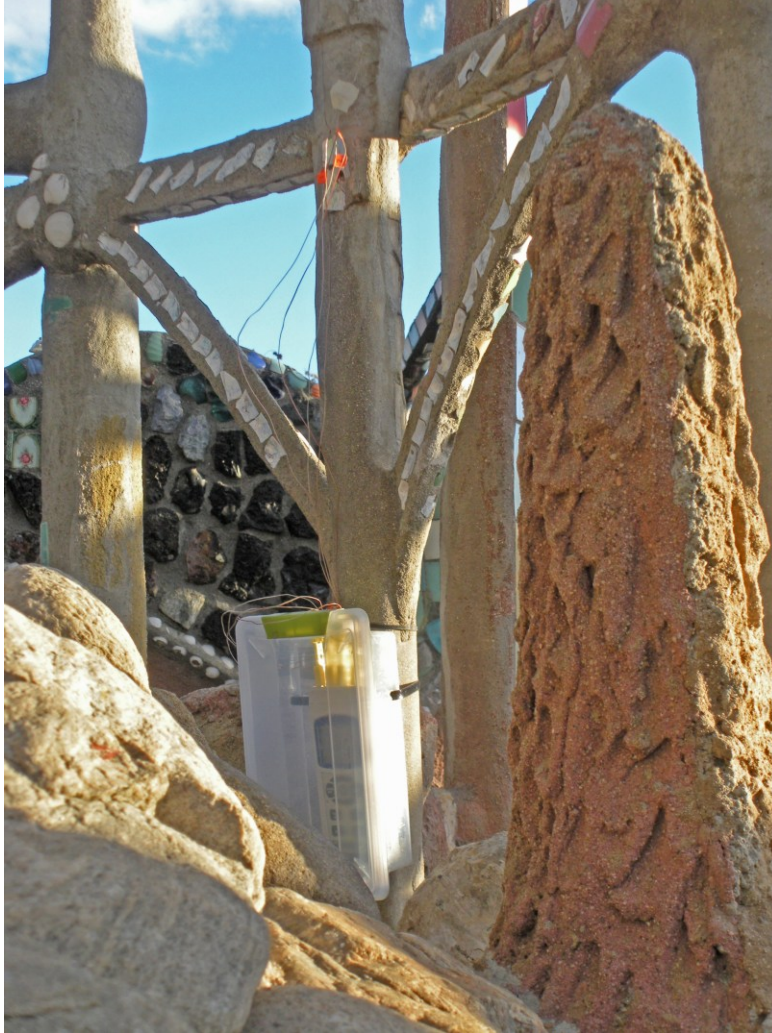
Figure 7: Completed installation

opening was then filled with an amended cement mortar and the thermocouples connected to a data-logger (figure 7).

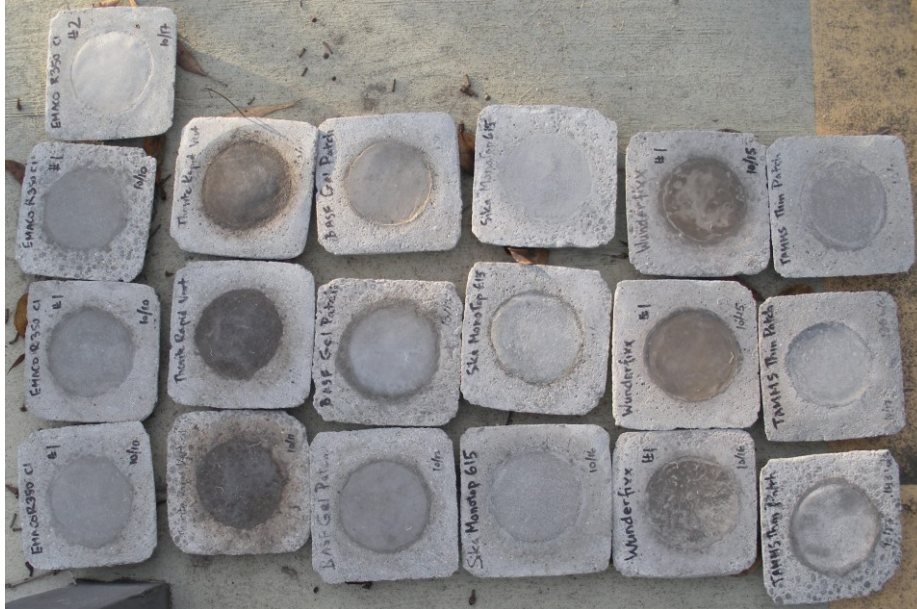
Figure 8: PMM workability and shrinkage test specimens

prepared (figure 8) and the mortars were evaluated for workability and shrinkage crack formation. The test plates consist of cast cement plates with a cavity, which then was filled with repair mortar. The plates are exposed outdoors on the house platform and in regular intervals inspected for shrinkage cracks and/or separation between repair mortar and cement plate.

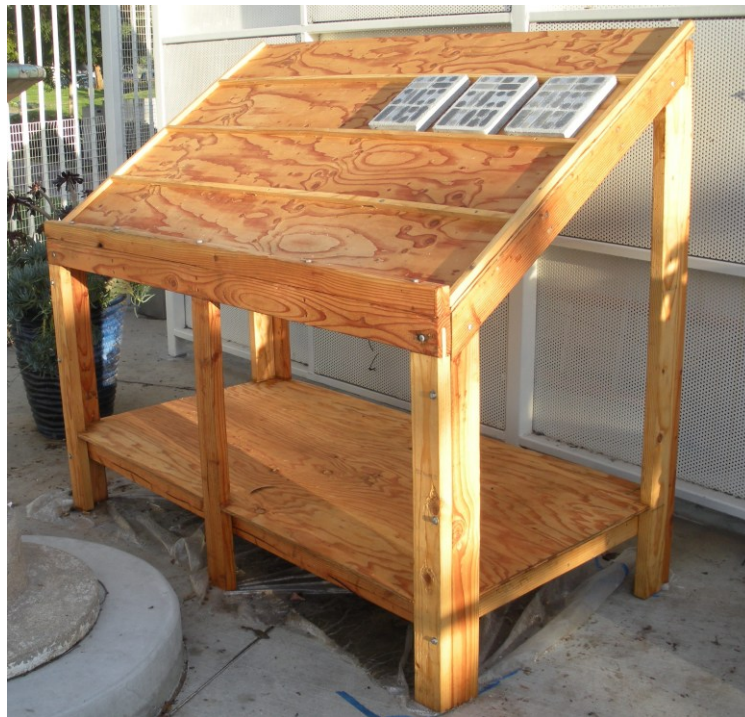
Figure 9: Exposure rack

Based on the results of these tests we reduced the number of mortars to be considered to seven. These seven mortars will undergo laboratory testing (temperature cycling in an oven at the Getty Conservation Institute; potential physical testing at UCLA), outdoor exposure on a recently completed exposure rack (South facing at a 35 degree angle; figure 9), and limited *in-situ* testing at areas of previously failed restorations on the monument.

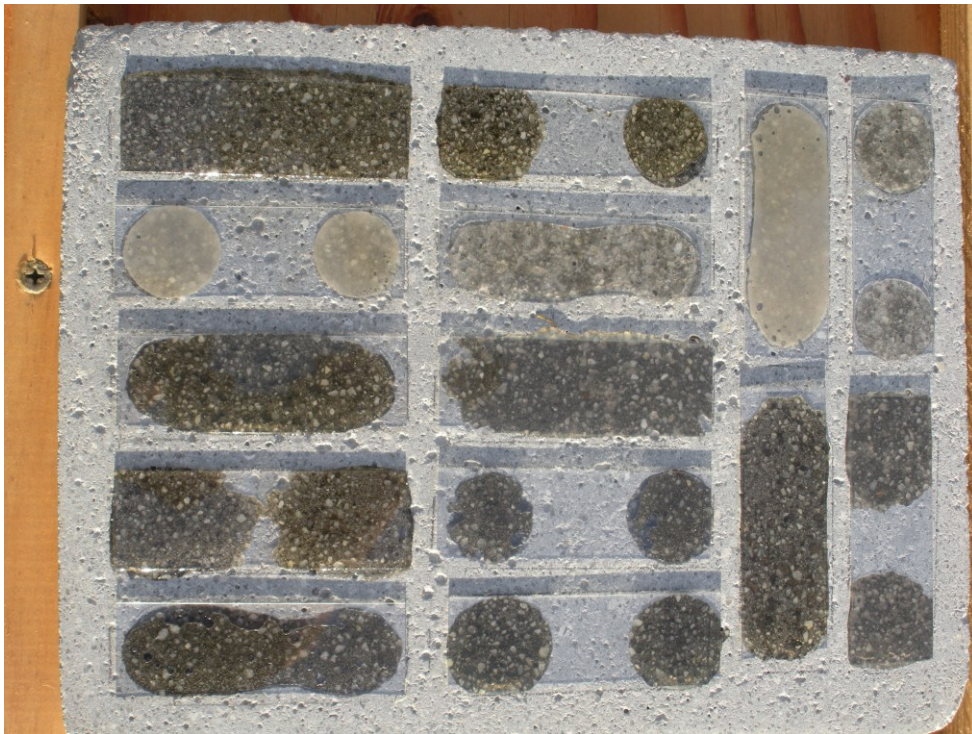
Figure 11: Adhesives test plate

All adhesives that have been used in the past to re-attach ornaments, or secure loose ornaments have failed. Sylvia identified a dozen adhesives that may have better performance. She prepared Portland cement test plates and adhered glass plates (microscope slides) to them (figure 11). These test plates are currently undergoing thermal cycling in the environmental oven at LACMA's Conservation Center. A second set is being exposed to UV-B radiation in a ultra-violet exposure chamber, and a third set is undergoing outdoor exposure.
