LACMA, DCA, and Watts Towers

Progress Report January 2013 through March 2013 (Eighth Progress Report)

Prepared for the DCA, City of Los Angeles, by Frank Preusser and Mark Gilberg

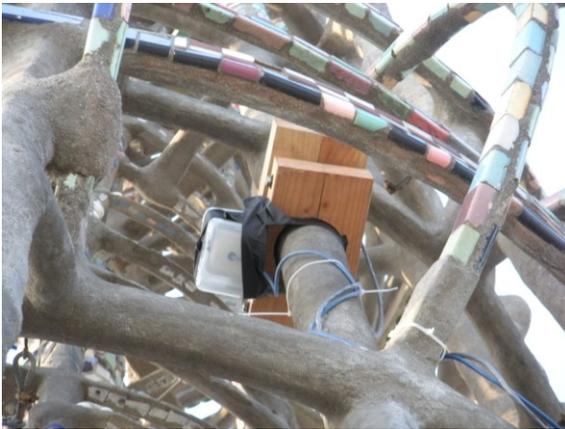
Figure 1:

On January 23 Profs. Ertugrul Taciroglu and Robert L. Nigbor (UCLA Department of Civil & Environmental Engineering) installed a tilt meter, one accelerometer, and the associated computer system at the Center Tower (figure 1). On March 12 they added the Wind Observer II (figure 2). The latter is a more sophisticated instrument for measuring wind speed and direction and turbulences than our existing weather station. They also

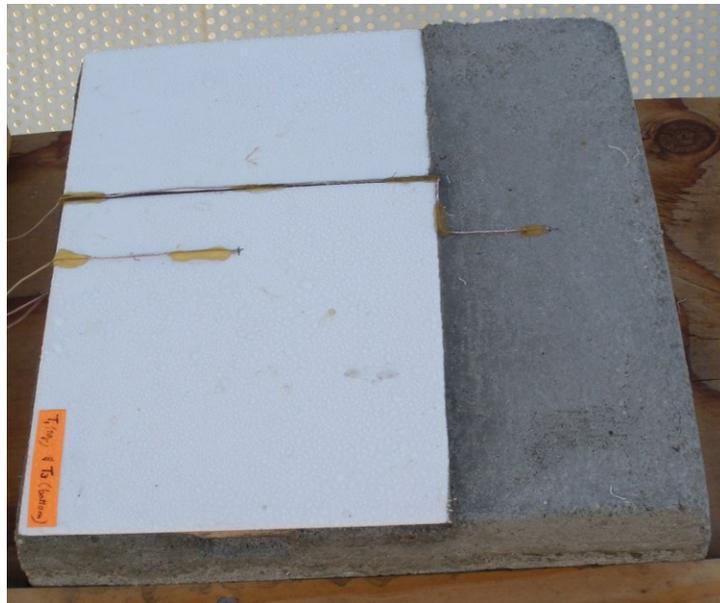
Currently the thermal imaging program is on hold due to other, more pressing issues. To further evaluate the effect of the ornaments on the temperature profile at the Towers we created a test plate (figure 3) in which we embedded thermocouples under a tile and in undecorated concrete and on the surfaces of the tile and the concrete. The test plate was placed on our exposure rack. The results (figure 4) confirm previous findings that generally the undecorated concrete heats up significantly more than the concrete under tile decorations.

Figure 3: test plate for thermal test

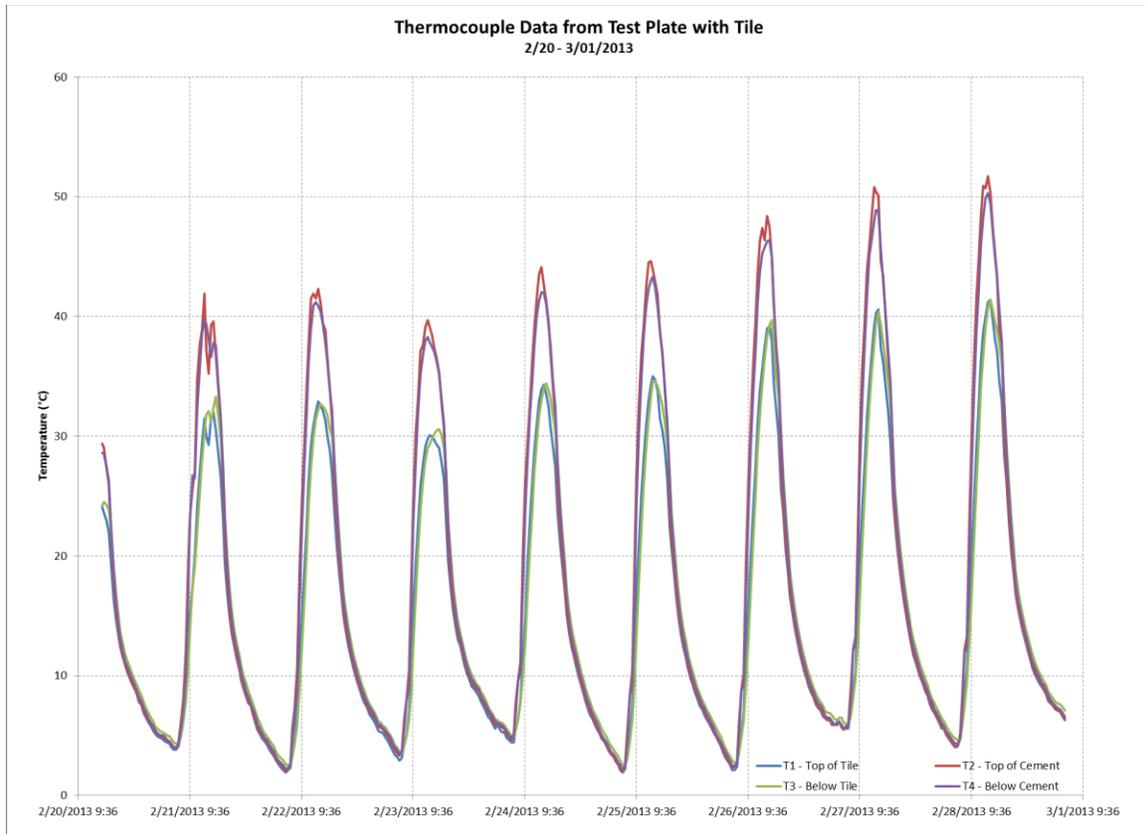
Figure 4: results of thermal test

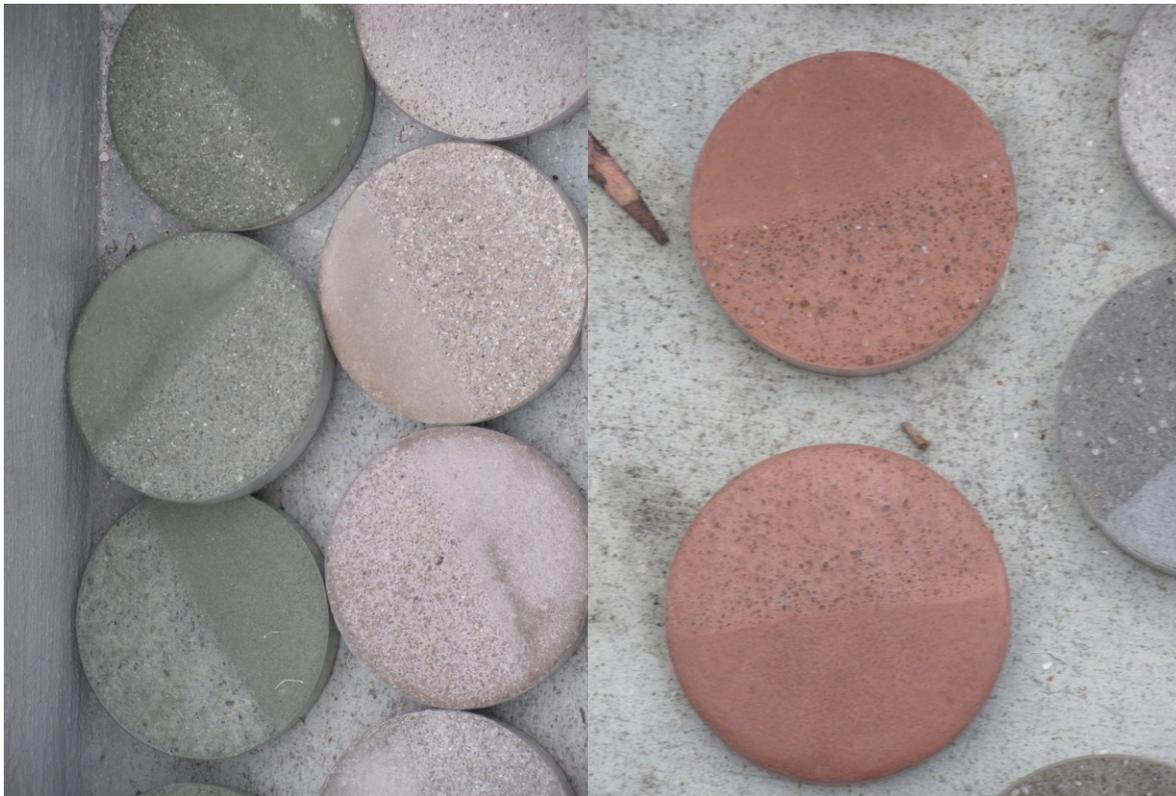
Figure 5:

Additional experiments were carried out to develop procedures to simulate the weathered appearance of Rodia's plaster and older repairs⁵. Figures 5 and 6 show the successful modification of the surface of amended mortar test samples.
