THE WATTS TOWERS
CONSERVATION REPORT

THE GAZEBO

June 1994

CONSERVATION OF THE GAZEBO
WATTS TOWERS CONSERVATION PROGRAM

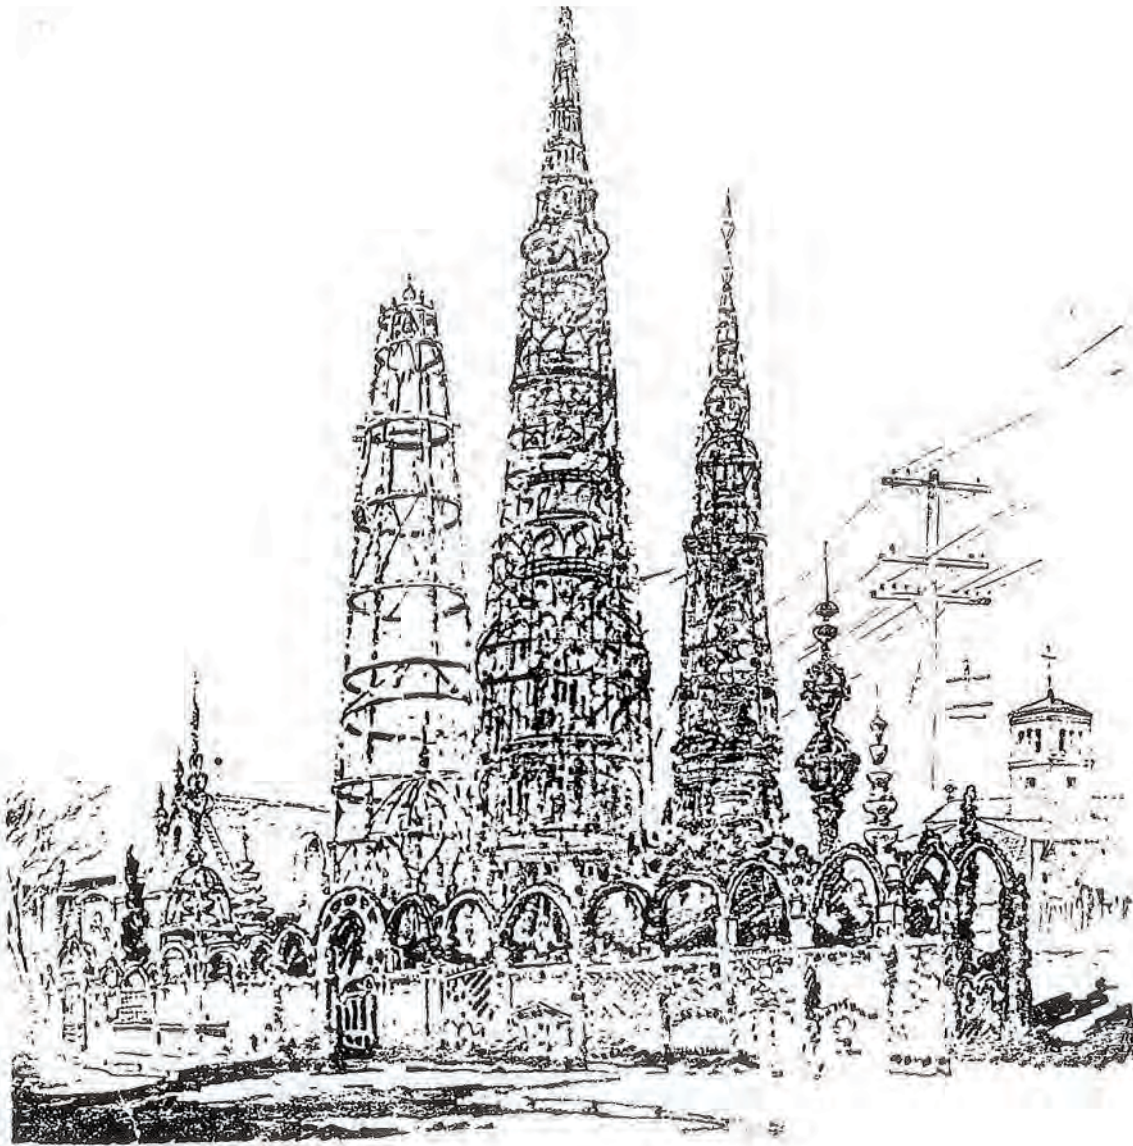
Figure 3.
Gazebo, left of tallest tower
through unfinished tower. Appears
the same as in Fig. 2.
L.A. Times 1939 sketch.

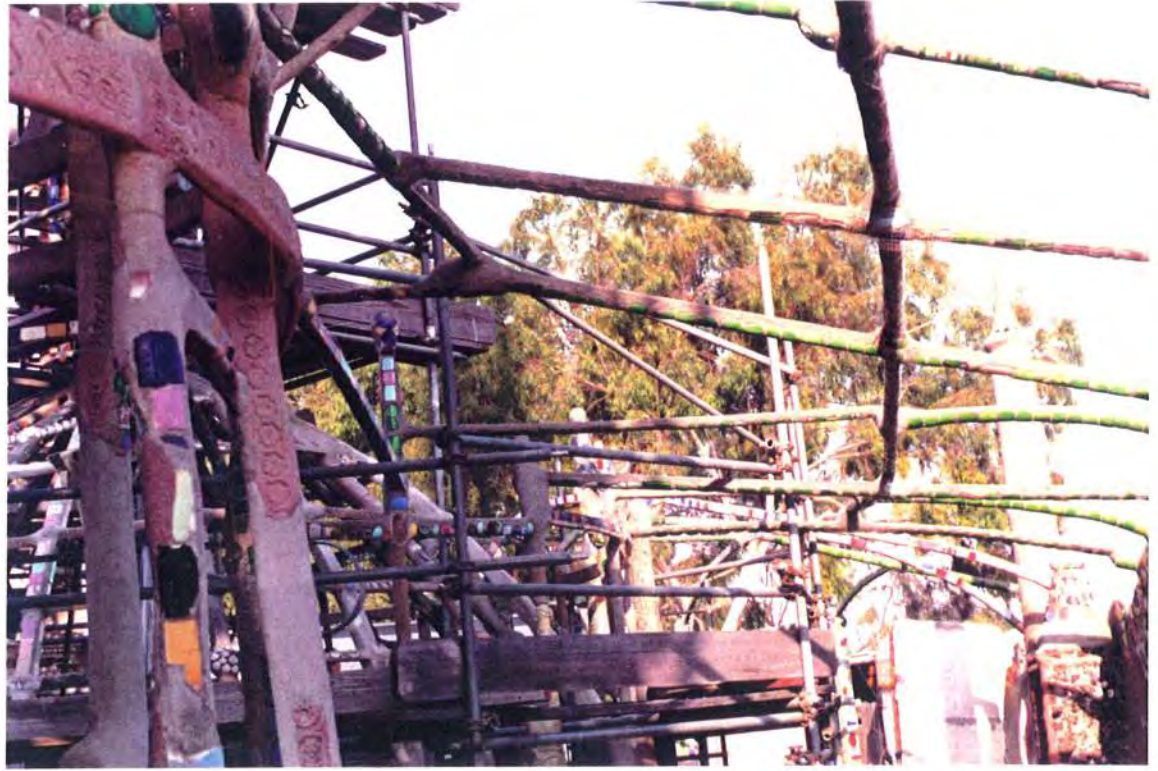
Figure 5.
Overheads between the North
Wall and Gazebo built after
1949.
Oct 1992.

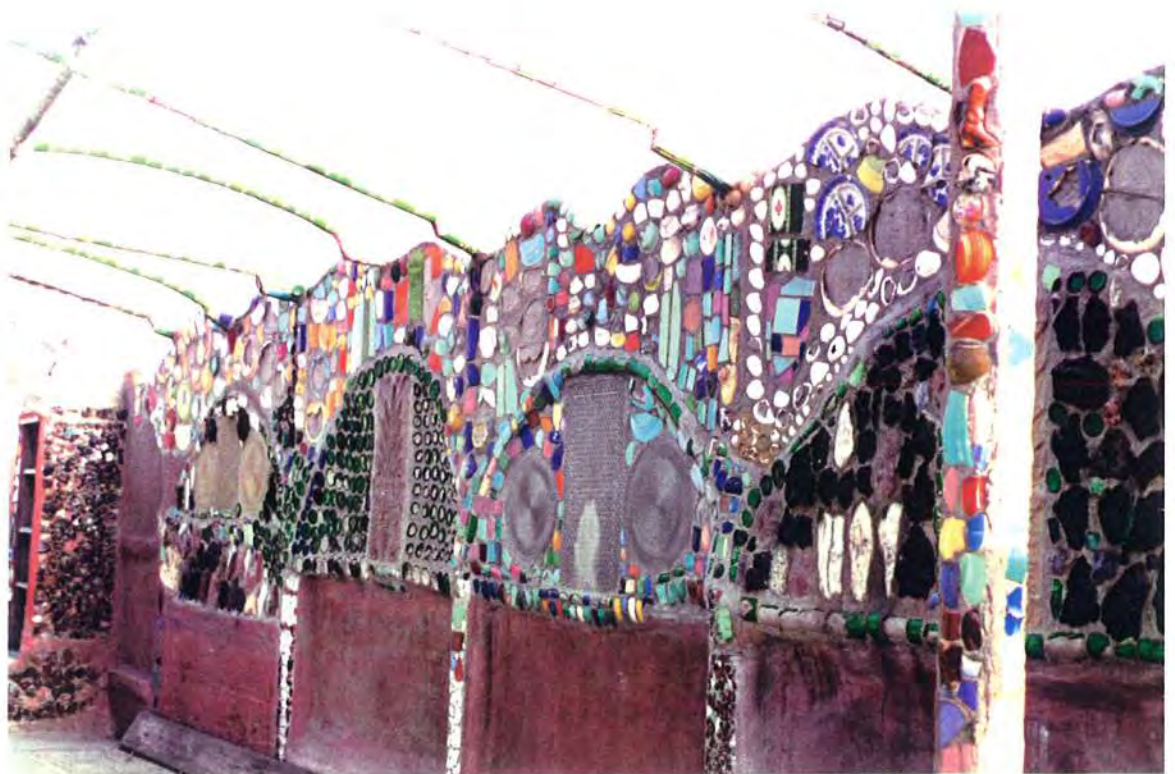
Figure 6.
Overheads from Gazebo to
North Wall built after
1949.
Sep 1992

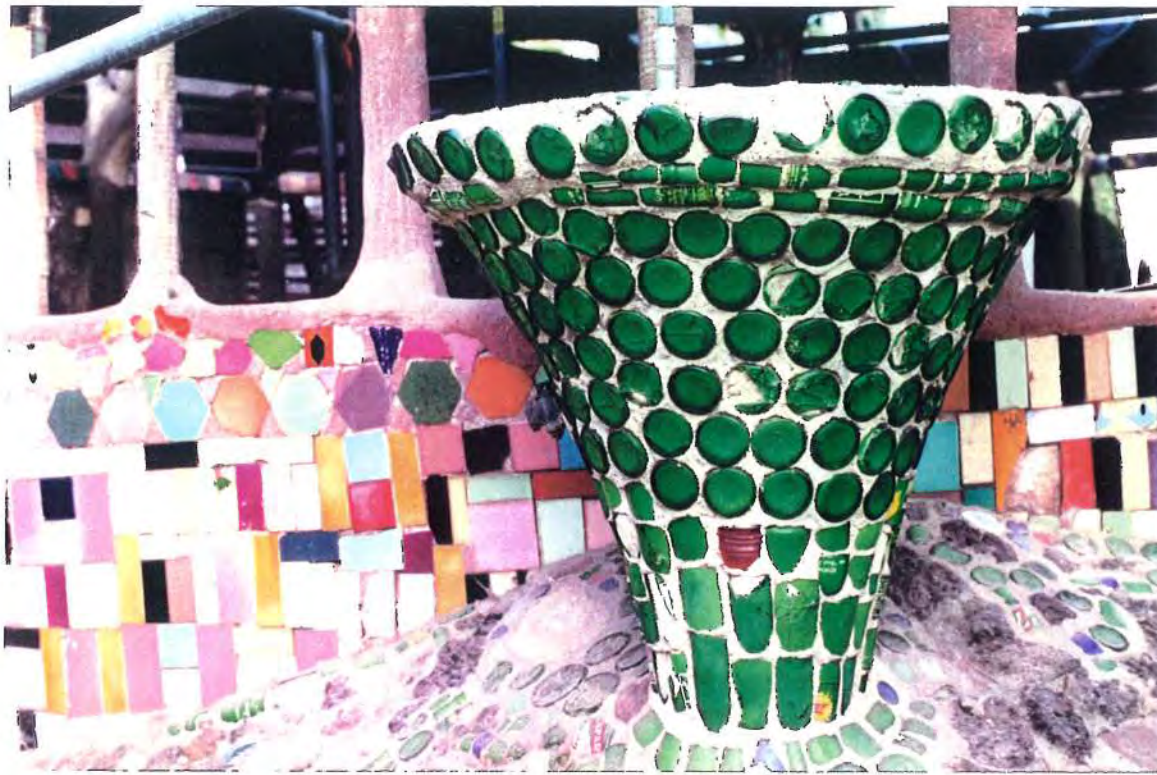
Figure 7.
Birdbath S.E. of Gazebo
built after 1949.
Sep 1992.

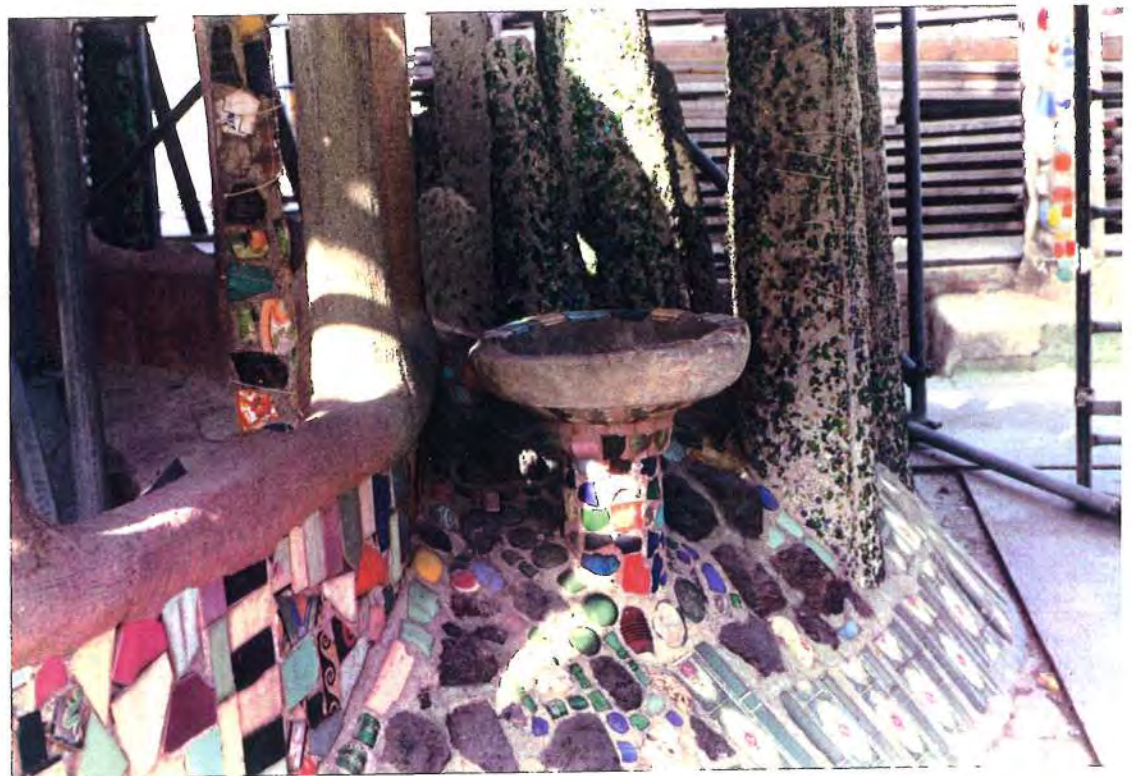
Figure 8.
Birdbath formerly on S.E.
side of Gazebo moved to
N.W. side after 1949.
Sep 1992.

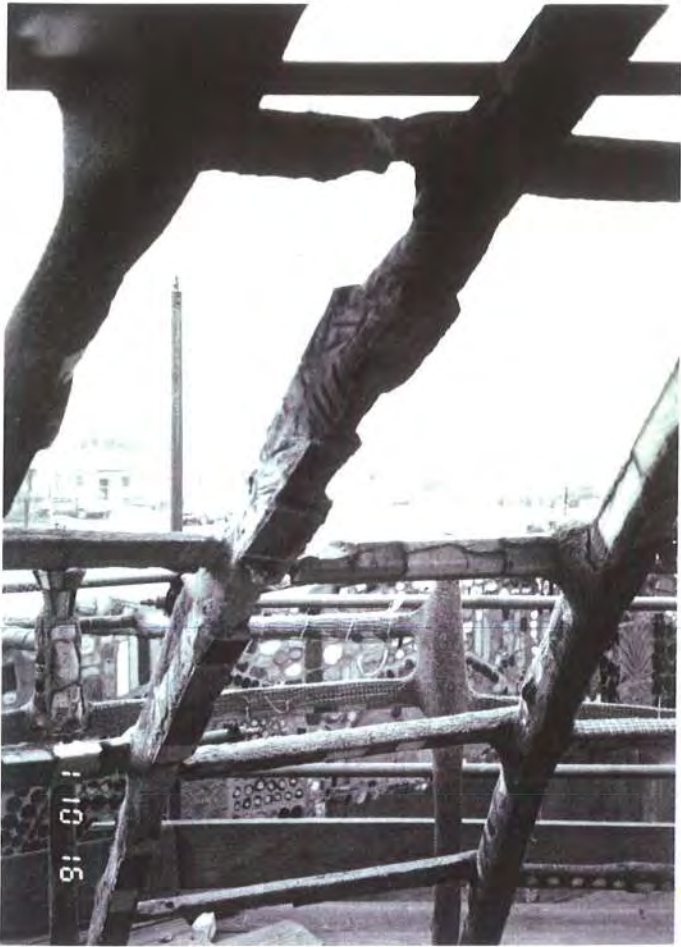
Figure 24.
Top of photograph shows
support MajV02 after repair
mortar application over
new 'T' reinforcement.
Oct 1991.

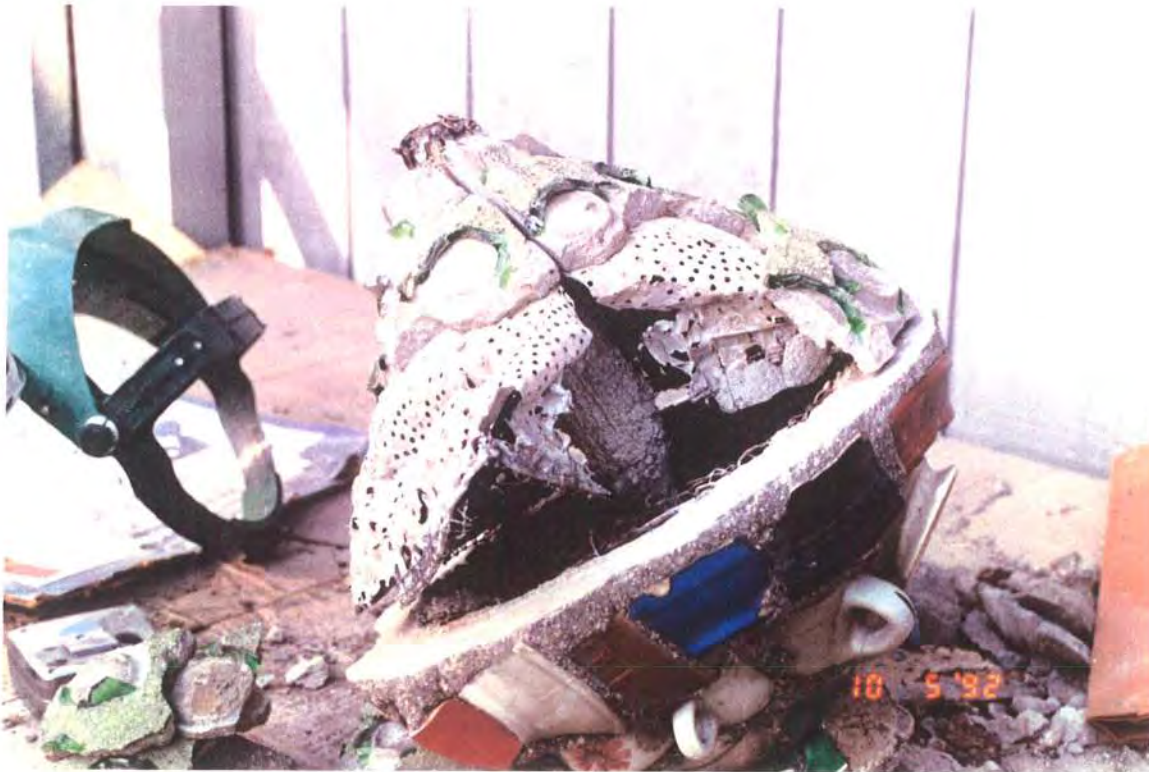
Figure 27.
Finial from top of damaged
outer vertical after removal.
Oct 1992.

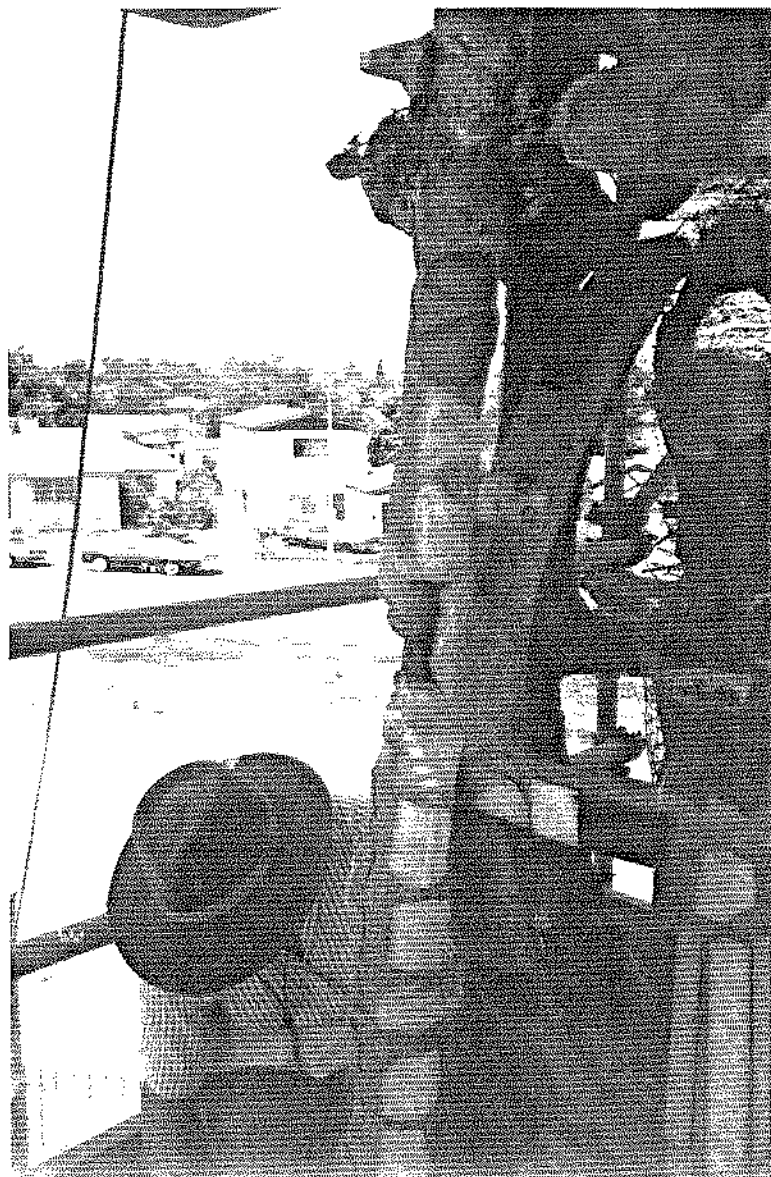
Figure 74. Horizontal band (#9 at G level) after detachment for removal of rust and mortar. July 1993.

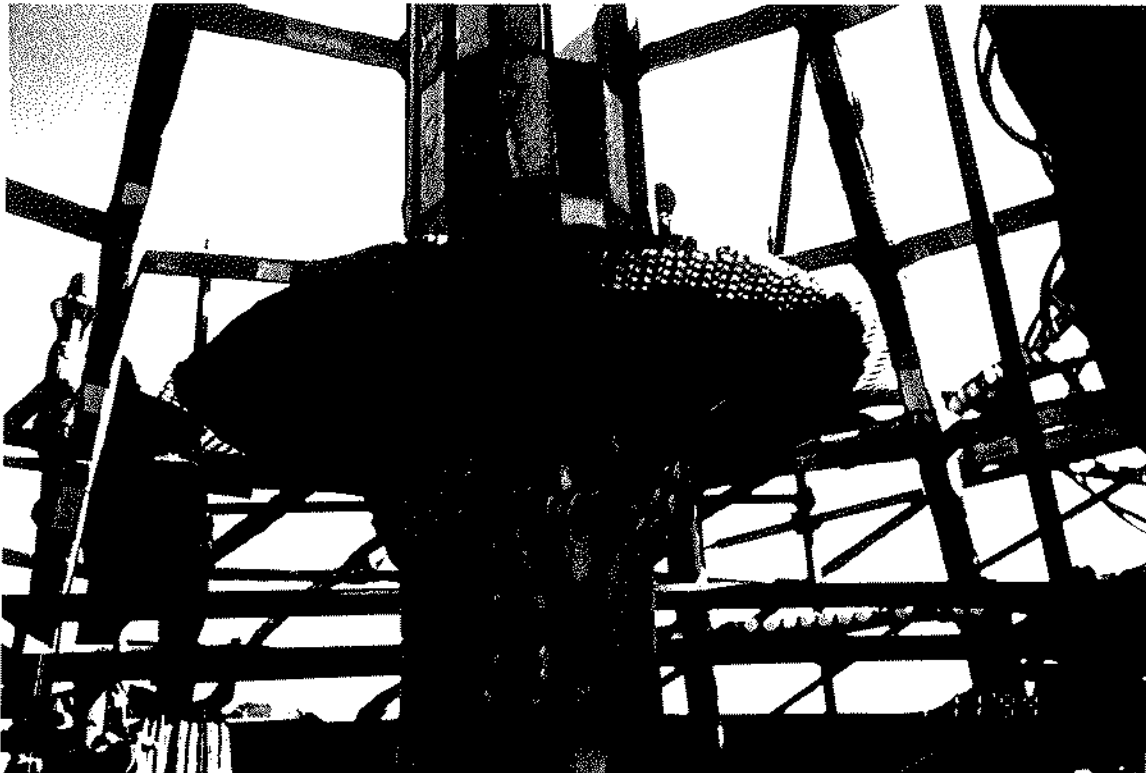
Figure 92. Center column base decorative flange at 5 foot elevation after removing mortar and ornaments and wrapping with steel mesh. (B level). January 1994.

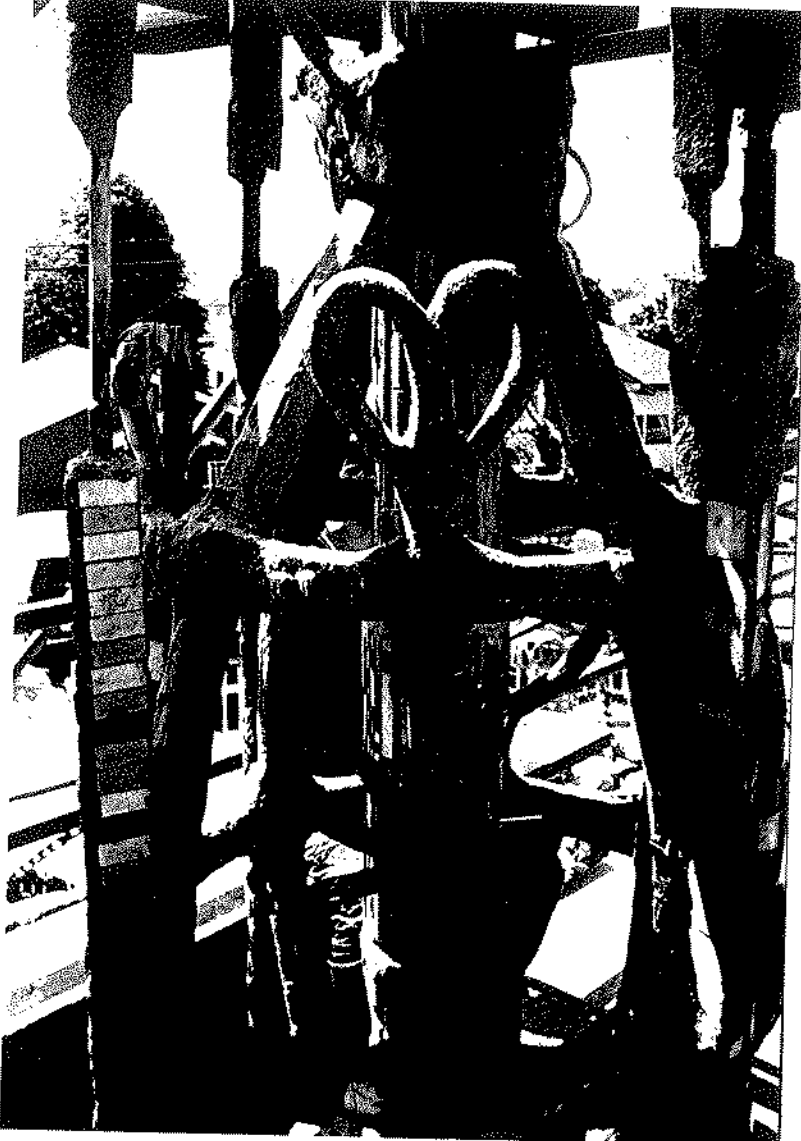
Figure 102. Damaged vertical arc, left center of photo, before conservation. (G level). March 1994.

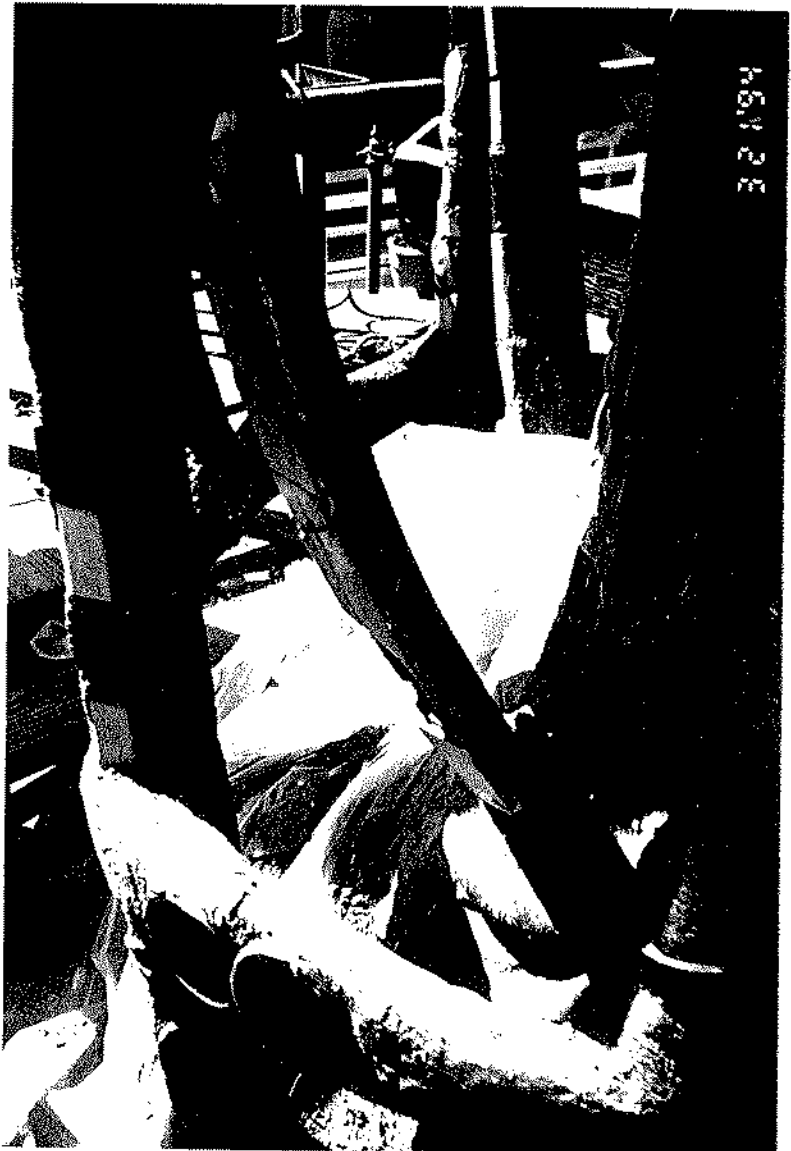
Figure 103. Damaged vertical arc, left center of photo, before conservation. (D level). March 1994.

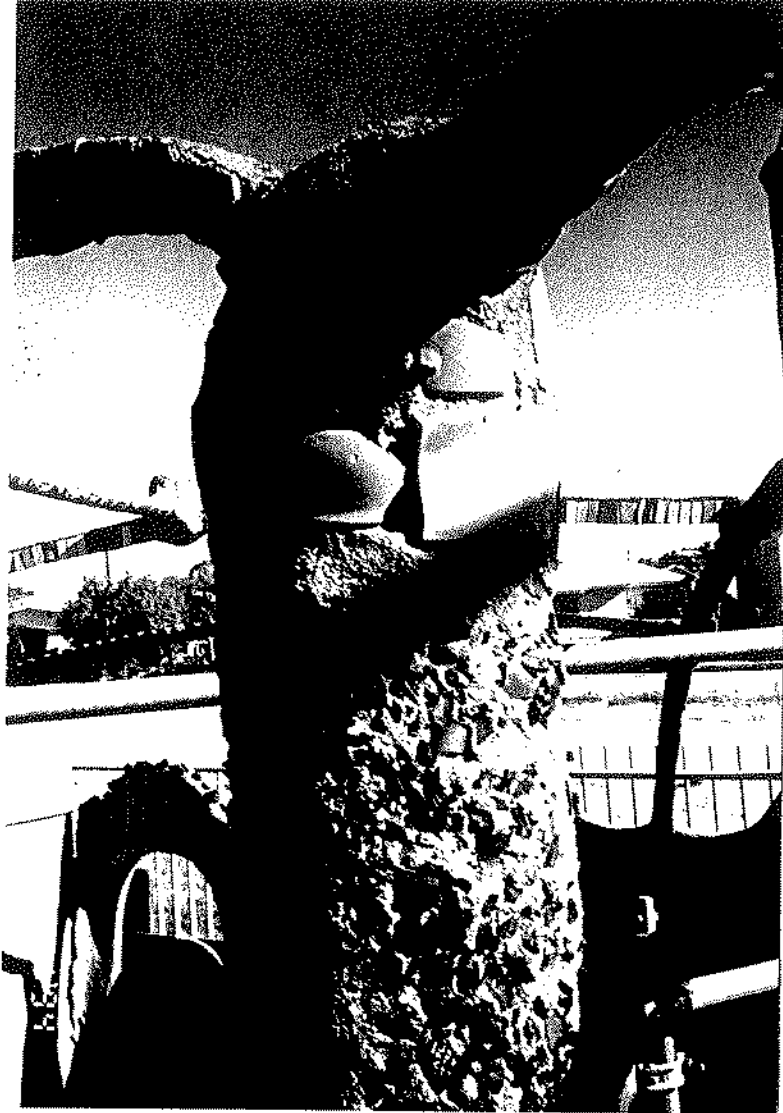
Figure 110. Rebond ornaments with Jahn mortar, top center of photo. (C level). April 1994.

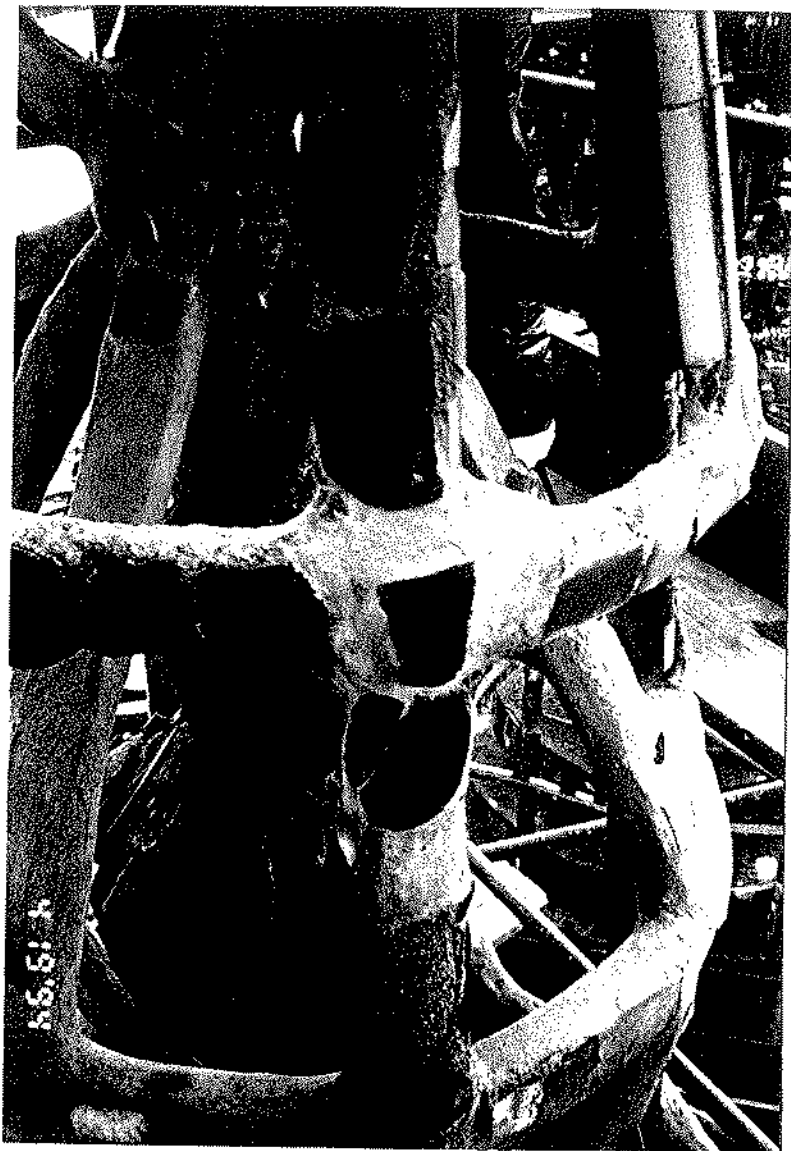
Figure 112. Build-up joint between ring and vertical column, center of photo. (F level). April 1994.

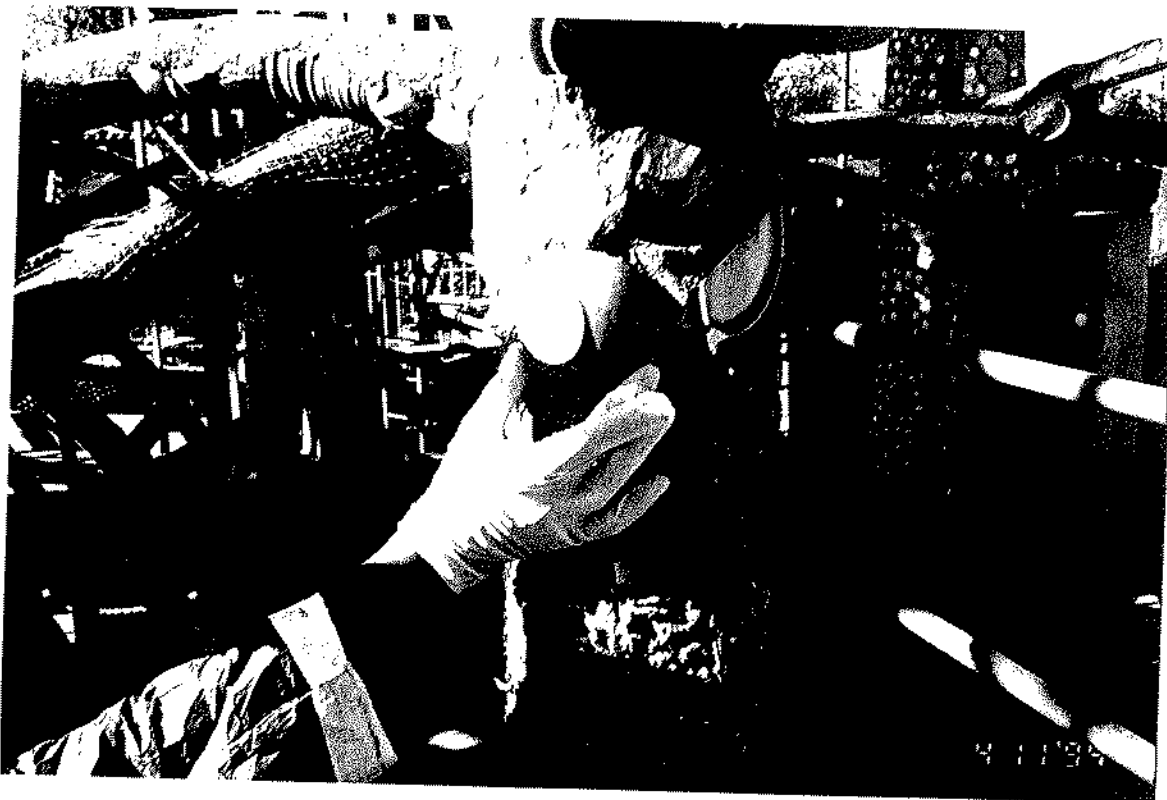
Figure 113. Rebond original ornaments with Jahn mortar. (C level). April 1994.

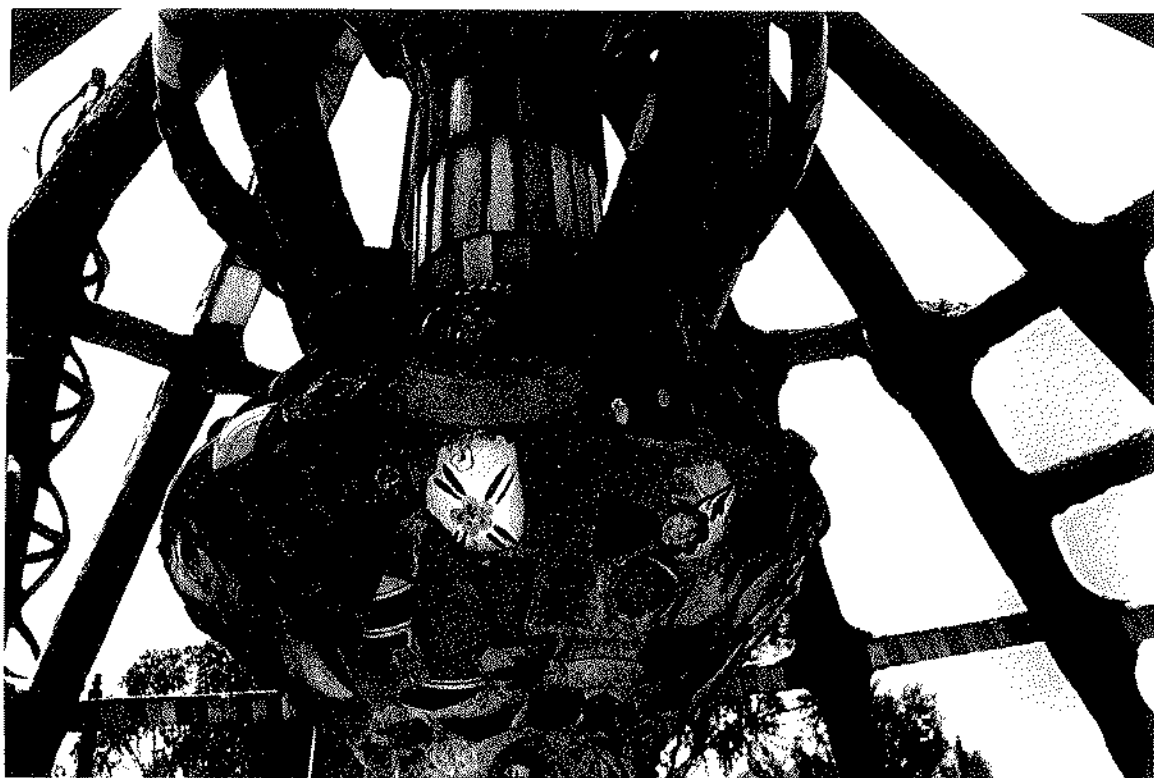
Figure 115. Bowl under dome before conservation work. (C level). May 1994.
